**Monitoring of Cultural Resources within Segments
of U.S. 180, U.S. 60, NM 12, NM 32, NM 36, and NM 435
for Tree Thinning in Catron County, New Mexico**

ARCHAEOLOGY NOTES 337

NMDOT Project No: TPS-180-1(1)19, CN 3954.

MNM Project No: 41.742 (Catron County Tree Thinning).

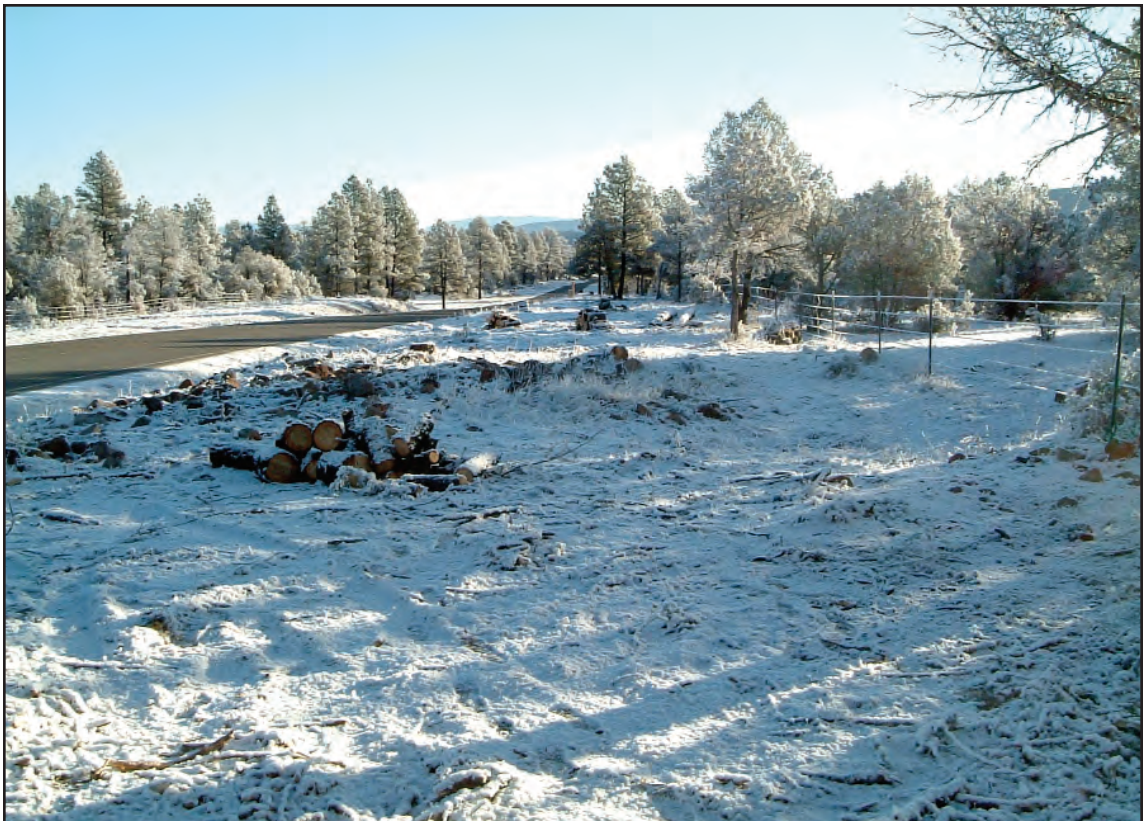
Effects of Tree-thinning Project: The archaeologist asked the tree-thinning crew to notify her when work was to start along NM 12 so she could monitor this previously excavated site, as requested by the USDA Forest Service. However, OAS staff discovered that the crew had cut trees on the site (Fig. 4) without notifying the monitoring archaeologist. Inspection of the site determined that no site damage had occurred as a result of thinning activities.

Figure 4. LA 39968 after tree clearing.

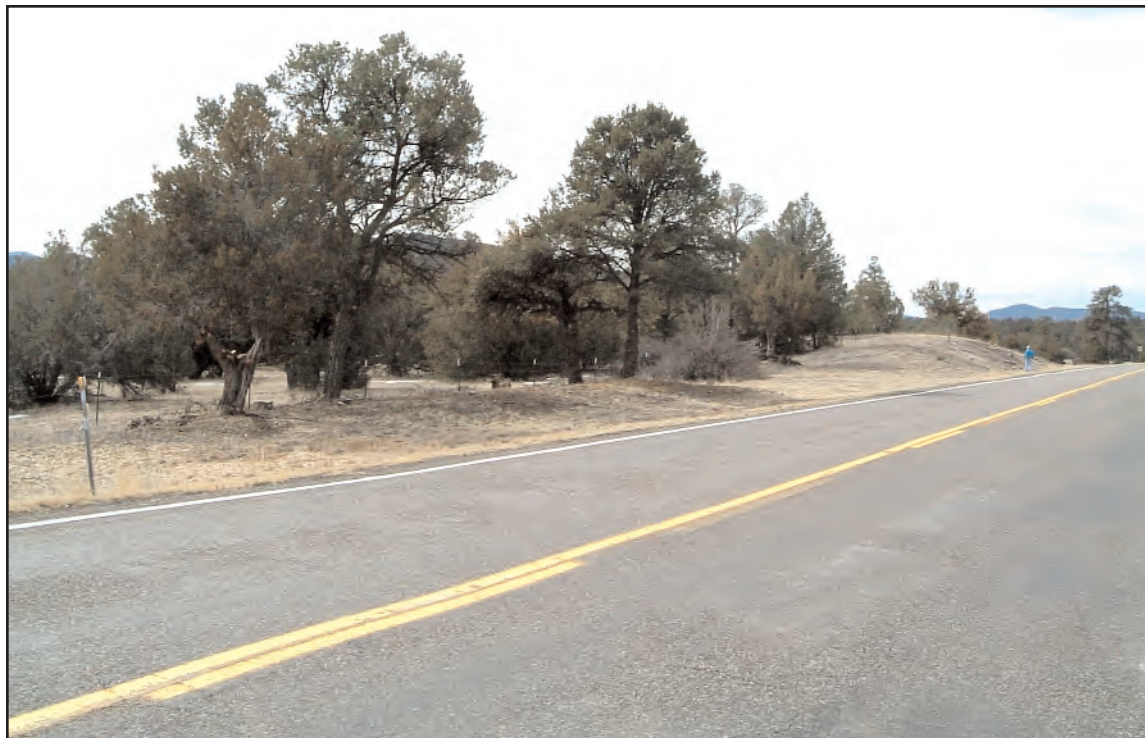
Results of Monitoring: Elkhorn Construction notified OAS that tree thinning was approaching LA 43885. OAS archaeologists mapped the site (Fig. 5) and took photographs of it (Fig. 6) before the thinning crew arrived. Only the east side of the highway required monitoring; no trees were present on the slope on the west side. The tree-thinning process was monitored by OAS. No equipment was driven on the site, and trees were lifted off of the site before chipping and mulching. Cut wood was stacked on the slope immediately adjacent to the bar ditch so that no traffic would occur on the site. The process went smoothly, and no damage was done to the site.

Figure 6. Trees to be cut at LA 43885, on the east side of NM 12.

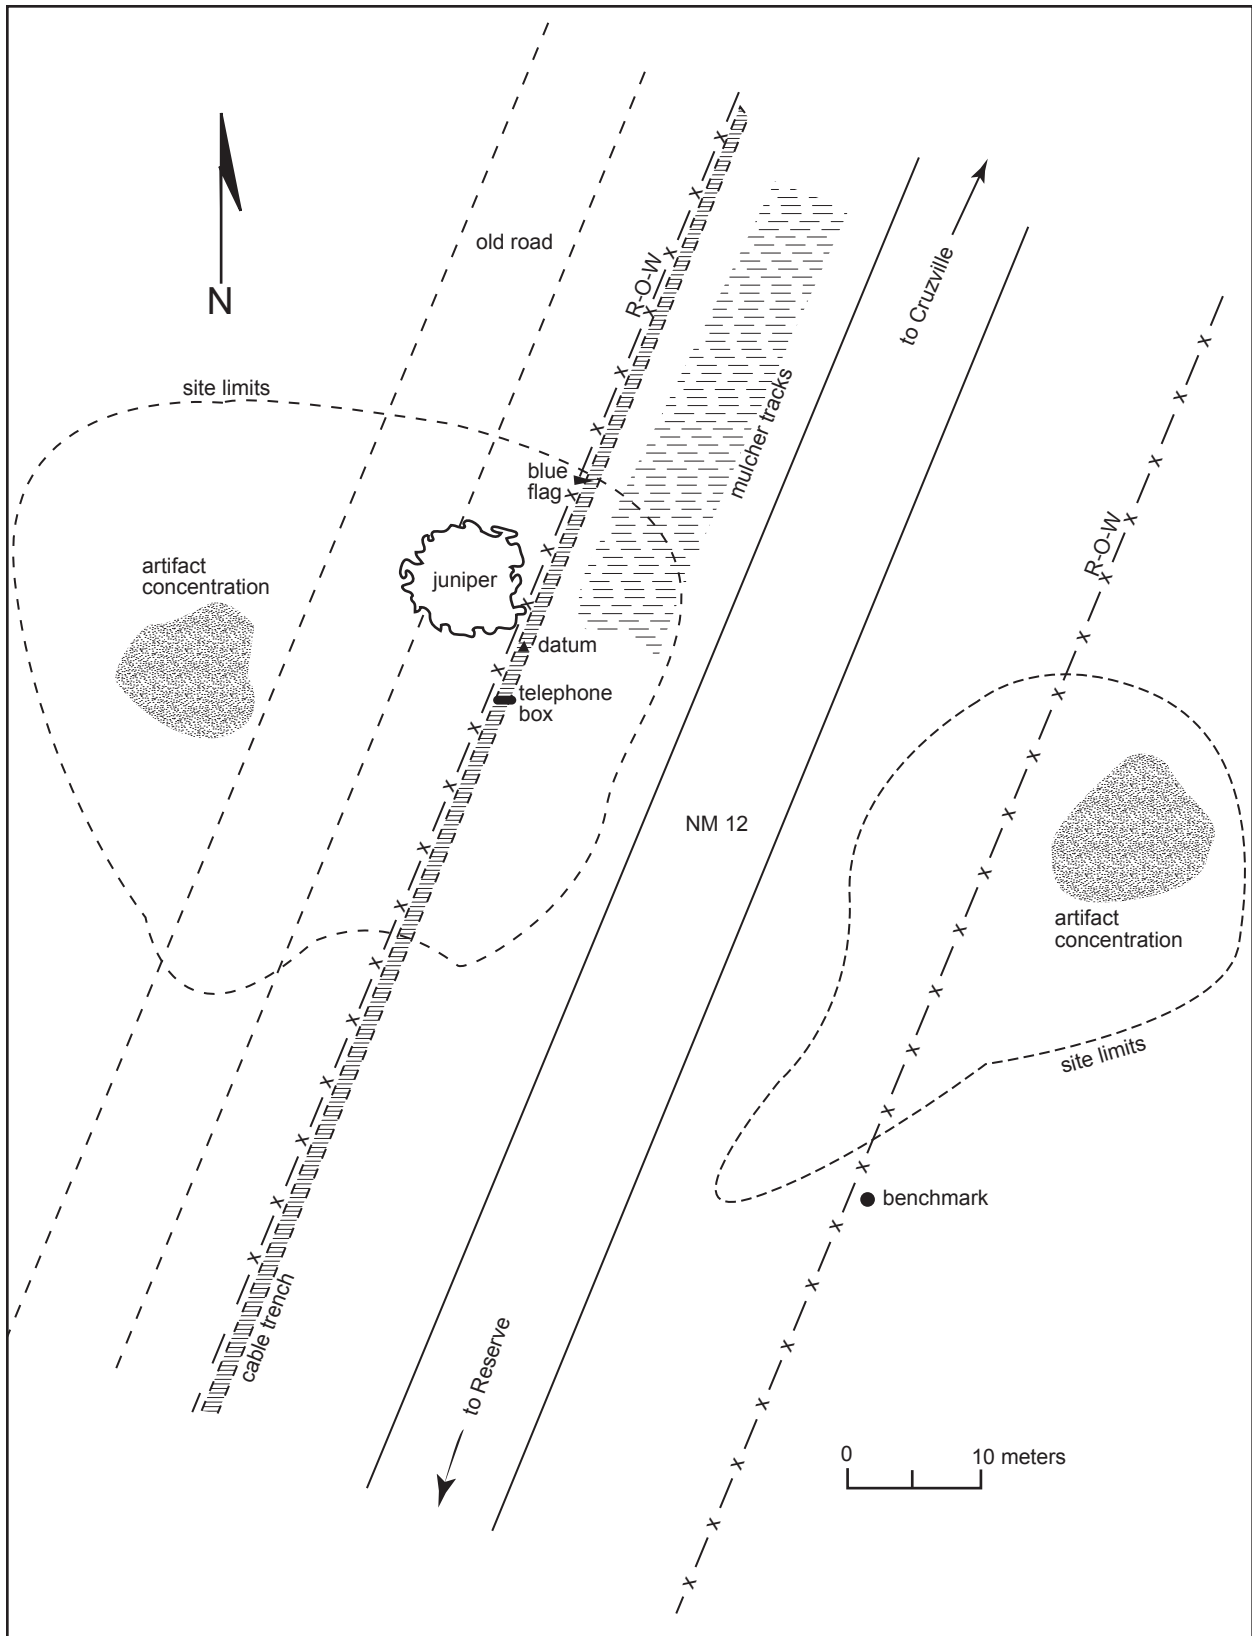
Figure 7. Site map of LA 143613, showing location of mulcher tracks.

At LA 143613, deep tread tracks resulted from tree removal at the north end of the site (see Fig. 7). Surface artifacts on the site in this area were not damaged.

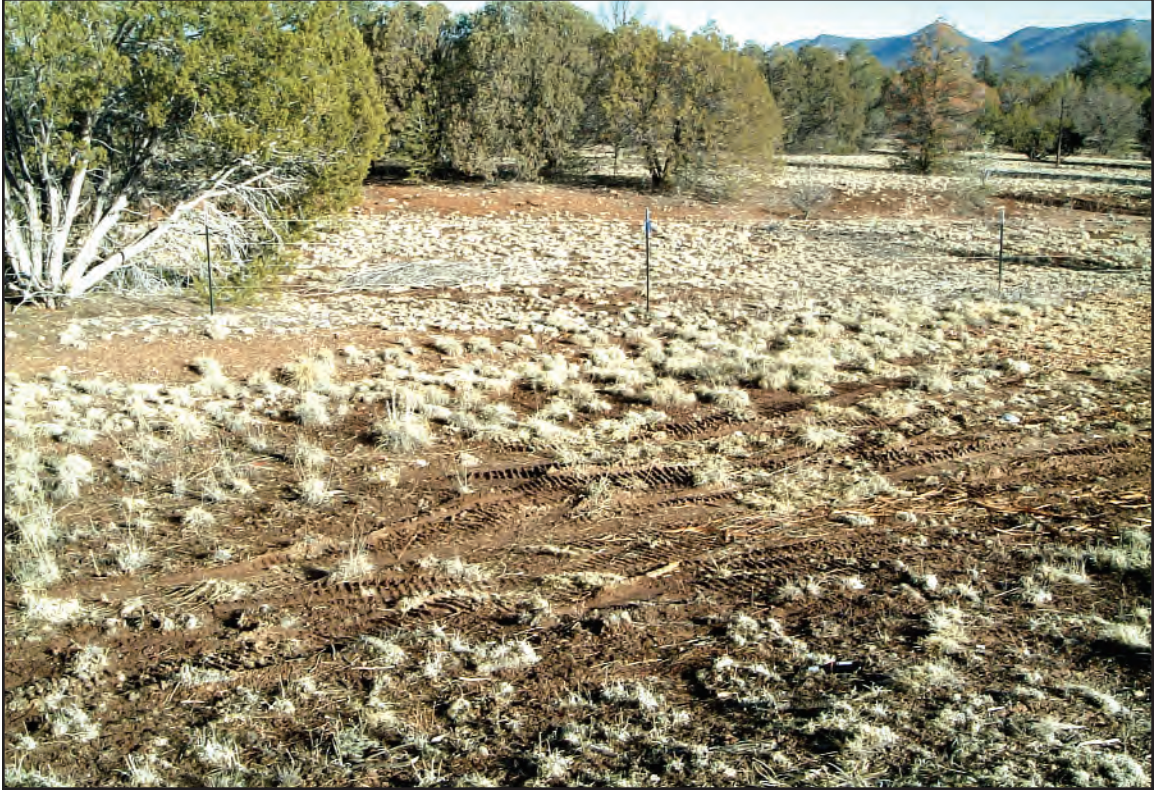
Figure 9. North end of LA 143613, showing mulcher tracks.

area. Heavy rains earlier in the week caused the mulcher to leave heavy tire imprints on the northern 18 ft of the site (Fig. 9). This activity by the mulcher was confirmed by NMDOT District 6 personnel.

A thin scatter of artifacts extends across the highway at the site. The tire tracks cut into the wet soil to a depth of 2 inches. No artifacts were broken by this disturbance. We believe that pithouses could be present in this disturbed area, but damage to the site was surficial, and an assessment of potential subsurface damage cannot be made.

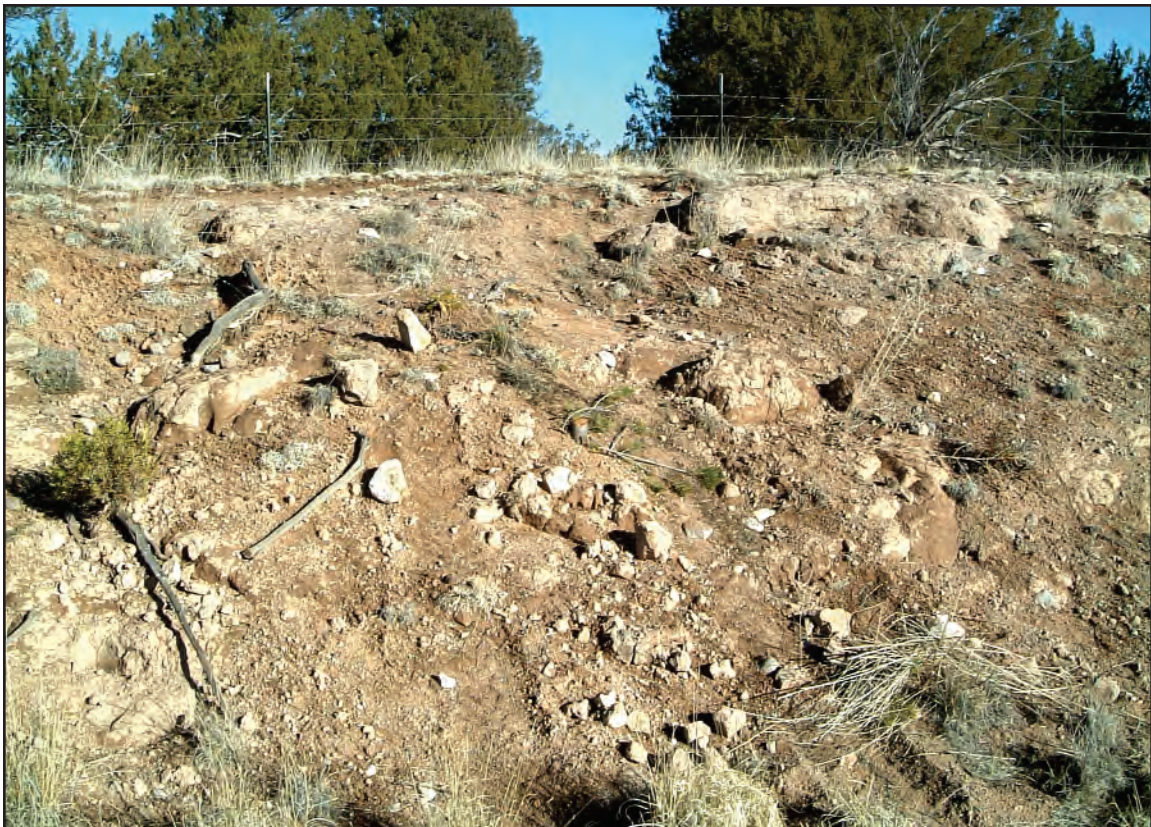
Effects of Tree-thinning Project: The archaeologist was not notified prior to tree thinning at LA 43884; however, no damage was done to the site during thinning. ATV trails run through the centers of both sides of the right-of-way. On the west side, this ATV trail runs over hundreds of artifacts and several probable pithouses. OAS noted recent tracks on these trails and very recent tracks running vertically up the road shoulders onto the site, directly over possible pithouses (Fig. 10). The thinning crew did not create these tracks. The installation of a fiber optics line left a cleared trail across LA 43884 and many other sites to the north along NM 12. This trail is now used extensively by ATVs and four-wheel-drive trucks. The site is in extreme danger of losing structural and artifactual integrity to erosion and vehicular traffic. A new site map was drawn with adjusted boundaries (Fig. 11).

Figure 10. Tire tracks at LA 43884 going up highway shoulder onto site.

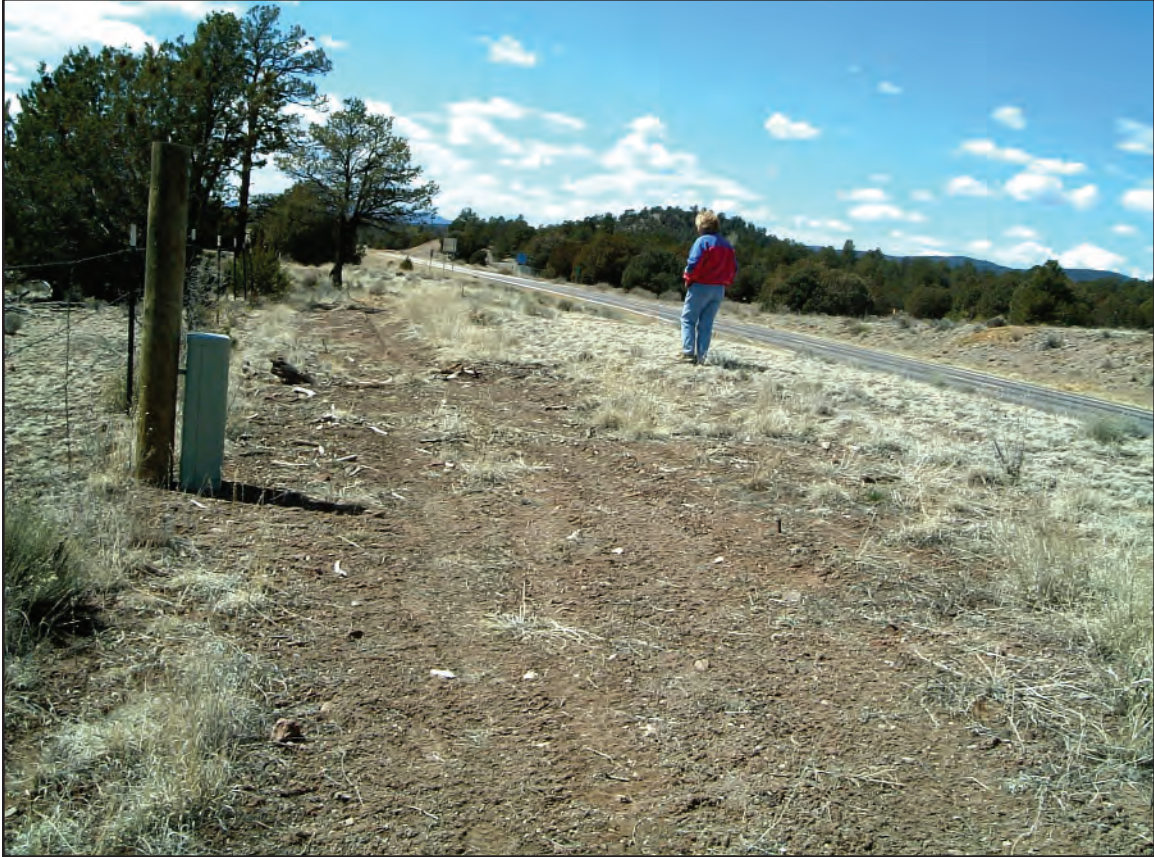
An ATV trail runs along the fence (see description of LA 43884, above), and the tracks visible on the trail indicate that the mulcher and other vehicles used the trail to traverse the site (Fig. 13). There was no visible damage to the site, since the trail already existed, but thinning equipment should not have been permitted on the site, which was on the avoidance list and flagged.

Figure 13. LA 43896, showing ATV trail and mulcher tracks.

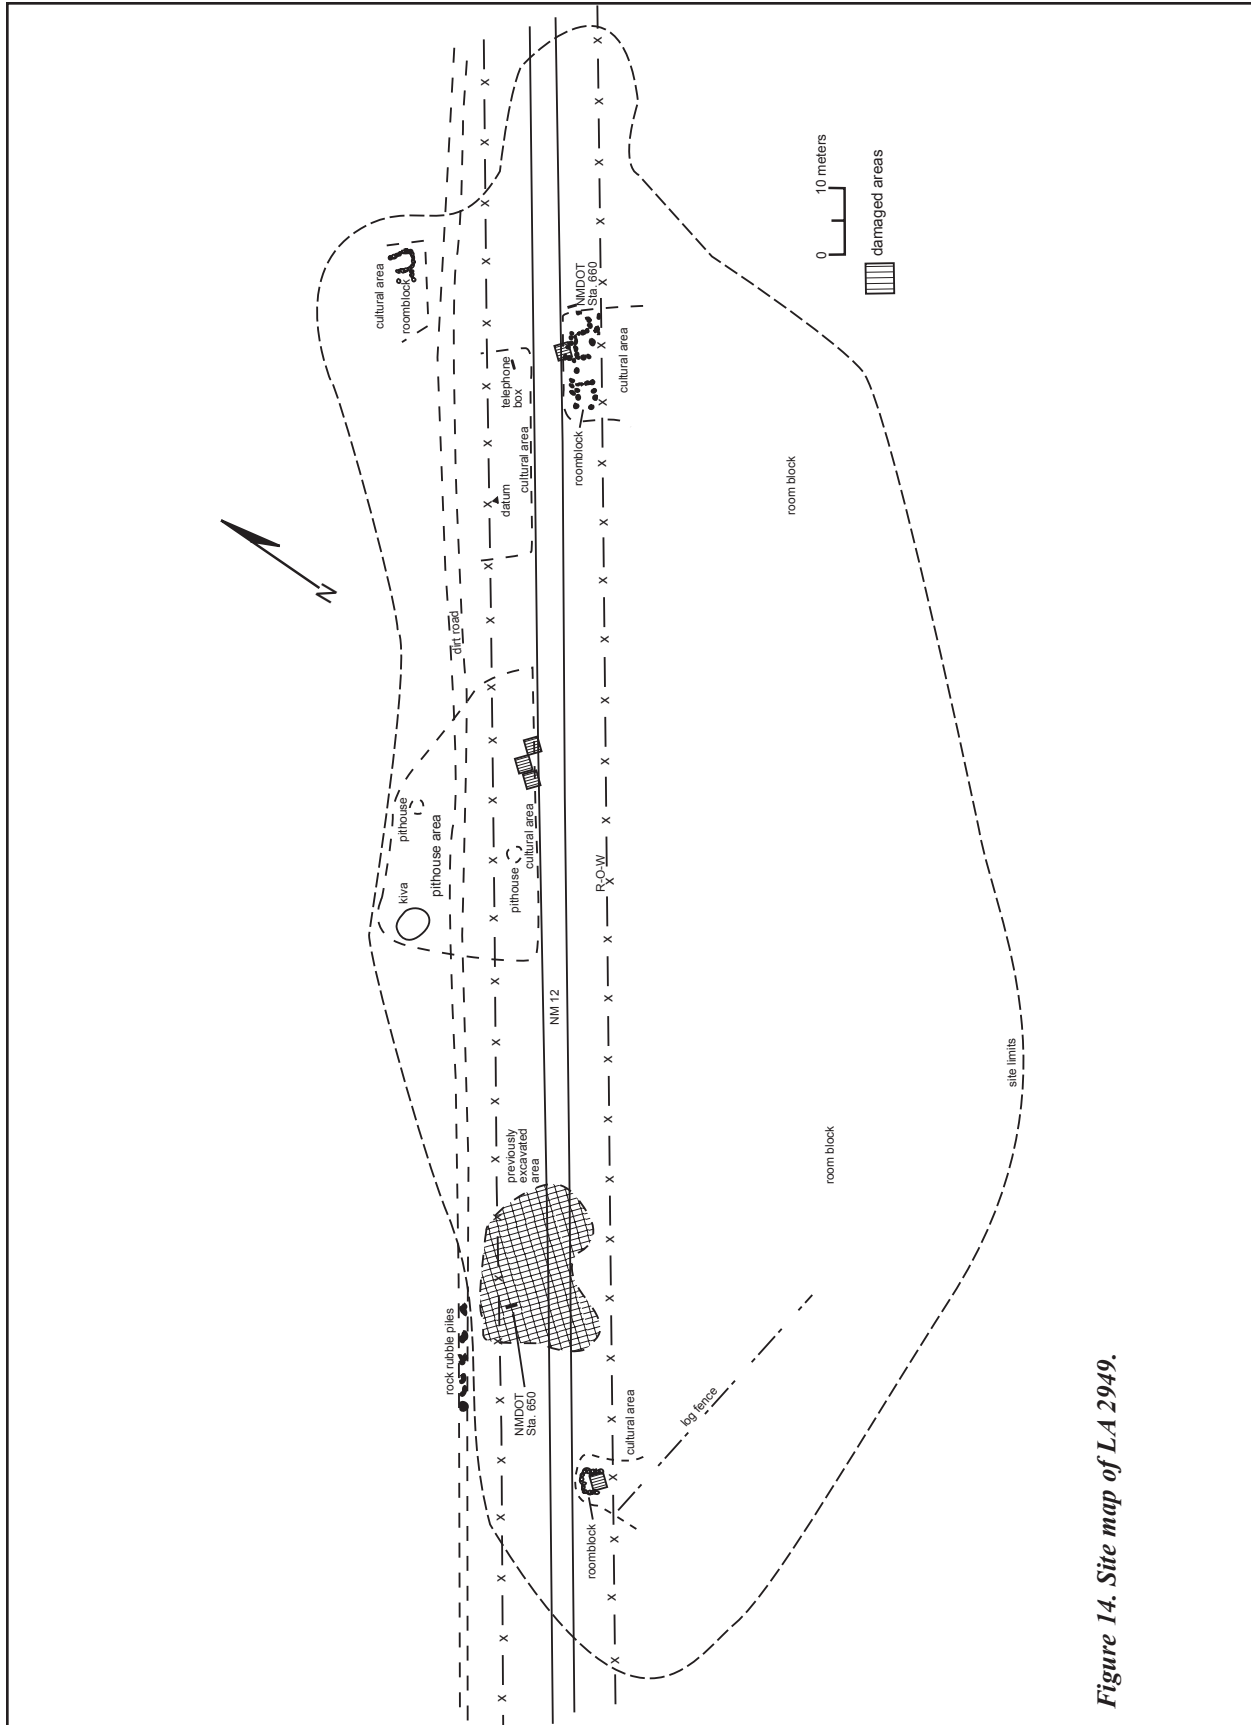
The previously mentioned ATV trail runs along the fence on the south side of the site. On the site map in Area A (see Fig. 14), the trail goes directly over a prehistoric masonry room and then north through a heavy artifact concentration. The mulcher used this trail for three-quarters of the length of the site, stopping at a tree cluster north of Datum B. The continuous compaction of soil over the room and the artifacts caused by vehicles in addition to the mulcher is stressing the walls of this unexcavated unit. It is also possible that continued use of the ATV trail could cause structural stress to any subsurface features that may be present. Trees were cut on the site, mostly east of Datum B and at the east end of Area C. In the Datum B area, mulcher tracks could be seen running down the slope from the tree cutting area (Fig. 15) and moving back and forth on the site in this area. Cut wood was apparently stacked in this area, because fresh tracks from other vehicles were seen entering and leaving the site in the cutting area (Figs. 16 and 17). Tracks of several vehicles were also visible on the north side of the site in Area C, where trees were cut and apparently stacked on site (Figs. 18 and 19). No mulcher tracks were seen here. Pithouses may exist in this area.

Figure 14. Site map of LA 2949.

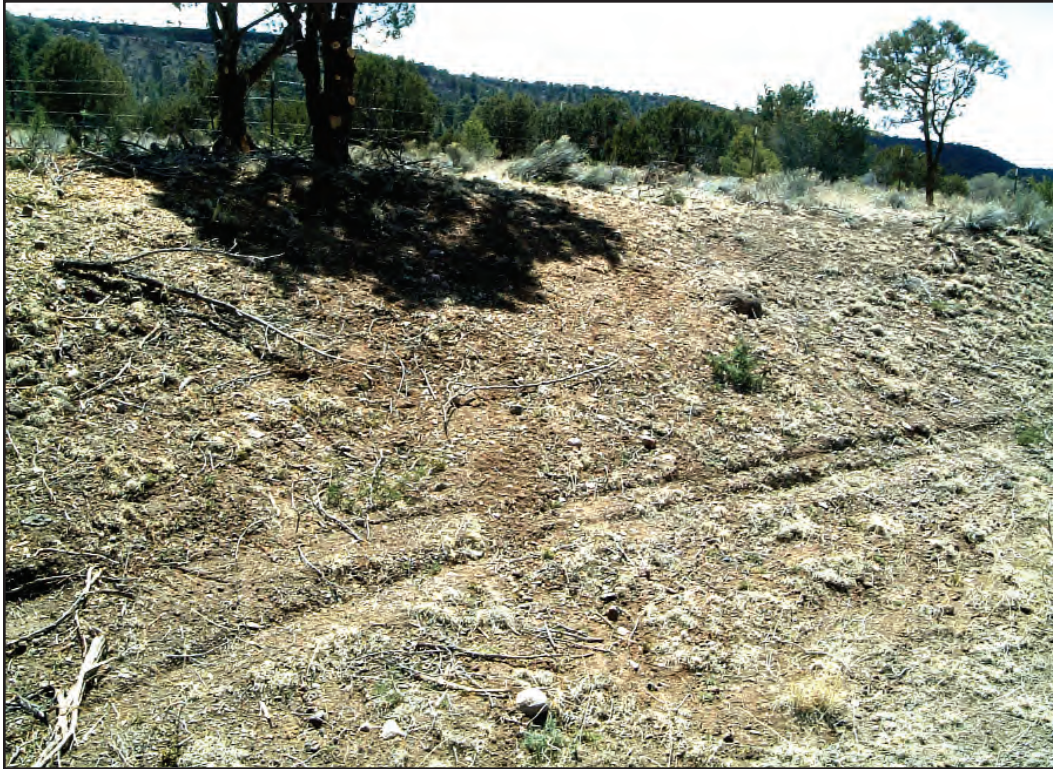
Figure 15. Mulcher tracks going downslope at LA 2949, crossing other vehicle tracks. Cutting area can be seen at top of slope.

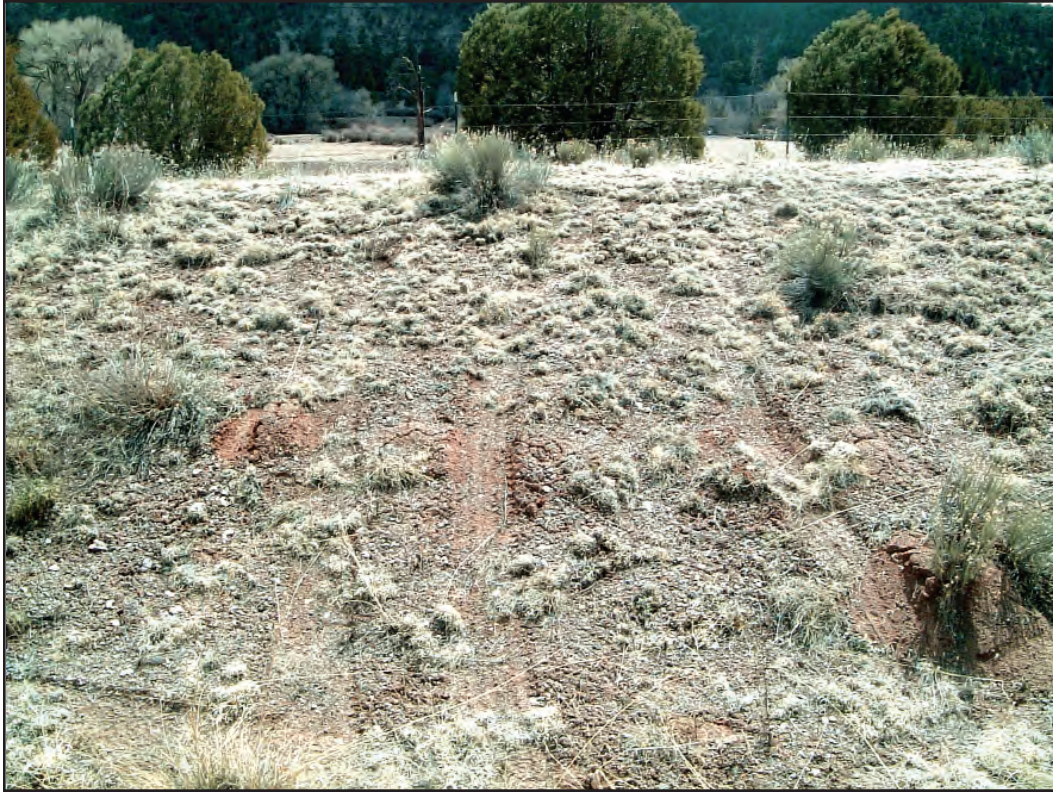
Figure 16. Vehicle tracks going onto LA 2949 near cutting area at Datum B.

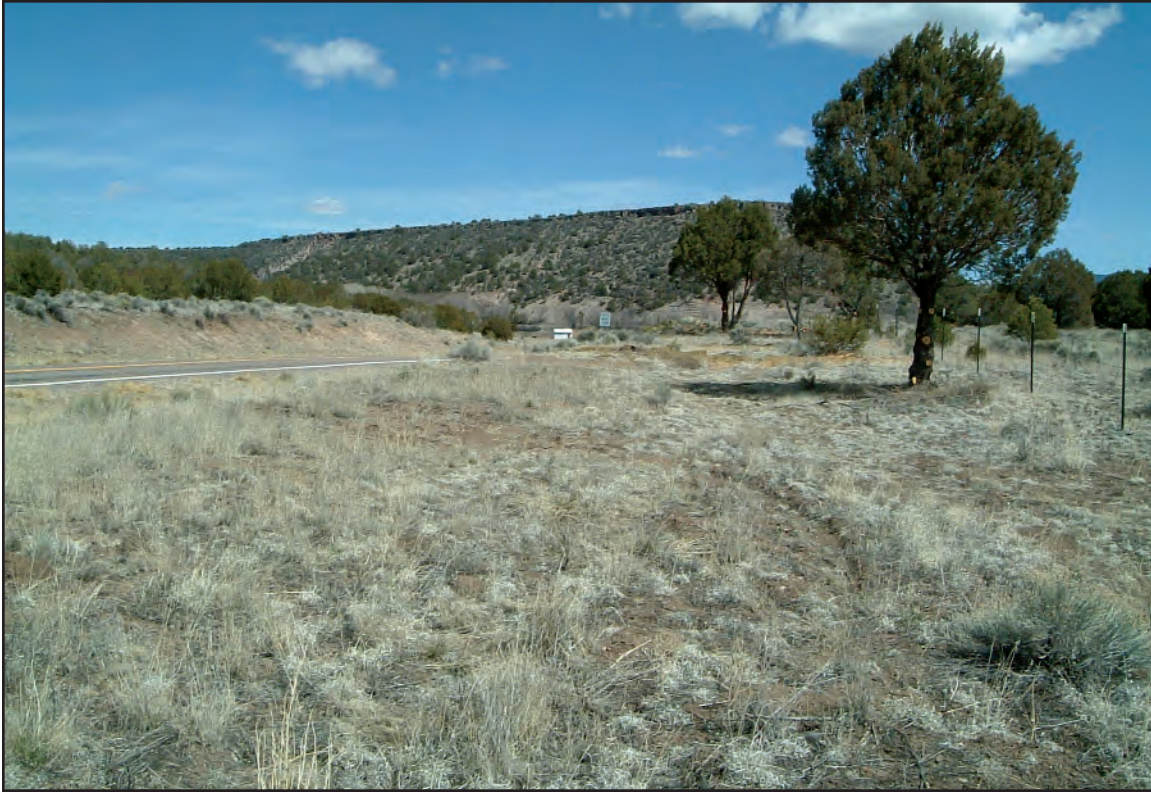
Figure 17. Vehicle tracks at LA 2949, with cutting area in background.

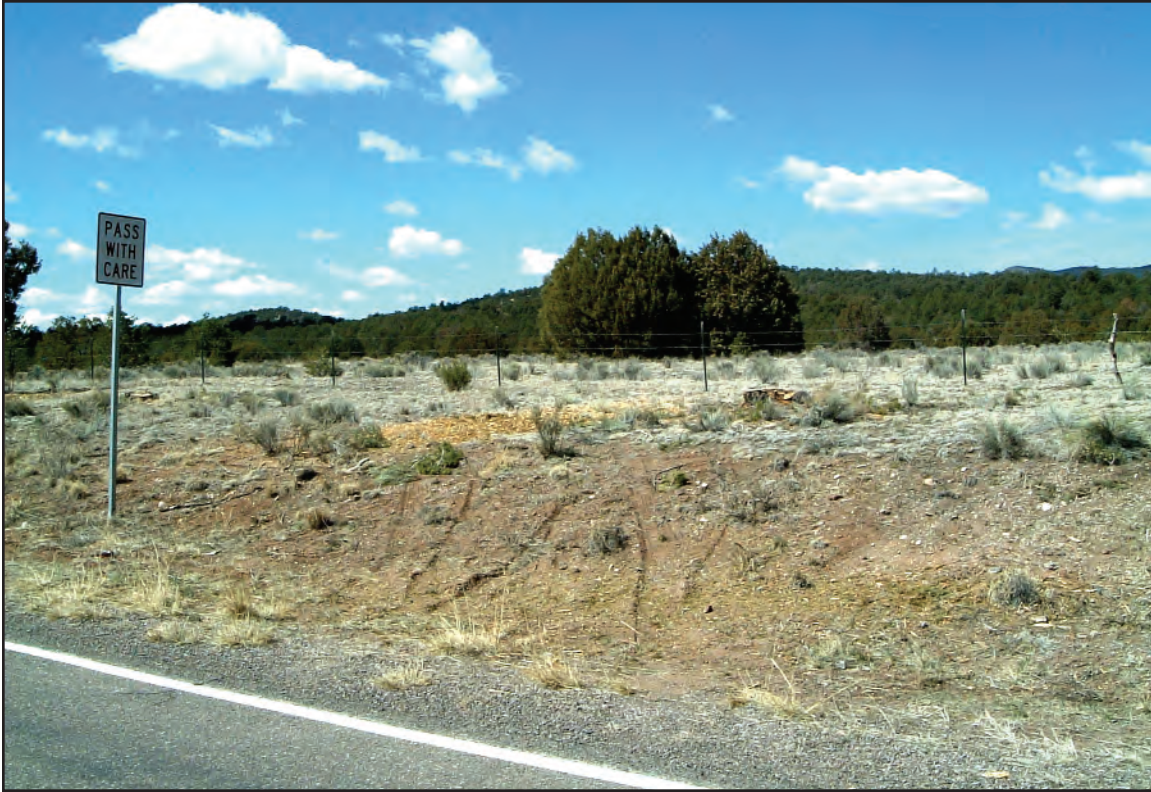
Figure 18. Vehicle tracks at LA 2949 going to cutting area, where wood was stacked.

side, cut wood was stacked on the site immediately adjacent to the cutting area. Several different tracks from private vehicles used to retrieve wood are visible leading on and off of the site. This is a dense artifact area (in the hundreds), and pithouses may be present below the surface. Surface disturbance is restricted to areas in which vehicles ran over artifacts and the roomblock. Because an ATV trail already existed, damage along the trail was minimal.

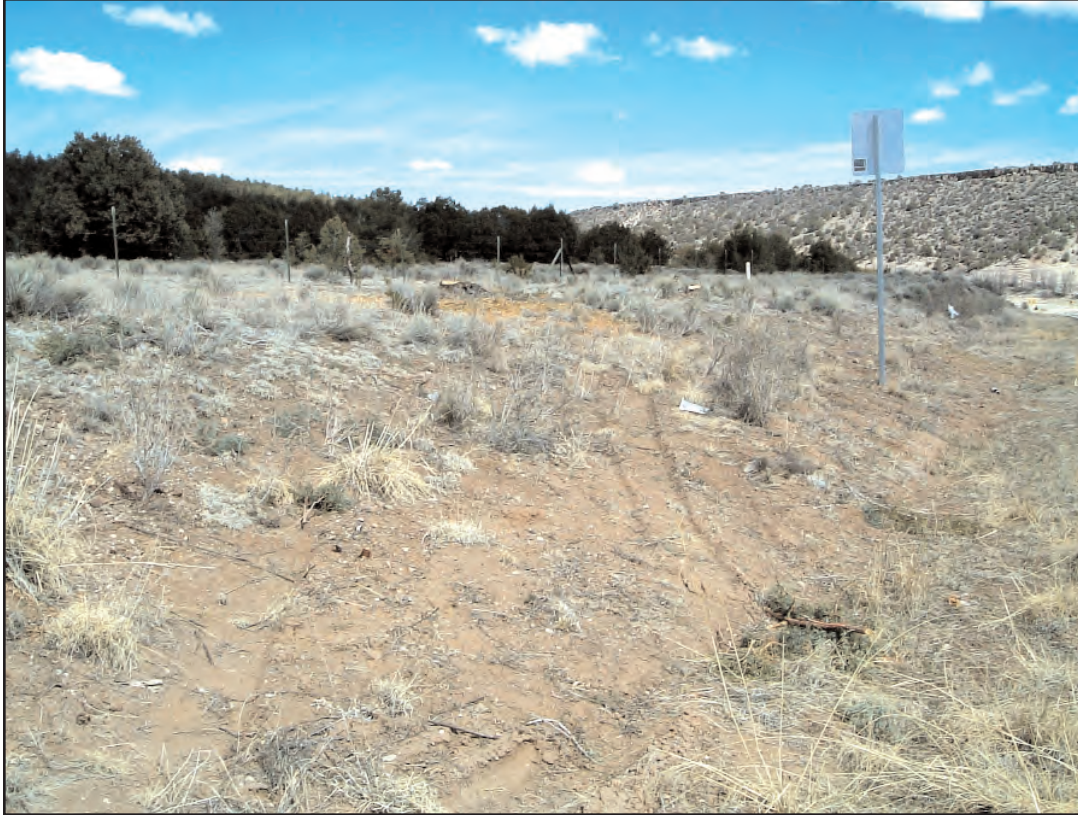
Figure 19. Vehicle tracks at LA 2949, leaving cutting area.

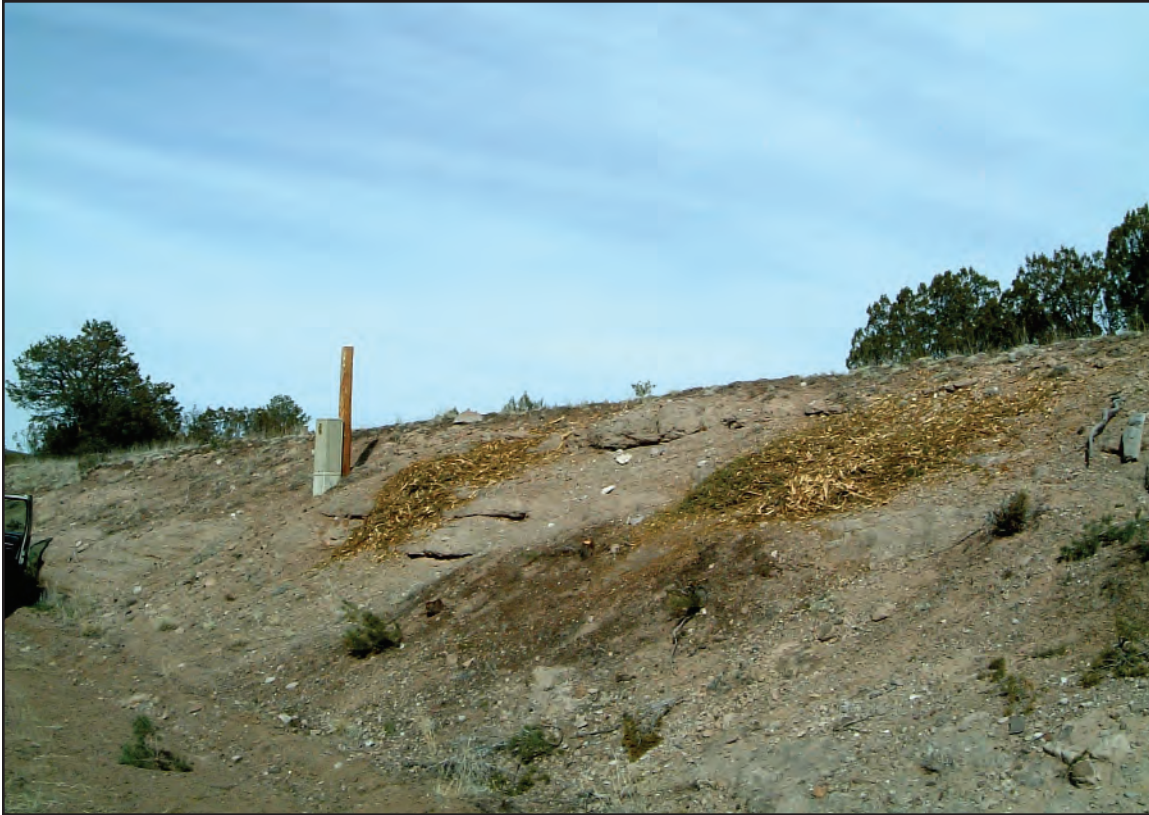
Effects of Tree Thinning Project: The thinning crew did not notify the archaeologist before cutting trees on the slopes of the site (Fig. 20). An inspection of the site showed that no damage had occurred to the eroding features. OAS utilized the map produced in 1999 for this report because no changes to the site were noted (Fig. 21).

Figure 20. East side of LA 3259 after tree cutting.

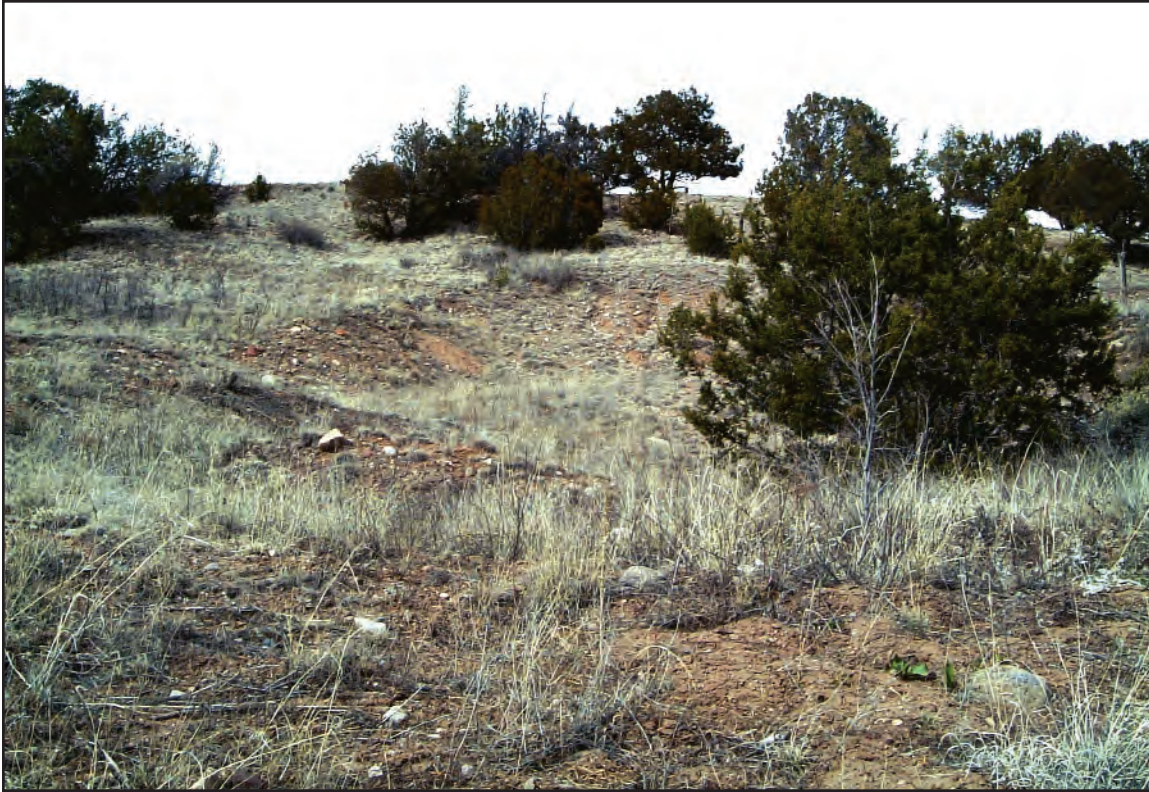
Figure 22. Bulldozed pueblo at LA 43910.

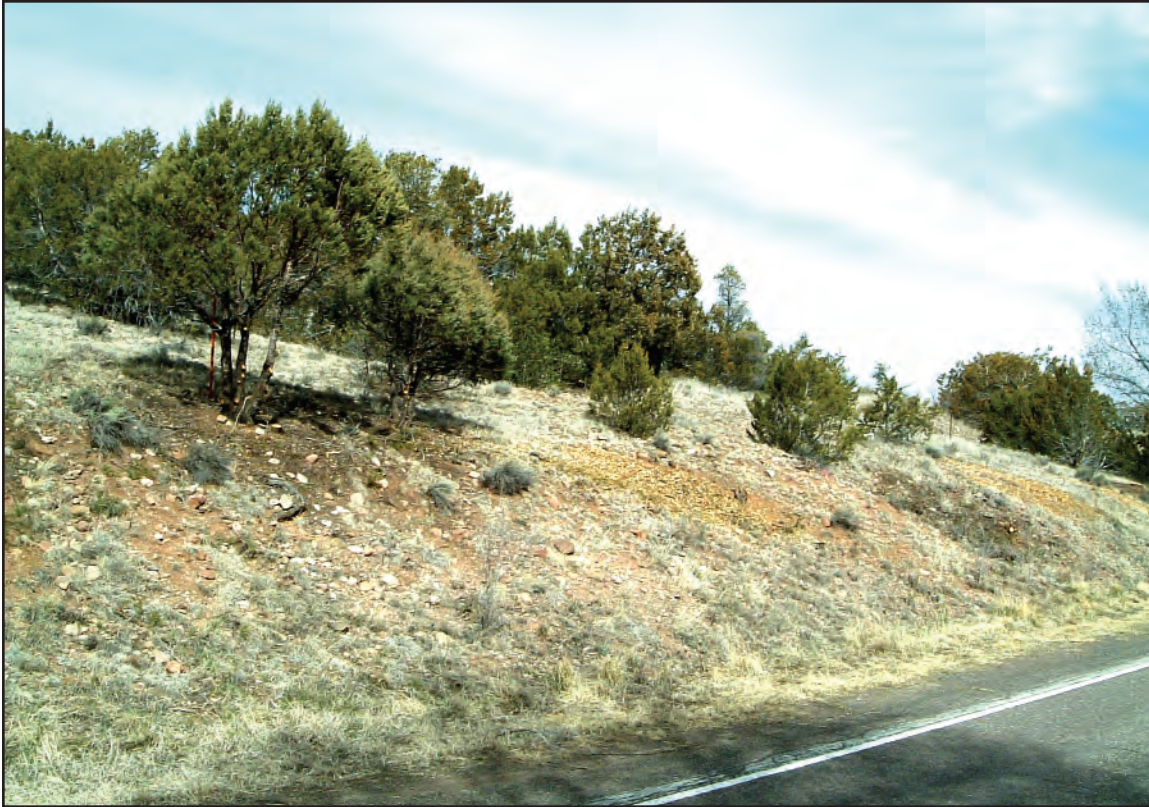
Effects of Tree-thinning Project: The archaeologist was not notified by the thinning crew of the cutting schedule for LA 43910; therefore, the site was not monitored. Upon later inspection of the site by OAS, it was observed that tree cutting took place only on the slopes in a few areas (Fig. 23), and there was no damage to the site. The site was mapped (Fig. 24).

Figure 23. Tree-cutting areas along slope of LA 43910.

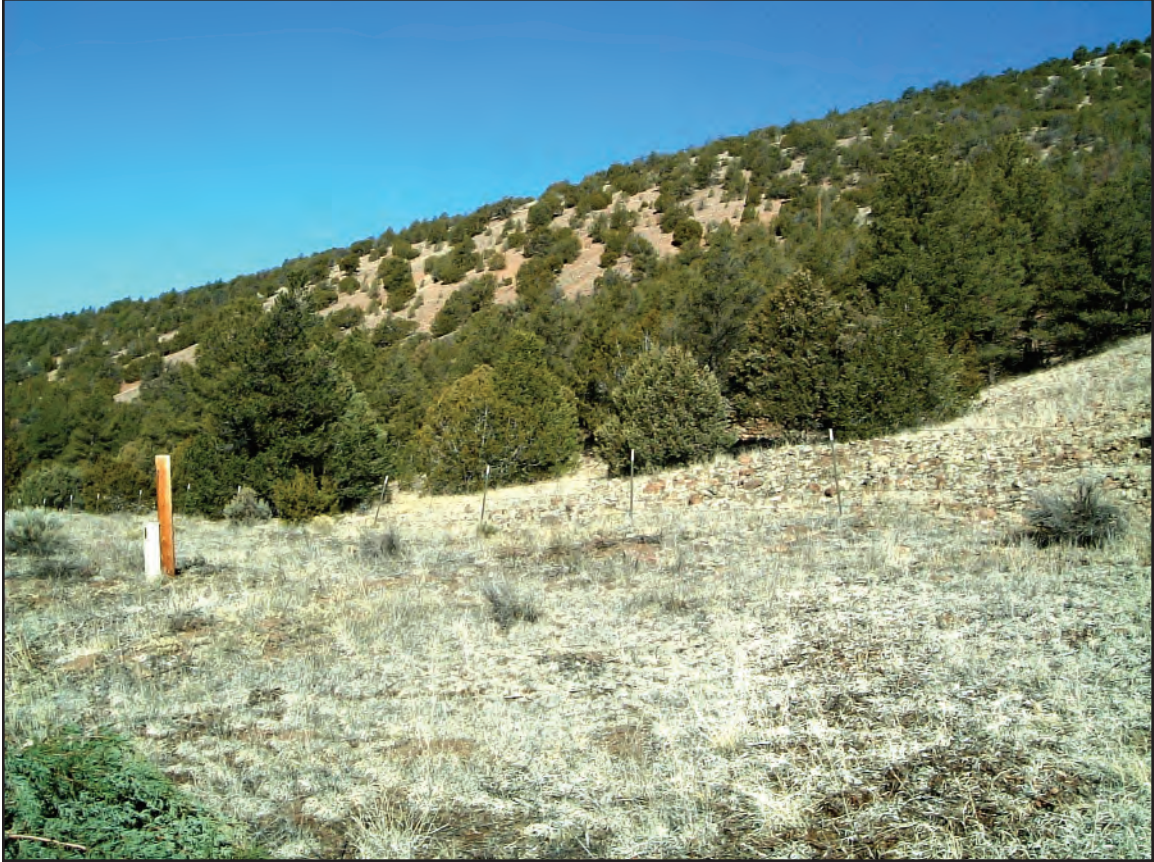
Figure 25. LA 43895, with cobble roomblock just beyond right-of-way fence.
