**ARCHAEOLOGICAL MONITORING OF AN EROSION
CONTROL PROJECT AT LA 126142, IN
MADRID, SANTA FE COUNTY, NEW MEXICO**

AN 471 • 2016

MNM Project No. 41.1008

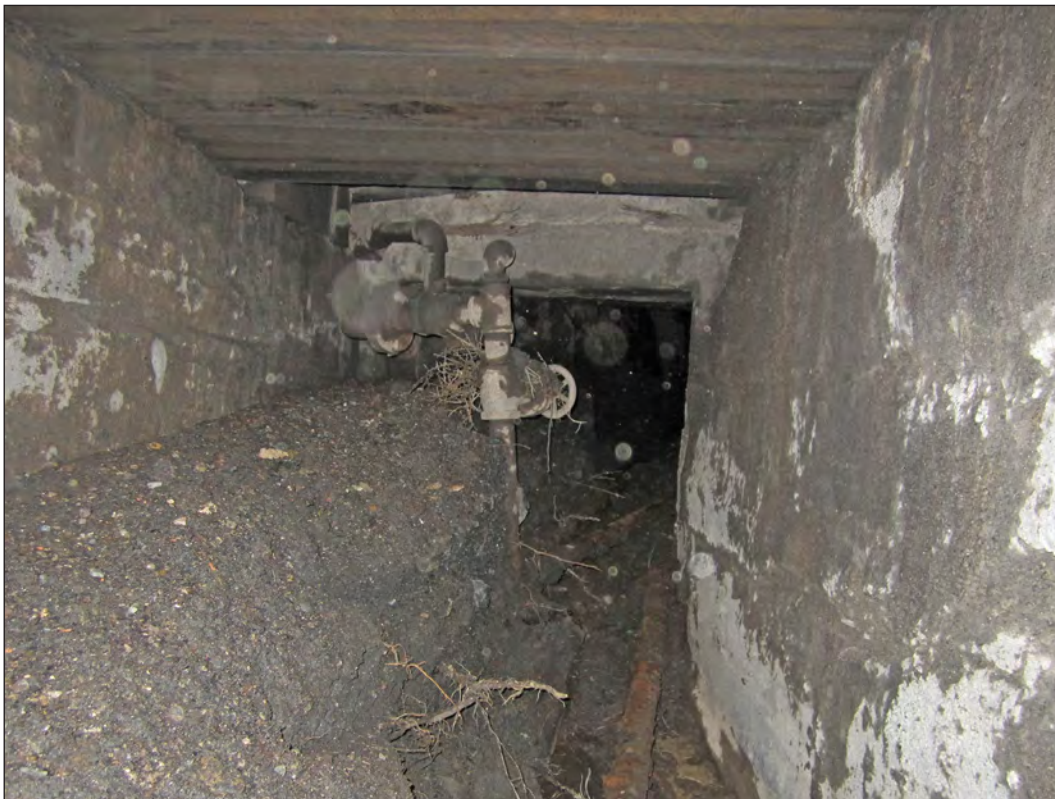
Figure 6.5. Box inlet interior with gob, sediment, and valves, view east.

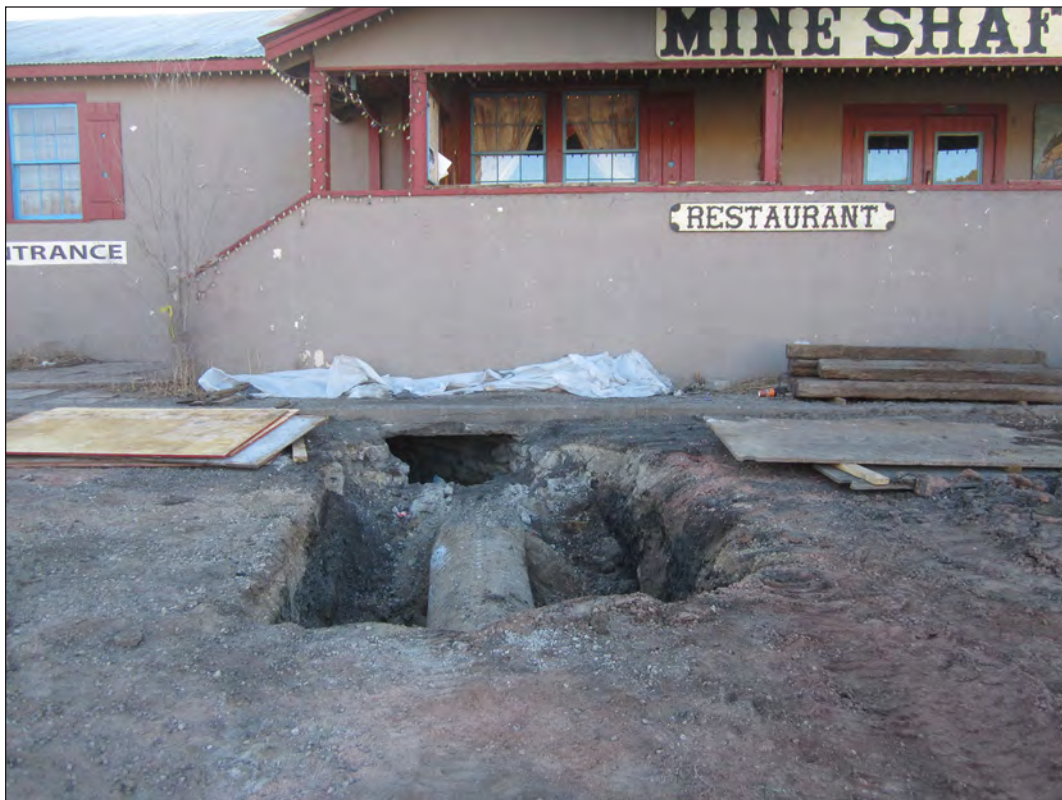
Figure 6.10. Old 60 cm (24 in) culvert at the western end of Feature 12, filled with sediment and gob, view east.

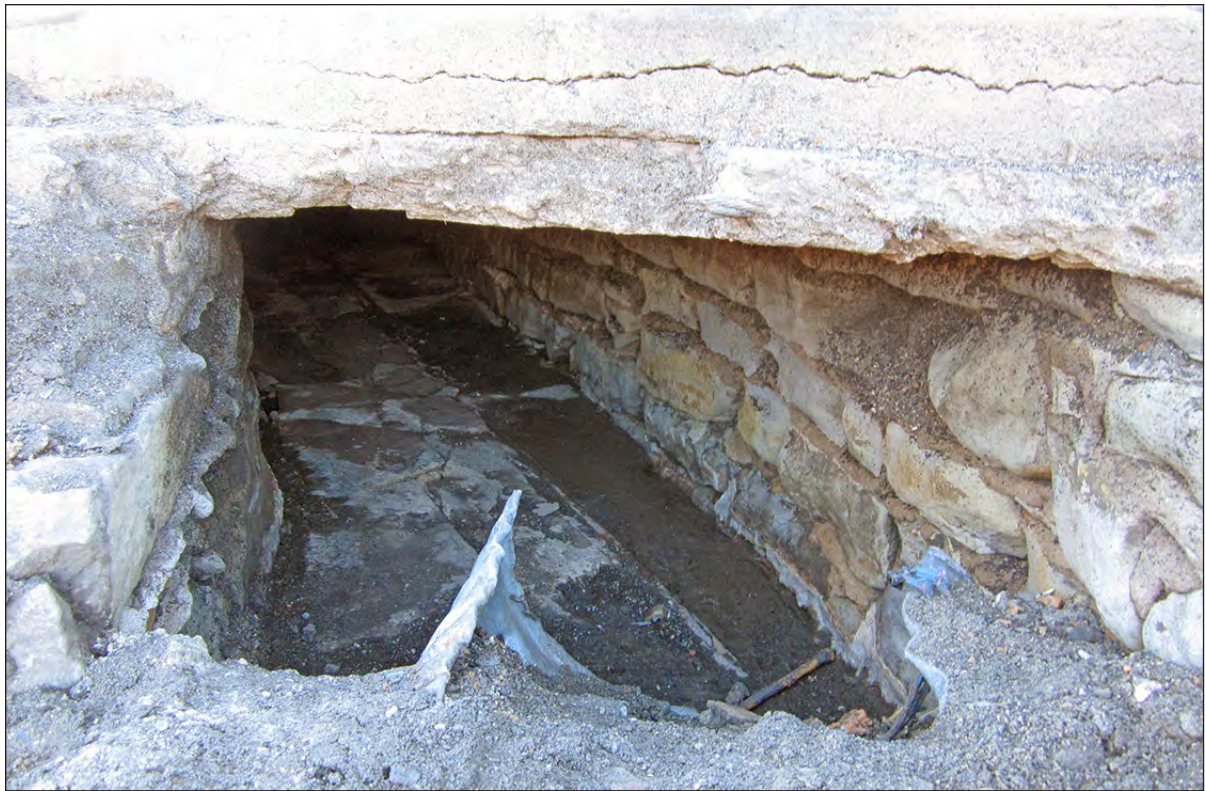
Figure 6.13. Feature 12, western end of cobble walls, view east.

cement. Instead, two separate walls consisting of cobble, limestone, and sandstone slabs were held in place with Linfield mortar (Fig. 6.13). A flagstone floor ran between the walls and continued approximately 4.5 m (15 ft) east with a 30 cm (1 ft) drop-off to the original poured-concrete floor. The drop-off was so severe it seemed to have been intentionally designed to slow water flowing through the box culvert from upslope. It is not known when, or by whom, this cobblestone addition was installed.

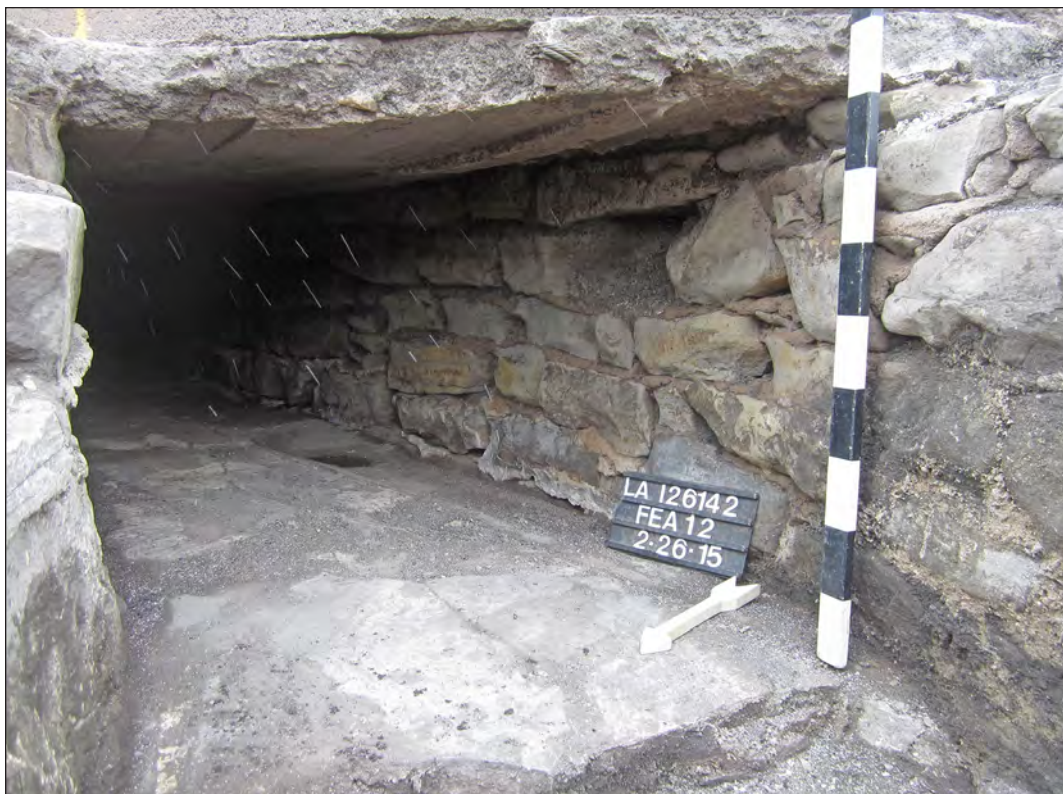
Figure 6.15. Cobble walls of Feature 12 box inlet, view east.

The interior and exterior cobblestone walls of the historic concrete box culvert were photographed (Fig. 6.15). The illusion that the cobble walls would be covered up and preserved faded when it was found that the new slip lining would not fit into the opening between the cobble walls (Fig. 6.16).

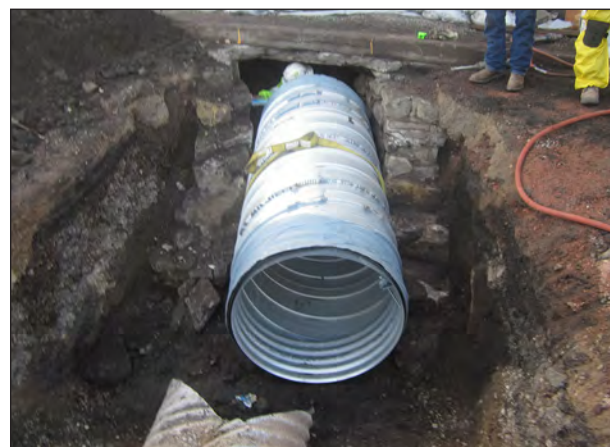
Figure 6.16. Slip lining installed between box inlet cobble walls, view east.

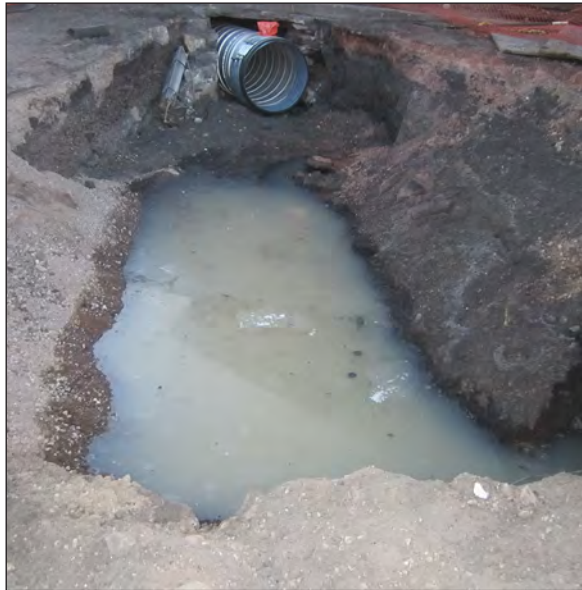
During excavation, the filtration caps were broken off the leach lines by the backhoe. Sewage gushed out, filling a portion of the trench (Fig. 6.22). Atlas Pumping was called to remove the sewage.

Figure 6.22. Broken sewage lines, view northeast.

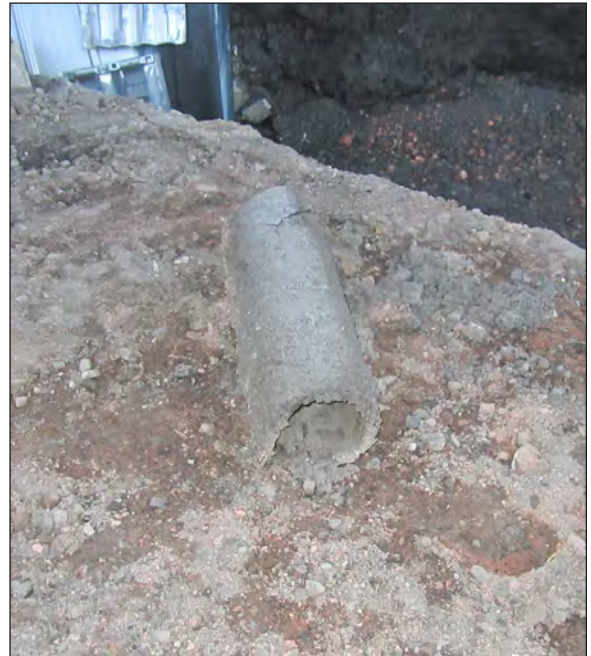
A small section of Orangeburg pipe also was pulled up by the backhoe (Fig. 6.23). Orangeburg pipe, made from wood pulp and sealed with hot pitch, was used between the 1860s and the 1970s. The pipe found at the site was no longer functional,

Figure 6.23. Section of Orangeburg pipe, view northeast.

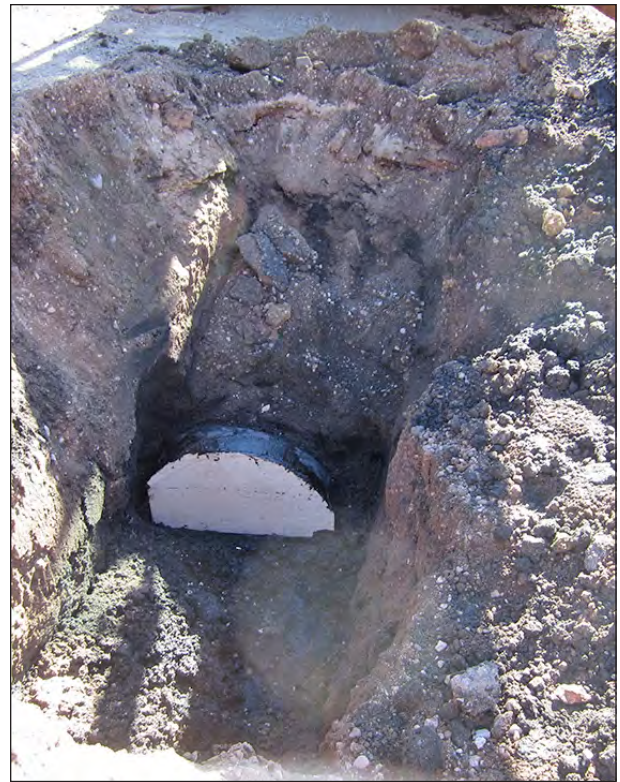
After excavation of the first trench, the infiltrators were cracked by the backhoe. JC Septic called for their pumping truck and removed the sewage overflow from the site (Fig. 6.72). The infiltrators were plugged with HardieBacker cement board, which was tarred and screwed into place (Fig. 6.73).

Figure 6.73. Plugged infiltrator, view east.
