**ARCHAEOLOGICAL TESTING OF A TWENTIETH-CENTURY SITE  
AT RODEO, HIDALGO COUNTY, NEW MEXICO**

**ARCHAEOLOGY NOTES NO. 18**

NMSHTD Project No. F-014-1(1).  
MNM Project No. 41.450 (Rodeo).

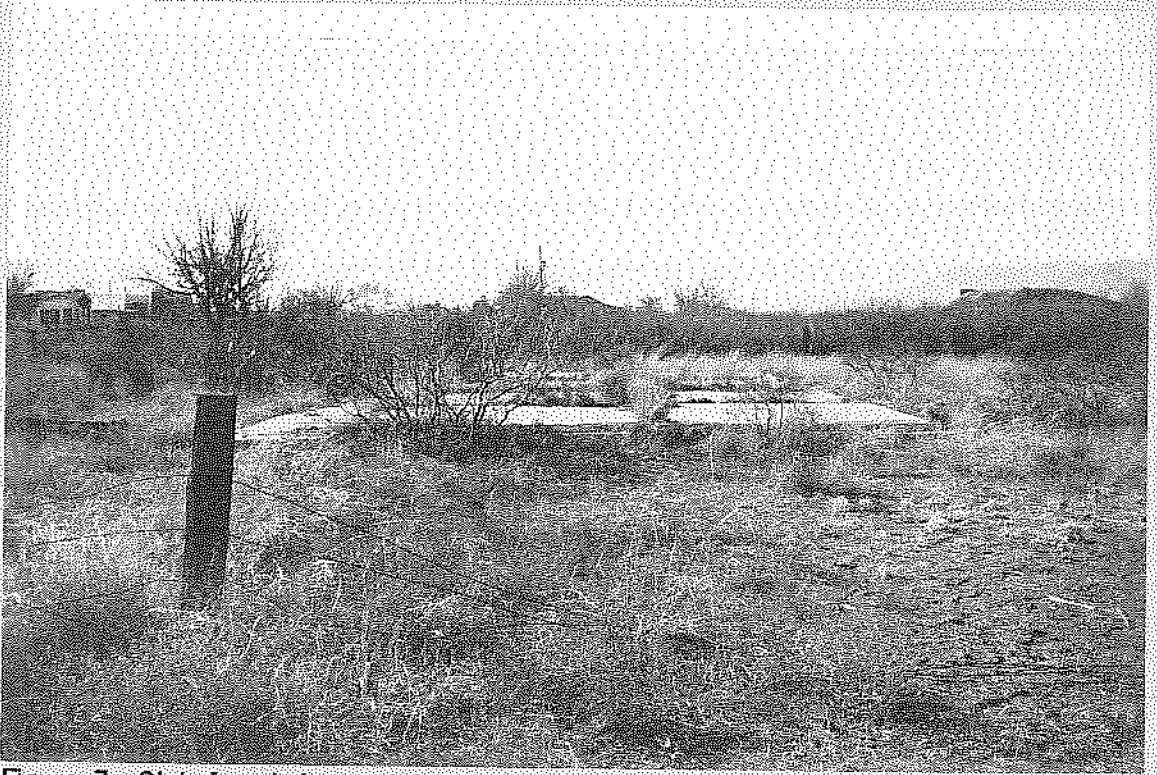
Figure 3. Slab foundation, LA 67962

Feature 1 is a cement foundation slab (Fig. 3), according to local informants, the location of the section crew's house. The house was oriented north-south and divided into four living areas of two rooms each. Each living area had an entrance on the west side, and a porch ran the length of the east side of the structure. The west rooms were the living/sleeping rooms, and the east rooms were all kitchens. An 80 cm wide doorway connected living rooms to kitchens in each "apartment." An inside doorway connects the two south apartments through the kitchens -- probably a later development when a family outgrew its two small rooms. The structure had brick interior and exterior walls, and apparently a wood floor. The interior brick walls were two courses wide. The slab appears to have been poured at some later date over a base of crushed slag, and porches and running water were added to the house at this time. The new foundation, 7 cm thick, was poured concrete mixed with slag. The house was torn down in the 1960s by a family leasing property from Southern Pacific Railroad. They did not know when the structure was abandoned.

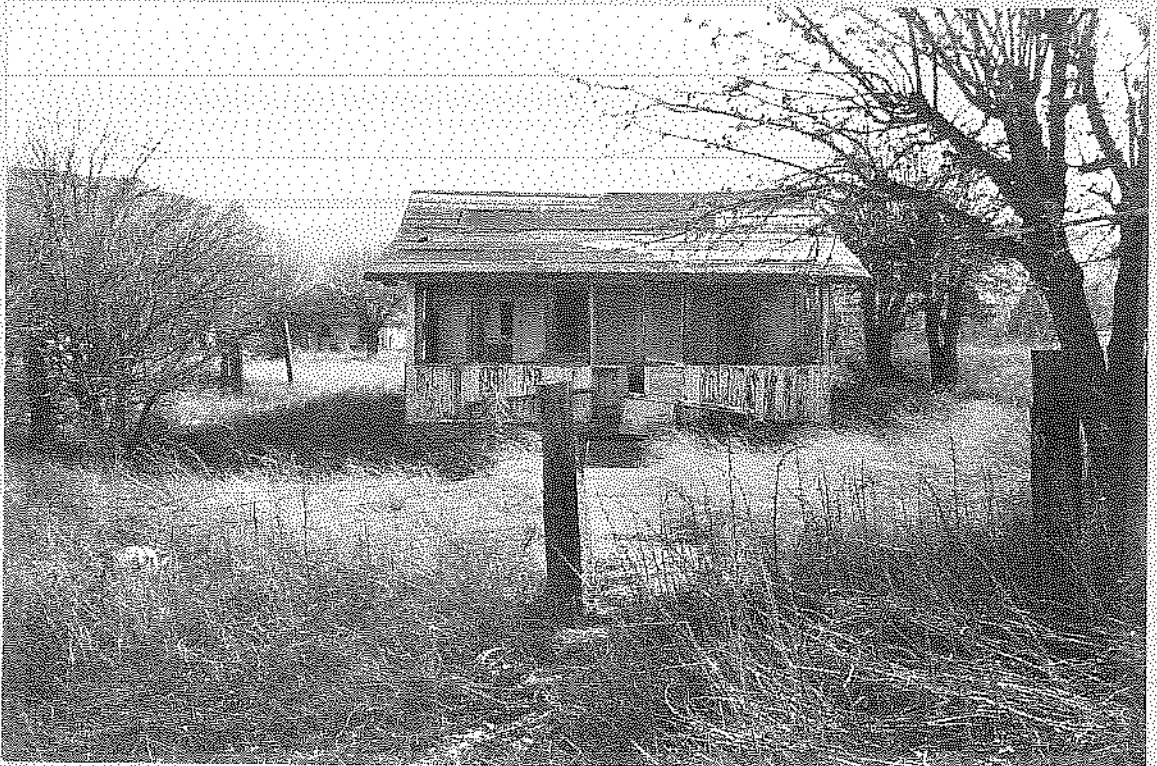
Figure 4. House, LA 67962.

The house is a wood building, painted white (Fig. 4). Because yellow with brown trim was the standard railroad color, it was probably repainted at some time. The house was designed for three families, and each section had three walk-through rooms. As in Feature 1, the kitchens are in the back (or east) of the house. The house has double-hung six-over-six windows and a porch in front (west side). The pitched roof is still intact.

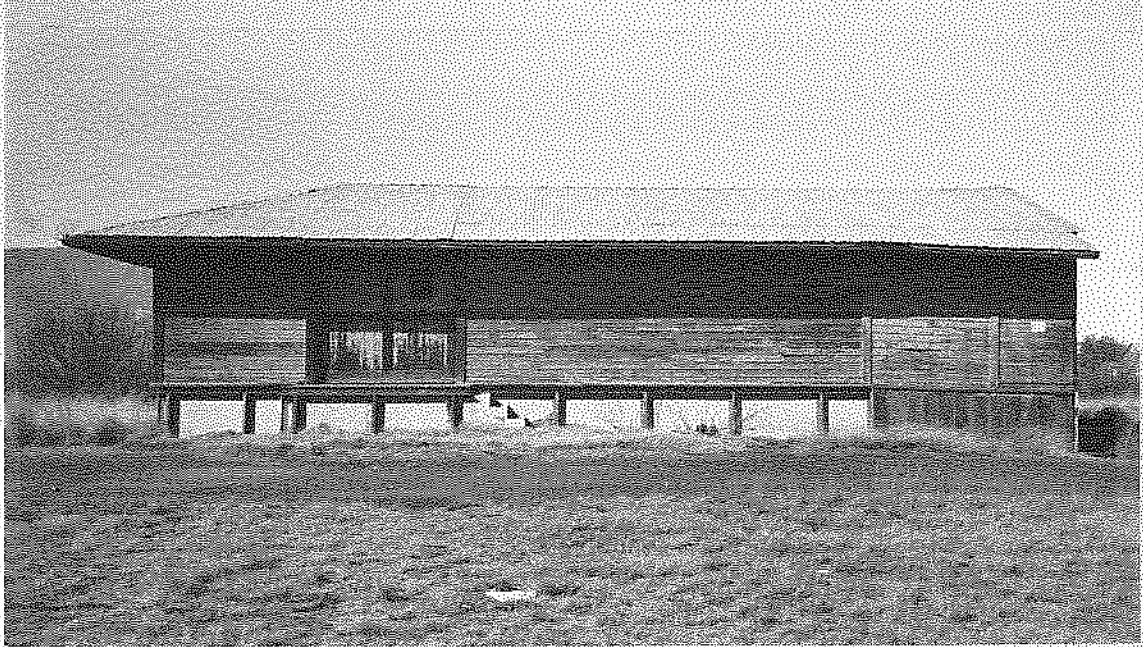
Figure 5. Rodeo depot, LA 67962.

The Rodeo depot (Fig. 5) is situated on U.S. 80 directly across from the general store. Originally it was a two-story building (as discussed below), but only the one-story portion remains. It is painted in the railroad's standard yellow and brown color scheme. The building is leaning precariously (Fig. 6). According to local informants, the second story had been leaning worse than the remainder of the building and was therefore torn down as a protective measure.

The depot has a hip roof and relatively new corrugated tin roofing. The door to the loading platform is still present on the west side, facing the track. The building is now being used for hay storage by the lessee of the property. The date "4-54" is carved on the wall of the depot by the door. A square foundation, probably from a signal tower, is located 12 m north of the depot. The date "8-31-54" was scribed in the damp concrete.

foreman inhabited the section house, and the maintenance crew lived in the section crew house. In a two-story depot, such as the one at Rodeo, the living quarters for the agent and his family were situated on the upper floor. The lower floor provided room for freight storage, shelter for passengers, and work space for employees. The depot was usually divided into three separate rooms, one for each of these functions (Sivinski 1973:39). There are very few two-story depots left in New Mexico. Some have been dismantled entirely, and others have had the second story removed to avoid taxes on the larger space. At Rodeo, the upper story had been removed because it was in danger of collapsing.

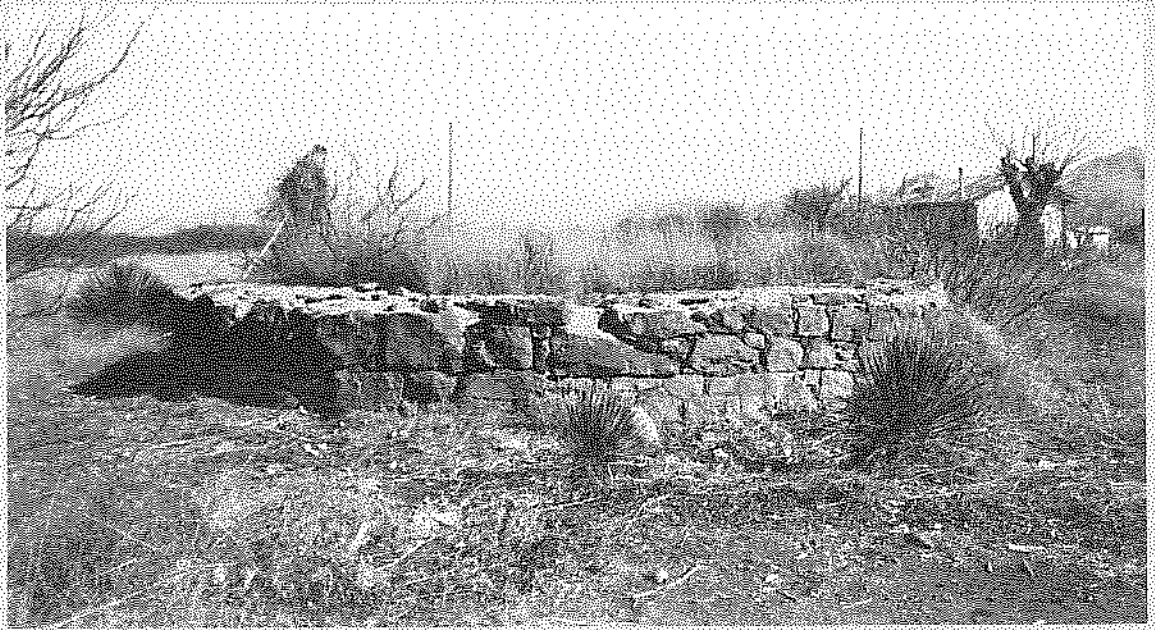
Figure 7. Rock base for water tank, LA 67962.

There is a continuous light scatter of trash between LA 67962 and the depot. Two cleared areas were evident where houses probably once stood. No concrete foundations remain, but the foundation may have been slag, or the buildings may have been constructed on wooden piers. One of these clearings may have been where the section house stood. There is a root cellar, a rock base for a large water tank located 10 m east of the rail bed (Fig. 7), and a wellhead associated with this clearing.

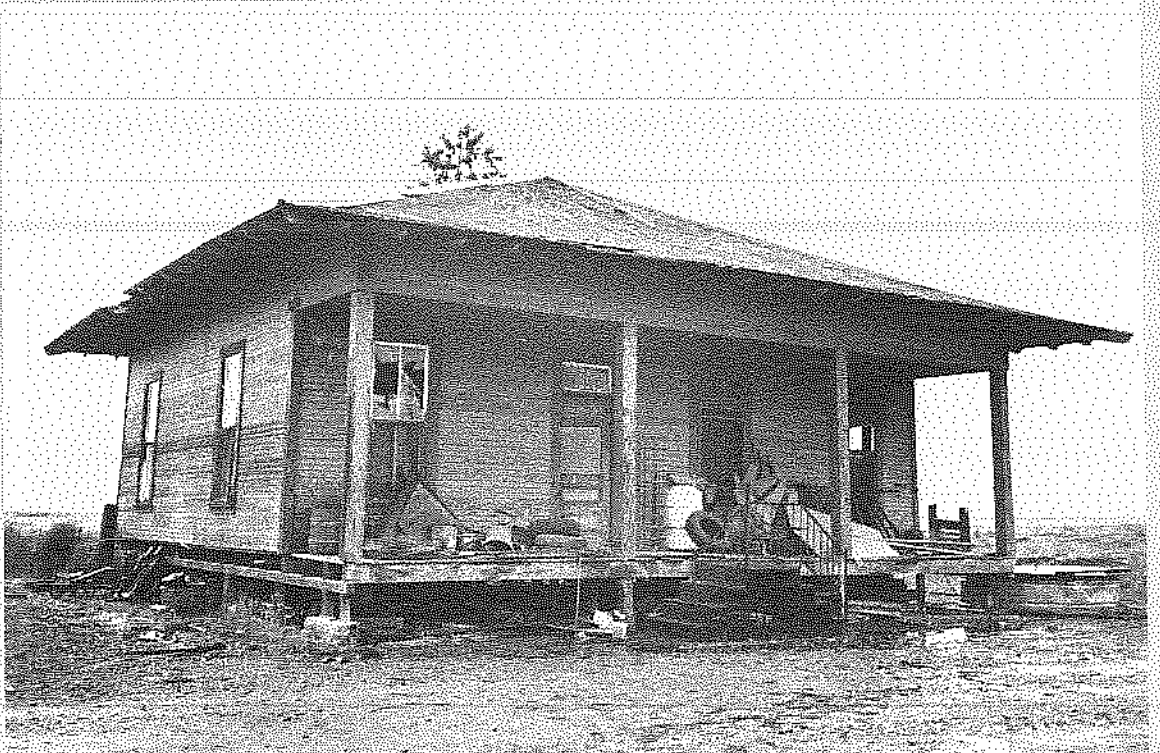
Figure 8. Section house, LA 67962.

The section house (Fig. 8) was moved sometime in the 1960s by the lessees to their ranch, 5 mi to the southwest. It is the typical yellow with brown trim railroad building, with a flared hip roof and a front porch. The rafter tails have rounded edges, and the chimney is brick. The siding is milled wood, clapboard style. The house is built on joists and was probably originally set on wooden piers. There are two doors on the front of the house, indicating original construction as a duplex, but at present there is no separating interior wall. The windows are all double-hung two-over-two, except one window on the back, which is one-over-one.
