**MUSEUM OF NEW MEXICO**

**THE OLD WELL EXCAVATION**

**ARCHAEOLOGY NOTES 246**

**1998**

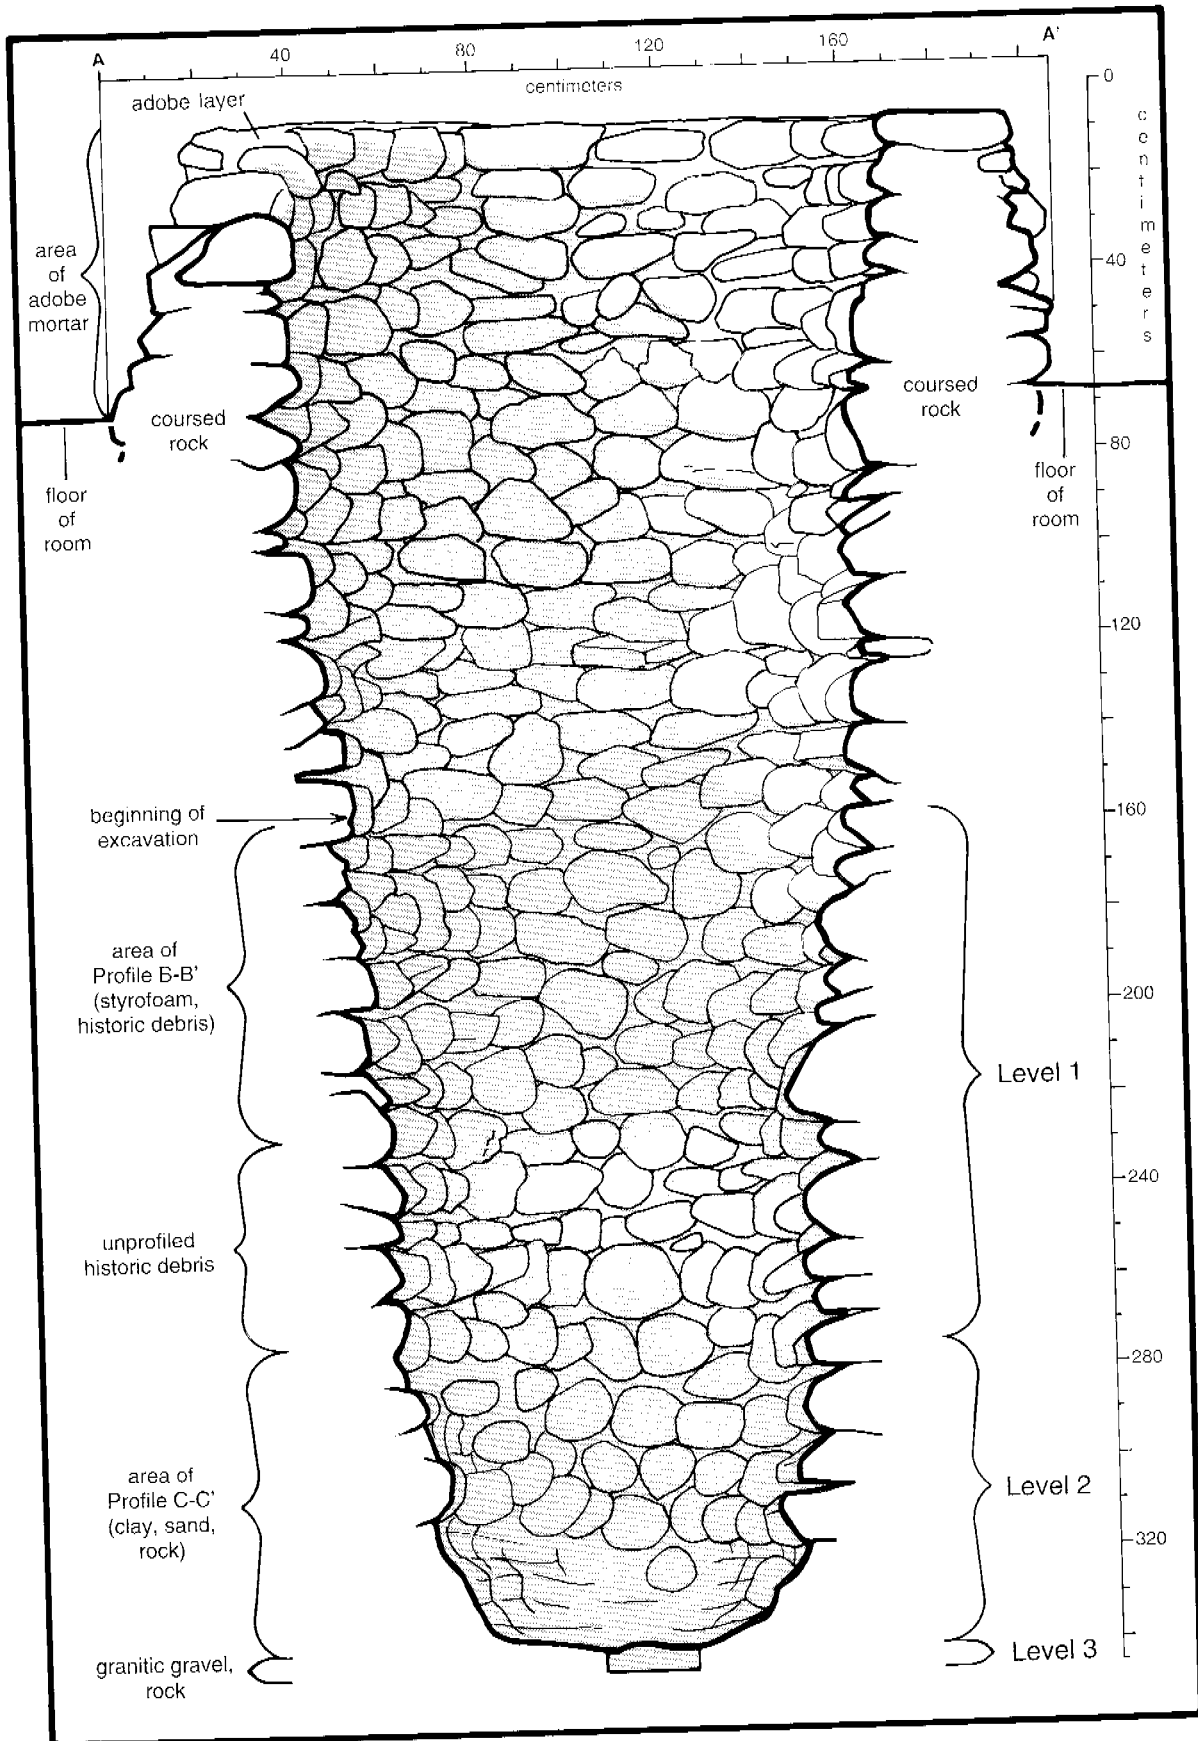
**Figure 2. Full profile of well.**

When fully excavated, the well was 3.4 m deep, and increasingly damp soil was encountered (Fig. 2). (The water table under Santa Fe, though dropping, is still high enough to make it necessary for large buildings with basements in the downtown area to keep sump pumps in operation.) The body of the well projects some 60 cm above the floor level. The construction is of flattish stone and some river cobbles laid in adobe mortar. Many of the stones are of igneous material. The mortar has receded into the wall, implying an erosional process, although not necessarily rain. Mortar is definitely present only in the upper part of the wall. Below ground level, it is impossible to say if mortar was present or not. Of course, it would be futile to use adobe mortar below the water line.

The well was excavated to 30 cm below the end of the masonry. In the past, the sides curved into a bowl-shaped bottom. A more or less contiguous layer of pale plaster covered the bowl, and the number of artifacts recovered dropped off to almost none. A "window" 15 cm deep and 20 cm by 15 cm was excavated in the center of the well, with the same results. The soil was red granitic gravel, and larger rocks had begun to appear. Auger holes were sunk around the perimeter of the well and in the window to establish the depth of the bottom. Very few artifacts and many rocks were recovered from three auger holes, and a rock too large to excavate was struck in the center.

The bottom had become an egg-shaped ovoid, no more than 85 cm wide in any direction. At 1 m above the bottom, the width was 95 cm each way. At 2 m, the well was 112 by 102 cm and 132 by 122-130 cm at the top, depending on which rock the measurement was taken.

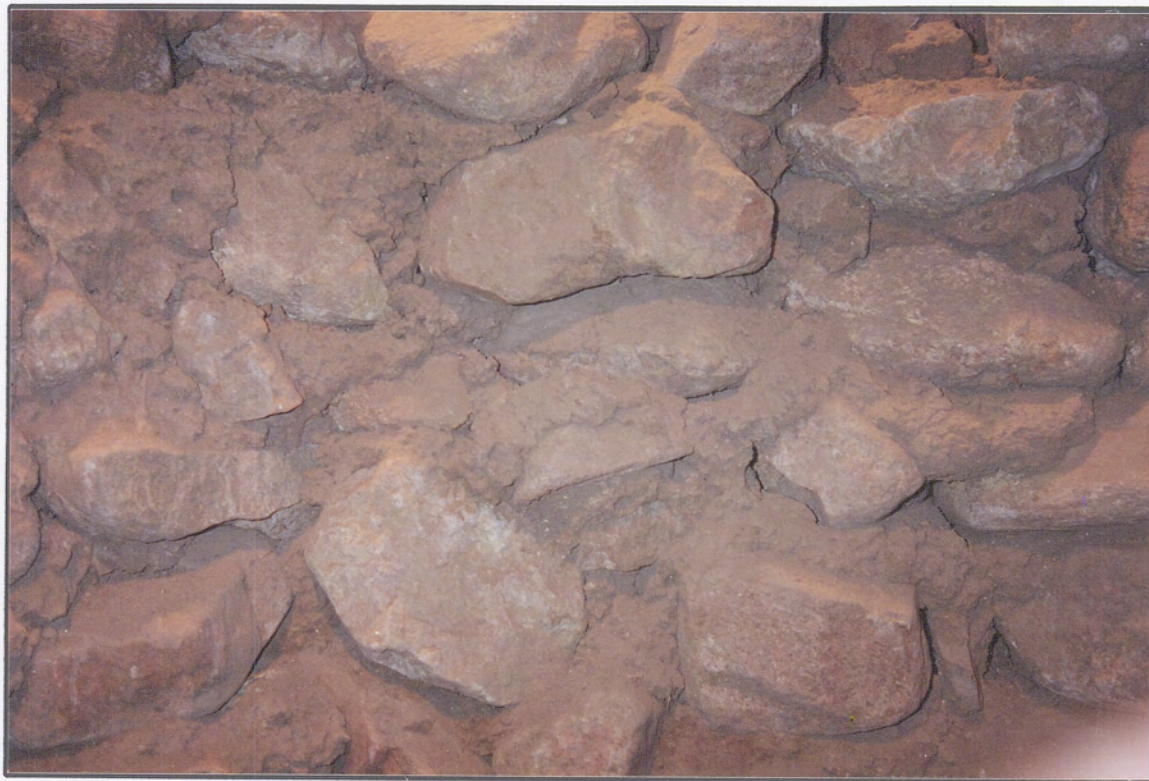
*Figure 3. Stones and adobe mortar.*

The well may have had an adobe coping, but in many places the upper course of stones is exposed. The upper course is missing in some places, especially on the west side, exposing the adobe mortar. Some but not all of the stones on the top of the well have blue paint on their upper surfaces. Was only one side painted, or have the rest of the stones washed clean? The adobe mortar is irregular, extending 30 cm farther down on the east side than on the west (Figs. 3-5).

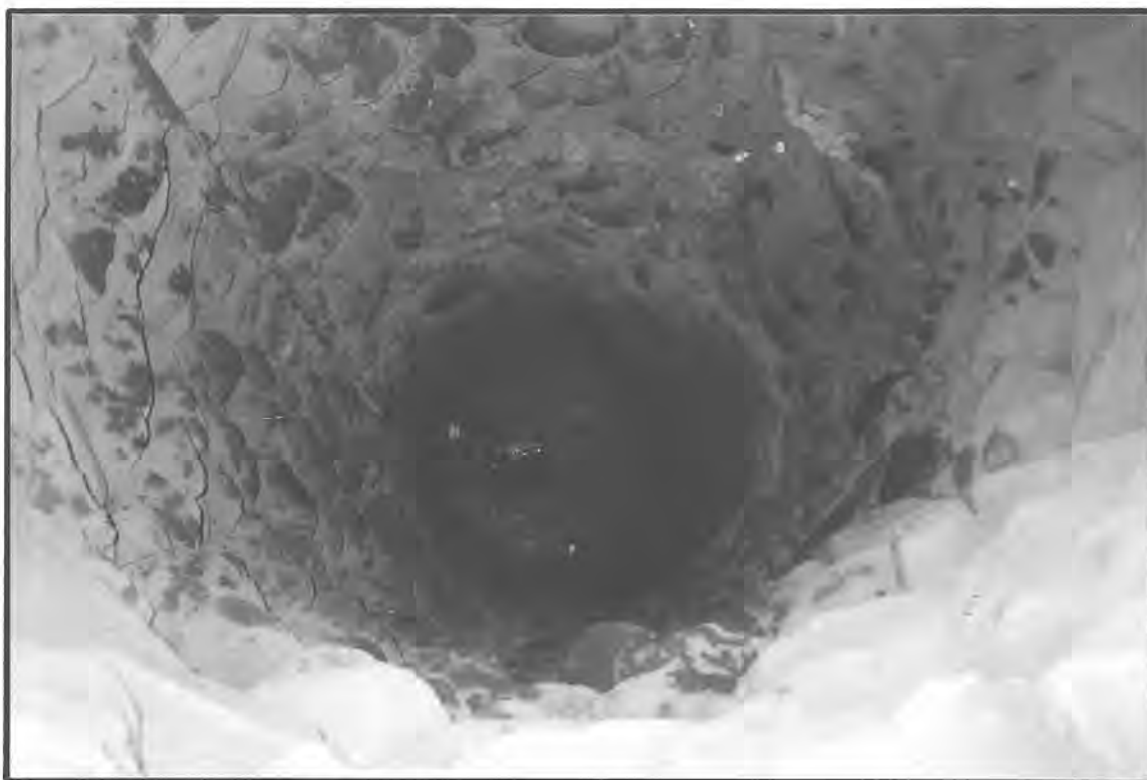
*Figure 5. Looking down into the well.*

A light fixture is attached to the inside of the well by means of metal conduit pipe, which enters the side of the wall just under the floor level (75 cm below top of well), turns, and runs down to the fixture, a standard white ceramic floodlight. The light must have rested very close to the bottom of the well when in operation, because the fixture was at a depth of a little over 3 m. The light fixture and the painted stones strongly suggest that at some point in its history, the well served as a tourist attraction, possibly a "wishing well." The dates of seven wheat straw pennies found in Level 2 indicate that it served this function during World War II. The earliest penny is 1921. There is also one coin dated 1937, three dated 1940, and two dated 1944. If this supposition is true, the well may have been accessible in some manner besides by coming down steep stairs into a dark basement, hardly an inducement to the average tourist.
