PRELIMINARY REPORT ON THE PHASE I  
ASSESSMENT AT LA 111322 FOR THE  
NEW MEXICO MUSEUM OF HISTORY  
IN SANTA FE, NEW MEXICO

### PRELIMINARY REPORT ON THE PHASE I ASSESSMENT AT LA 111322 FOR THE NEW MEXICO MUSEUM OF HISTORY IN SANTA FE, NEW MEXICO

## Archaeology Notes 321

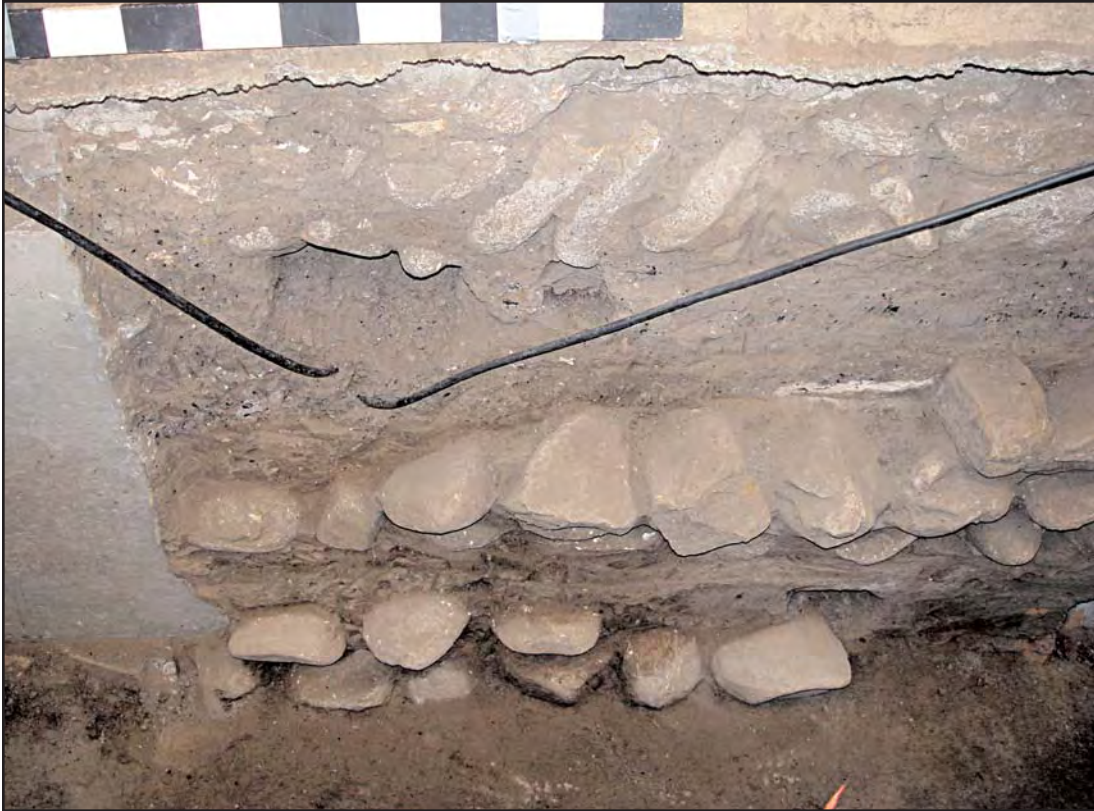
*Figure 5. Feature 19, early Spanish Colonial foundations (lower) and Feature 19, middle Spanish Colonial foundation (middle), and 1867 foundation (upper).*

The largest and most evident feature was the massive cobble foundation (Feature 19) exposed beneath the Palace patio office building at an 8.48 m to 8.18 m elevation or 1.10 to 1.50 m below the starting excavation level. The Feature 19 foundation segment was 12 m long from east to west (Fig. 3c, d). The east and west ends were unfinished or ragged suggesting that the wall or building was demolished and partly salvaged. The cobbles occur in one to four courses and two to three rows for a height ranging from 15 to 35 cm and a width of 50 to 75 cm. The actual width could not be determined because the foundation extended south beyond the excavation area under the patio offices. The cobbles were mortared and the mortar was almost indistinguishable from the enveloping matrix. A total of 156 cobbles were weighed and measured. An example of Feature 19 is shown in Figure 5.

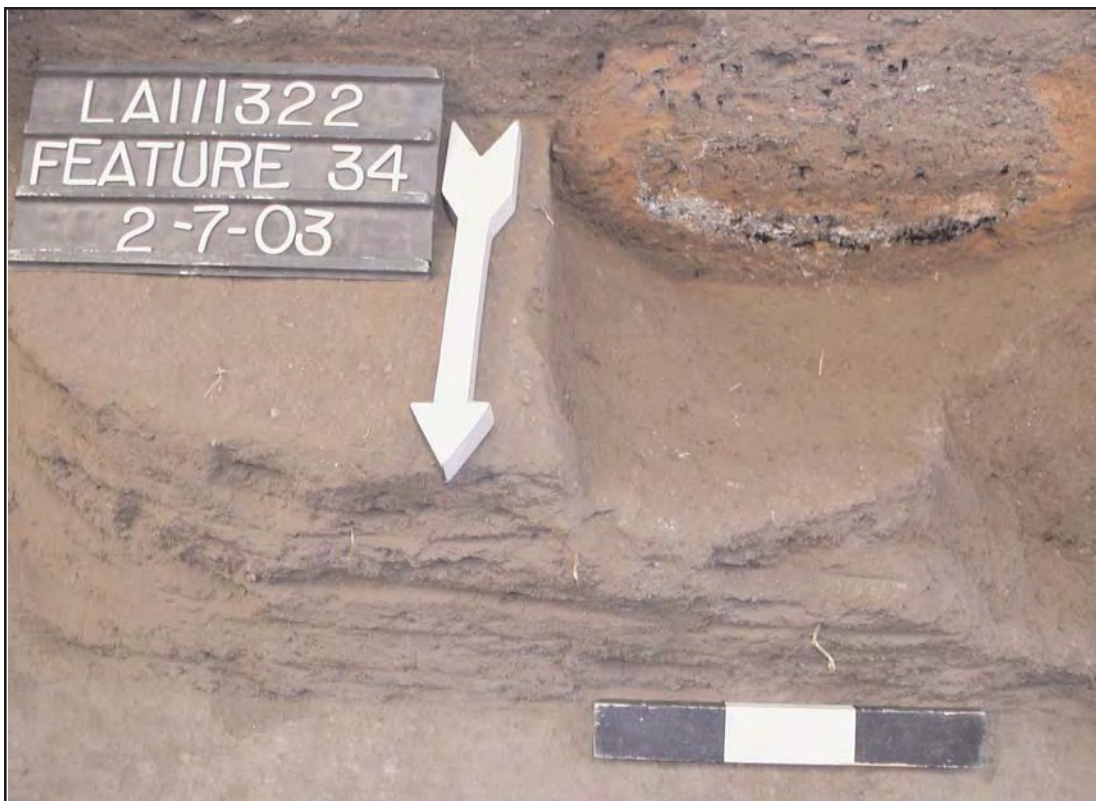
*Figure 6. Feature 34, metallurgy feature partly excavated and in profile.*

Feature 34 was exposed below the eighteenth-century foundation (Feature 7) in 98–99N/107E (Fig. 6). Its position below Feature 7 indicated that it predated the foundation construction. Artifacts recovered from Feature 34 did provide a more reliable date. However, an archaeomagnetic sample was collected from the oxidized feature rind. Feature 34 is morphologically different from other metallurgy features reported from early Spanish Colonial contexts in northern New Mexico. The pit profile was U-shaped. The sandy-clay feature interior was oxidized, forming a 2-cm-thick rind. The lower 12 cm of pit fill was stratified ash and charcoal containing small slag fragments. Feature dimensions were 55 cm long, 45 cm wide, and 28 cm deep. The feature was excavated into Stratum 11, which was interpreted as a Prehispanic occupation stratum. Other recently reported small-scale Spanish Colonial metallurgy features have been large oval basins, such as those reported at Comanche Springs (Ramenofsky 2002).

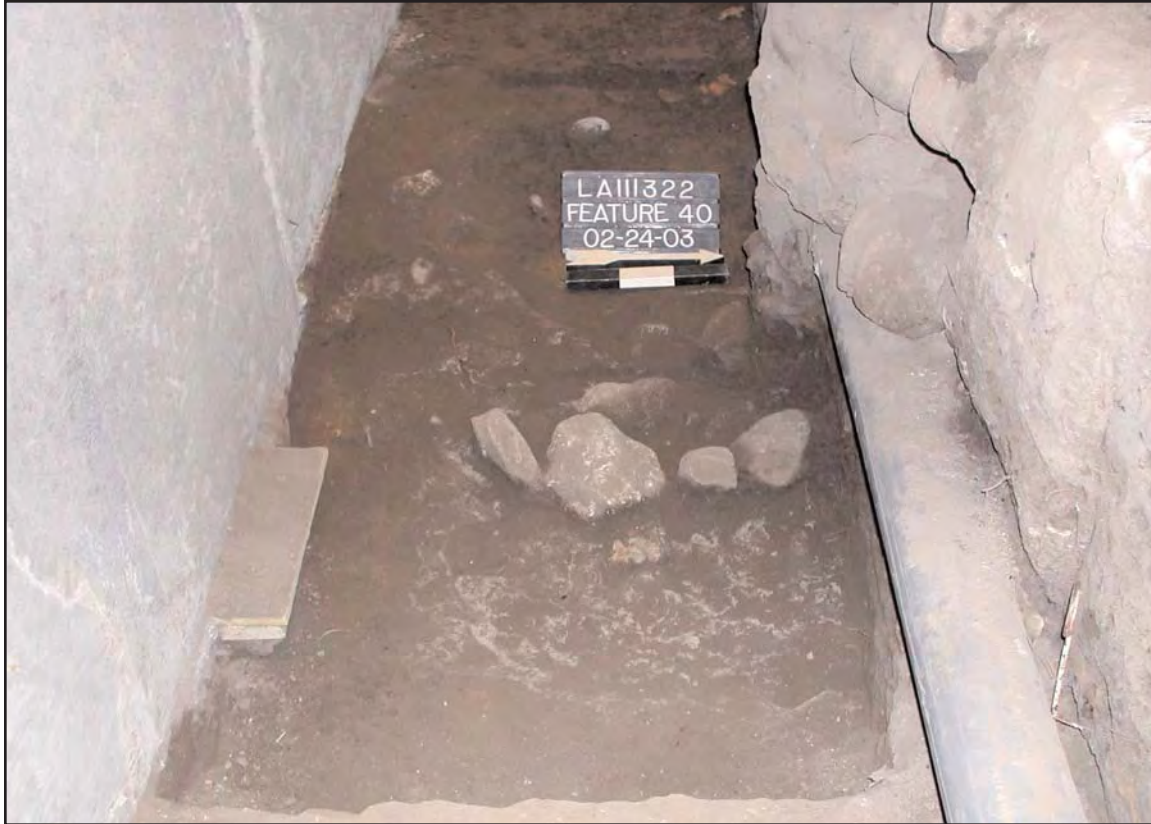
**Figure 7. Feature 40, open pit metallurgy feature and ash lens.**

Feature 40 was encountered in 99N/119–120E. It was excavated into Stratum 11 and capped by Stratum 13 (the seventeenth-century sheet trash deposit). At an elevation of 8.10 m, the top of Feature 40 was 10 cm below the bottom of Feature 19, the early Spanish Colonial foundation. The large, shallow, oval-shaped pit had an irregular bottom covered with a thin layer of ash (Fig. 7). It measured 120 cm long (north-south) by 80 cm wide by 4 to 9 cm deep. The width is a partial dimension because the feature extended north into 100N/120E. One piece of slag and two burned cobbles contacted the feature bottom. The feature fill was difficult to distinguish because it had been mixed with Stratum 13. Interestingly, Stratum 13 from the immediate area yielded five pieces of metal slag that may be associated with feature use. This simple open pit form is similar to the Comanche Springs features (Ramenofsky 2002), but Feature 40 is not oxidized. Based on strati-

graphic position, Feature 40 is the oldest early Spanish Colonial feature found during the excavation. It predates the Feature 19 foundation and the Stratum 13 sheet trash deposit. It is excavated into a noncultural material-bearing layer, marking the beginning of the historic occupation. While an absolute or reliable date is unavailable, it is likely that the feature dates to the first half of the 1600s.

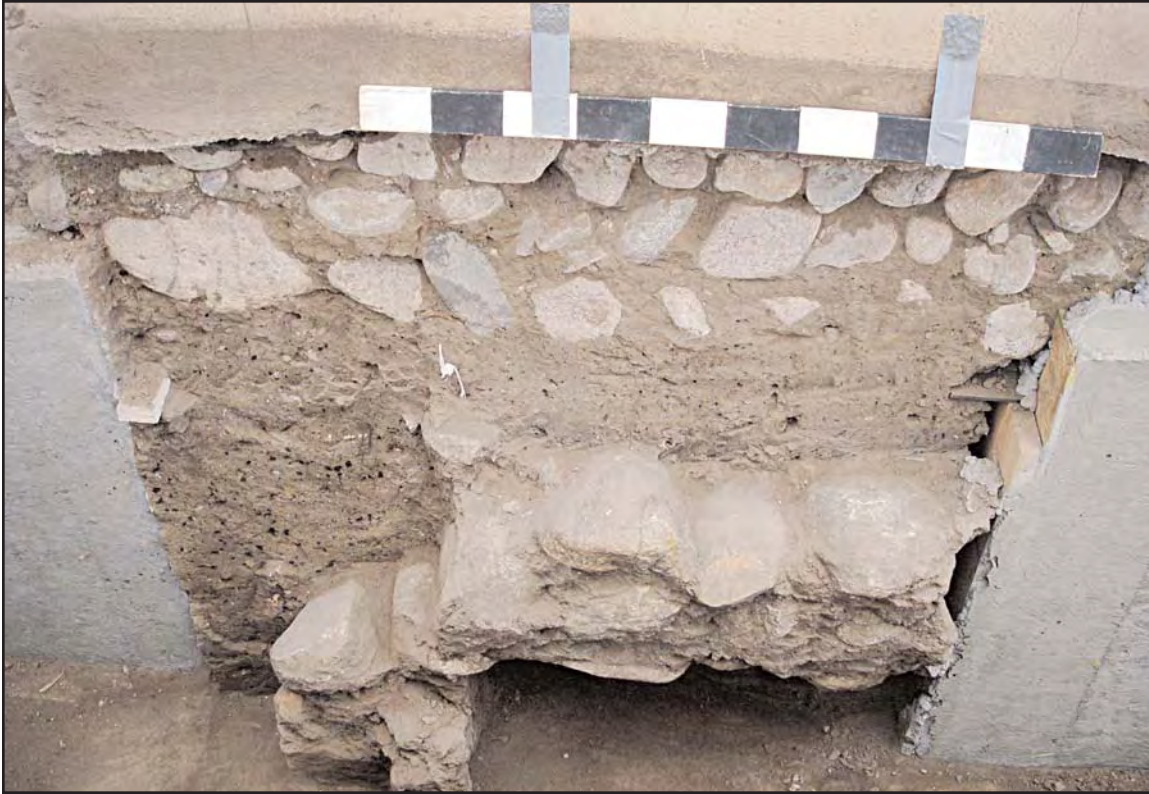
*Figure 9. Feature 7, middle Spanish Colonial foundation and 1867 foundation.*

Below the current Palace patio offices' foundation and above the probable seventeenth-century foundation, our excavation exposed a mostly continuous segment of a massive cobble foundation. This massive cobble foundation is currently believed to date to the 1700s and the above-paraphrased description strongly supports the temporal assignment. The foundation appears to be from a wall or building that would have enclosed the inner Palace courtyard in a manner similar to the current layout. Because there were no formal floors or intramural features identified along the length of the foundation, it most probably represents the back or north wall of a building that had its primary access from the south.

The foundation segment spanned 34 m from 97E to 131E. It was typically excavated into deposits that contained late seventeenth-century ceramics. However, this was not consistent along the foundation, indicating that deposits were disturbed or mixed. Feature 7 had a range of course and row configurations: from one course and three rows to three to four courses and at least three rows (Fig. 9). Different configurations reflect intrusions into the foundation by later material borrowing, pit excavation, and basement installation. The cobbles were set in mortar, although differentiating between mortar and footing trench backfill was occasionally difficult. Maximum dimension for the foundation was 40 cm high by 70 to 90 cm wide. A total of 807 cobbles were recorded. They had mean dimensions of 24 cm long by 17 cm wide by 10 cm thick and a mean weight of 9 kg. All were unmodified river cobbles of metamorphic and igneous origin.

The preliminary interpretation of Feature 7 is that it represents the north wall of a long building that may have been one or two stories high. This building could have been erected between 1693 and 1715. By 1715, the Palace and associated buildings were described as being in poor condition and needing repair. Two governors in 1731 and 1737 claimed to have rebuilt the royal houses and "plaza de armas" during their term (Shishkin 1972). The extent of the rebuilding, remodeling, or renovation is not described. However, it is possible that work on the buildings that enclosed the near Palace courtyard might have been part of these efforts.

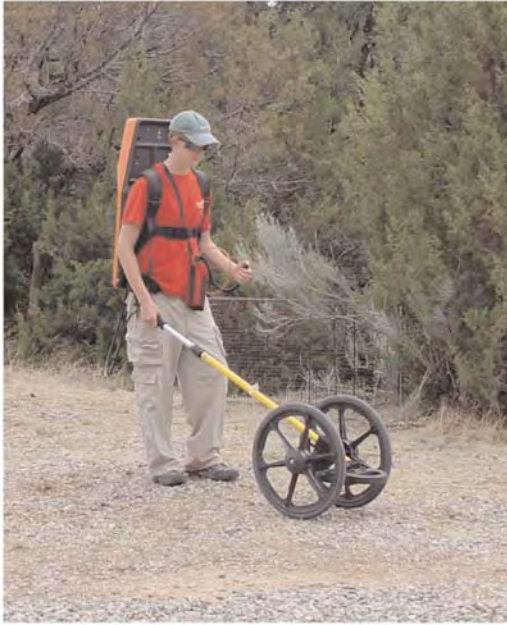
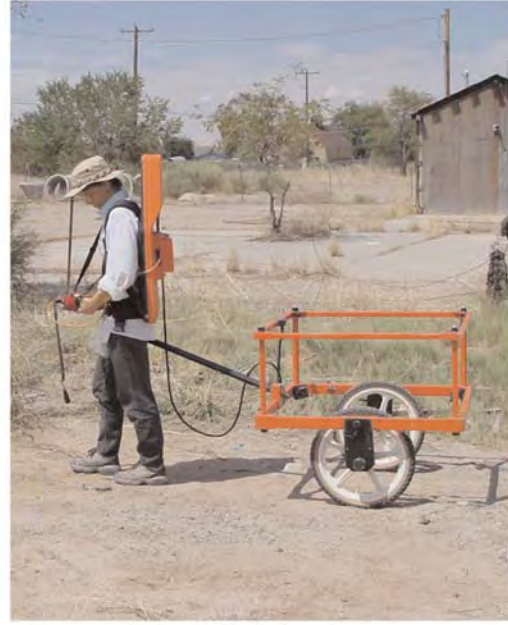
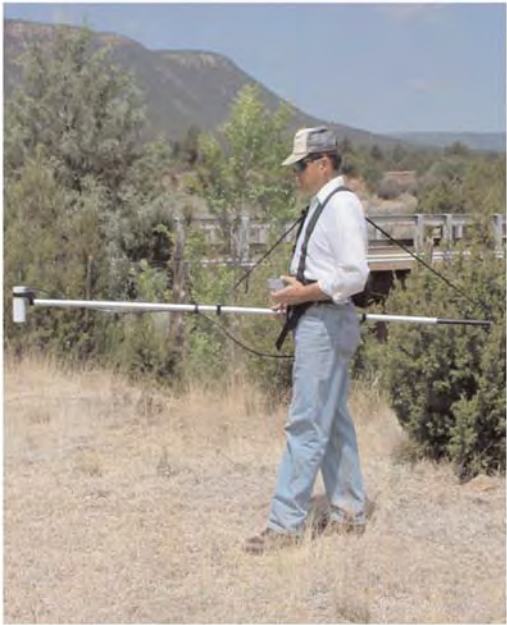
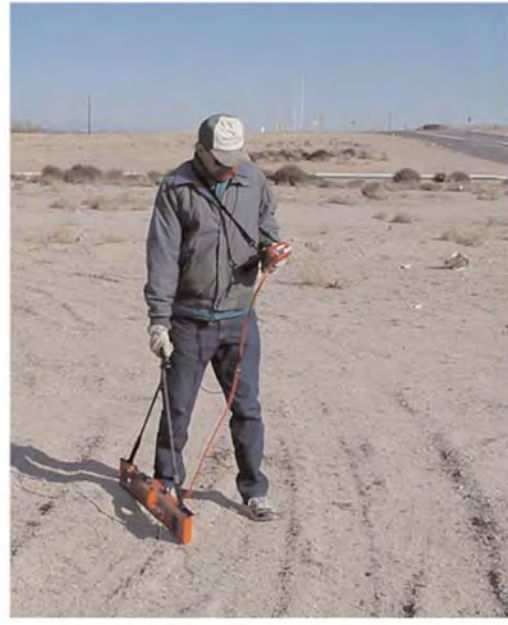
Figure 2. Geophysical Instruments

EM-61 with 15 centimeter antenna

EM-61 with one-meter antenna

Geometrics G-858 Magnetometer

Geonics EM-38 Conductivity Meter

The EM-61 was deployed with two difference antenna sets. The entire site was surveyed using the so called "Hand Held" (HH) coils, which are 15-cm-diameter antenna designed for maximum spatial delineation of small, relatively shallow objects. A portion of the site was resurveyed utiliz-

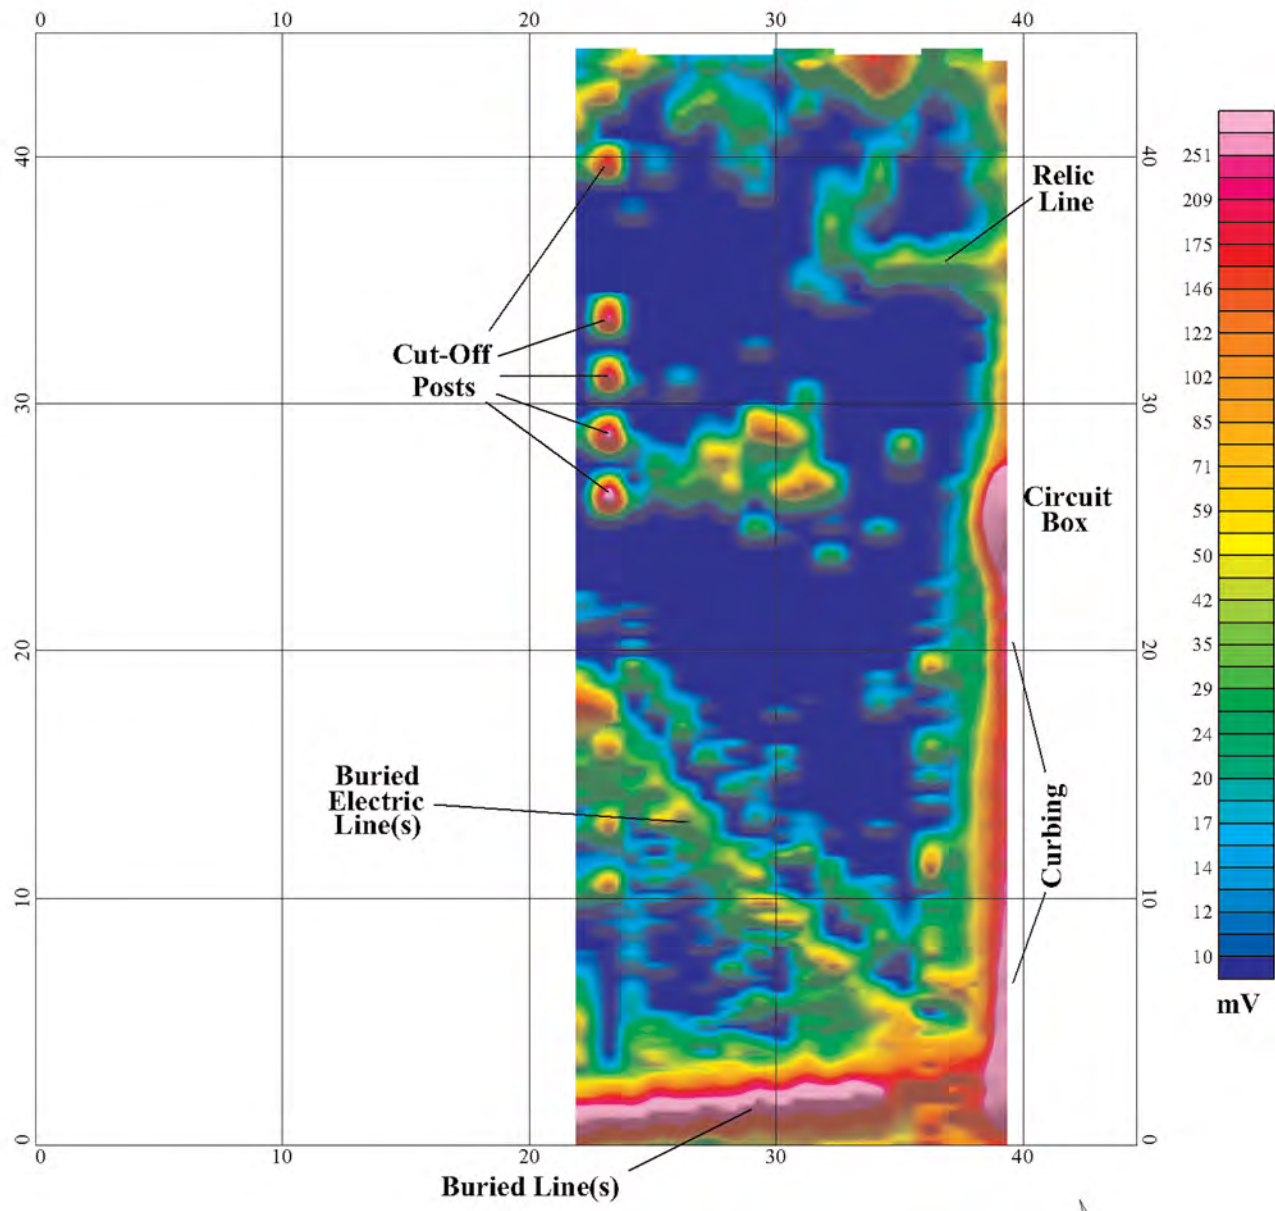
**Figure 4. Palace of the Govenors**  
EM-61 (one-meter coils) Response

The data from the deeper seeking 1-m antenna are shown in Figure 4. This image reveals a buried line, possibly two, running from the northeast corner of the Museum Administration building to the southeast corner of the survey. Electrical power conduit can be observed near each end of this feature, and interference from alternating current would account for the character of the data seen in Figure 3.
