ARCHAEOLOGICAL TESTING AT THE MUSEUM OF FINE ARTS, LA 930, SANTA FE, NEW MEXICO

Archaeology Notes 361
2005

Administrative Summary

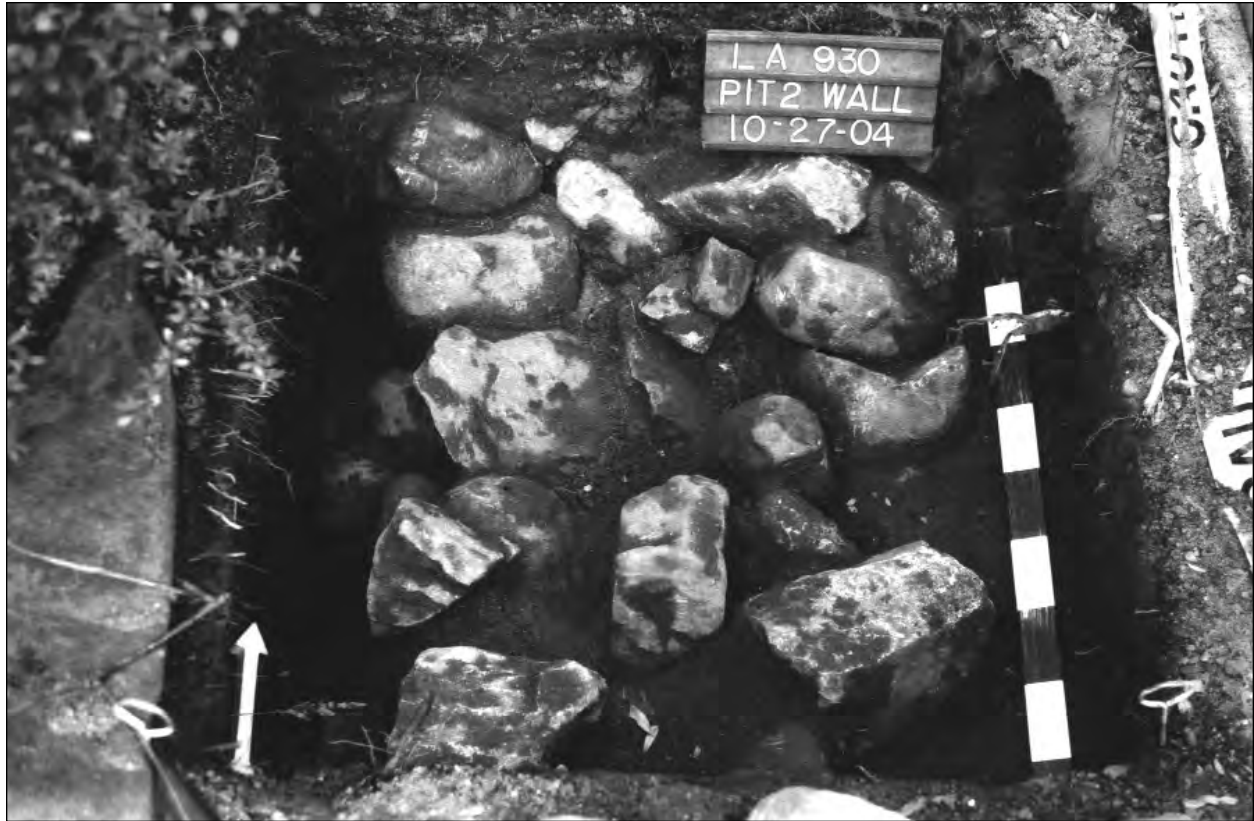
Figure 8. Cobble wall, Test Pit 2.

The western half of the wall was still intact and showed that the cobble wall had originally stood at least four courses (80 cm) tall. The base of the wall consisted of a massive lime-mortar footing about 15 cm thick. Double-wide cobbles set in the footing show that the original wall had been about 60 cm wide. A small 35 by 20 cm excavation unit, laboriously picked through the very hard lime mortar footing, encountered about 15 cm of dark gray sandy loam with charcoal staining. The cultural affiliation and depth of the fill below the lime mortar footing was not deter-

Test Pit 2 uncovered a segment of the lime mortar footing and cobble foundation stub associated with the headquarters of the Fort Marcy Military Reservation. The foundation segment exposed in Test Pit 2 is a portion of a north-south wall and would have been part of the east wall of the Headquarters Building. Maps show that a building stood here from the beginning of the Territorial period in 1846. The upper walls had been constructed of adobe bricks, which rested on the cobble foundation stub. The north profile of the test pit revealed a small 10 cm space of melted adobe and adobe fragments outside the west edge of the cobble wall. This adobe probably originated from the final raising of the upper adobe wall. Several adobe lenses were also noted in the profile of a smaller 5 cm space outside the east side of the wall. The source of this adobe was less clear because of the small exposure, but it may include upper wall debris and earlier Spanish Colonial era deposits. The Territorial

Test Pit 2 revealed intact cultural deposits east of the MFA basement excavation. A segment of the cobble and lime mortar foundation associated with the Fort Marcy Headquarters Building along with potential Spanish Colonial era deposits both beneath and to the east of the foundation are likely to yield additional information important to the history of Santa Fe's Spanish Colonial era and the Fort Marcy era. These intact cultural deposits were preserved in place, and the proposed drainage replacement was rerouted along the foundation of the MFA west of Test Pit 2.

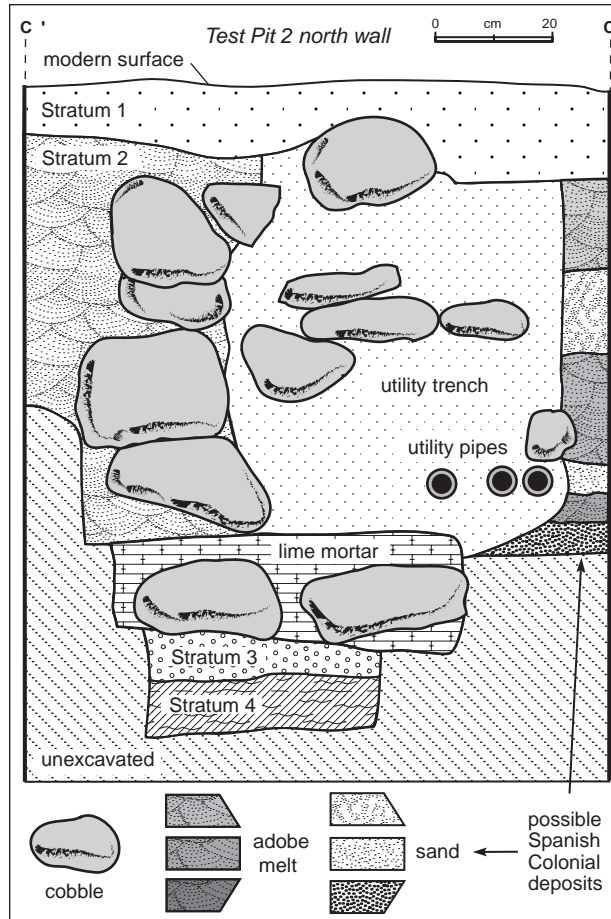
Figure 9. Profile of north wall of Test Pit 2.

period foundation may have been dug into earlier Spanish Colonial era deposits that survive under and east of the exposed wall segment.

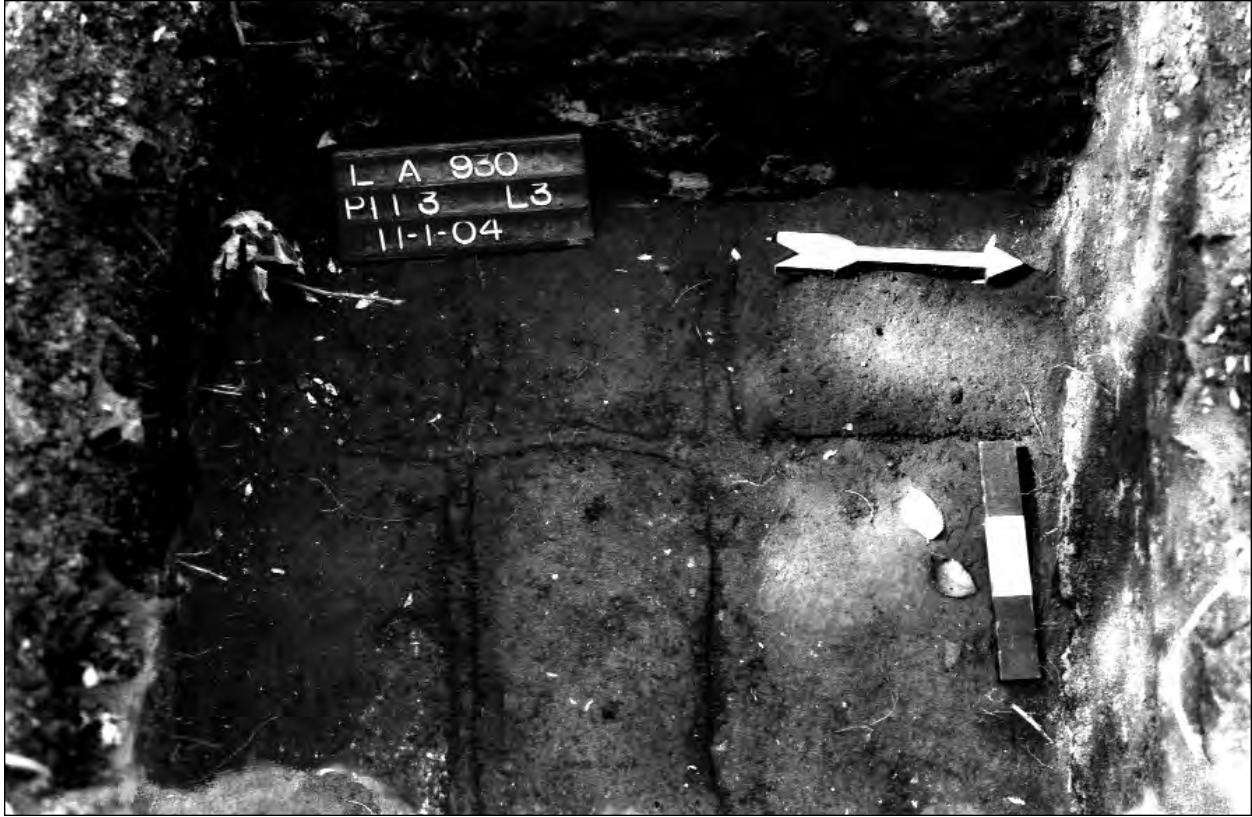
Figure 11. Adobe walls and room corner, Test Pit 3.

A second adobe wall was against the west wall of the test pit. This wall was only one adobe brick wide, and the bricks trended north-south. The wall was 25 cm wide and was apparently an interior dividing wall, while the thicker south wall was a major exterior wall in which two thicknesses added insulation. A 1 cm layer of white lime plaster was on both the east and west faces of this wall and on the interior surface of the south wall (Fig. 12). The junction of the walls formed the interior corner of a room extending beyond the exposed walls in the test pit to the north and east.

The thickness of the adobe bricks and the number of adobe courses was not ascertained because the adobe was wet. However, both adobe walls rested on cobble foundations at a depth of 70 cm. The remaining adobe wall stubs were therefore about 35 cm tall. The layer of white plaster extended to the base of the adobe walls. The floor of the room was probably at the juncture of the adobe and cobbles, but no evidence of the floor was encountered in the exposed 70 cm by 30 cm corner. Both cobble foundations were two courses tall, and the lowest cobbles rested at a depth of 82 cm. The south cobble foundation was 60 cm wide and constructed of unshaped river cobbles averaging about 20 by 10 by 5 cm. The cobble foundation wall was roughly four cobbles wide, but cobbles were randomly placed in the foundation trench and cemented with a light tan mortar. The cobble foundation of the narrower north-south wall was 25 cm wide. The two courses were constructed primarily of double-wide 20 by 10 cm cobbles, but also randomly interspersed with larger single 25 by 25 cm cobbles and smaller triple-wide cobbles. The cobbles

Test Pit 3 revealed cobble foundations and adobe wall stubs associated with the headquarters building of the Fort Marcy Military Reservation. The wall segments include a portion of the primary south wall of the headquarters building and an interior dividing wall forming the corner of a room in the northeast corner of the test pit. Potential Spanish Colonial era deposits are beneath the foundations from a depth of 92 cm to at least 1.2 m. The structural remains and lower deposits are likely to yield additional information important to the understanding of both Santa Fe's Spanish Colonial era and the Fort Marcy era. These cultural deposits were preserved in place, and the proposed drainage replacement was rerouted along the disturbed foundation of the MFA north of Test Pit 3.

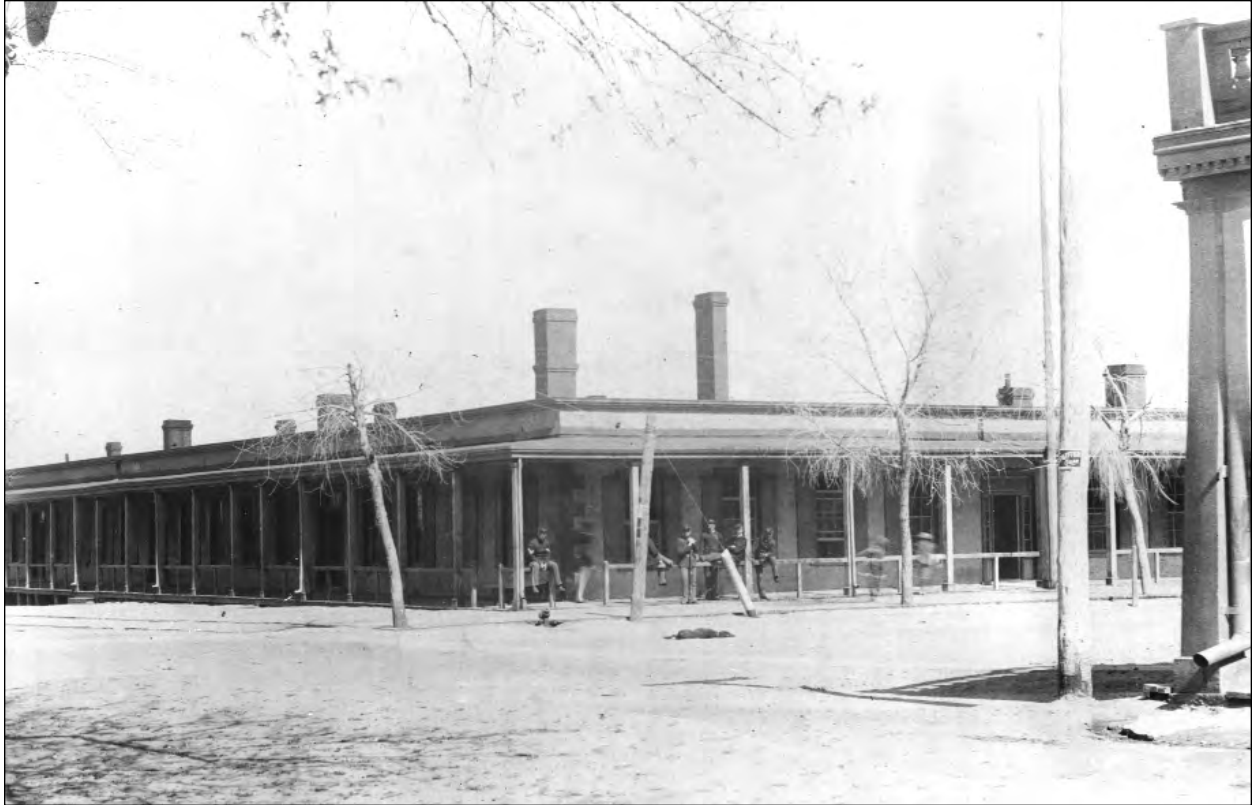
Figure 16. Headquarters Building (1880s).

1890s. An 1880s photograph from the northwest corner of the plaza shows the Headquarters Building with portals on both the east and south sides (Fig. 16). An 1890s photograph from approximately the same spot shows the building, now labeled "barracks," in a state of deterioration (Fig. 17). The portals have been removed, and the exterior plaster has weathered, exposing the adobe wall construction. The cobble foundation stubs are visible on both the east and south sides of the building. Test Pits 1 and 2 would be near the door on the east side, and Test Pits 3 and 4 near the covered door on the south side. The structure advanced into a state of decay until the building was razed in 1915 and the MFA building was constructed in 1917 (Fig. 18). Although the project area has been greatly transformed by the evolving cityscape of downtown Santa Fe, the testing program verified that intact archaeological remnants from both the Spanish Colonial era and the Fort Marcy Military Reservation survive under the surrounding sidewalks and gardens of the MFA building.
