MONITORING OF EXCAVATIONS
AT THE COMMANDING OFFICER'S QUARTERS,
FORT STANTON, LINCOLN COUNTY,
NEW MEXICO

**Monitoring of Excavations at the Commanding Officer's
Quarters, Fort Stanton, Lincoln County, New Mexico**

ARCHAEOLOGY NOTES 420

The Property Control Division, New Mexico General Services Department, proposed stabilization work at the commanding officer's quarters (Building 1) at Fort Stanton State Monument, New Mexico. The visible surface manifestation of Fort Stanton (LA 8744) is listed in the *National Register of Historic Places* (No. 60) and the *State Register of Cultural Properties* (SR 60).

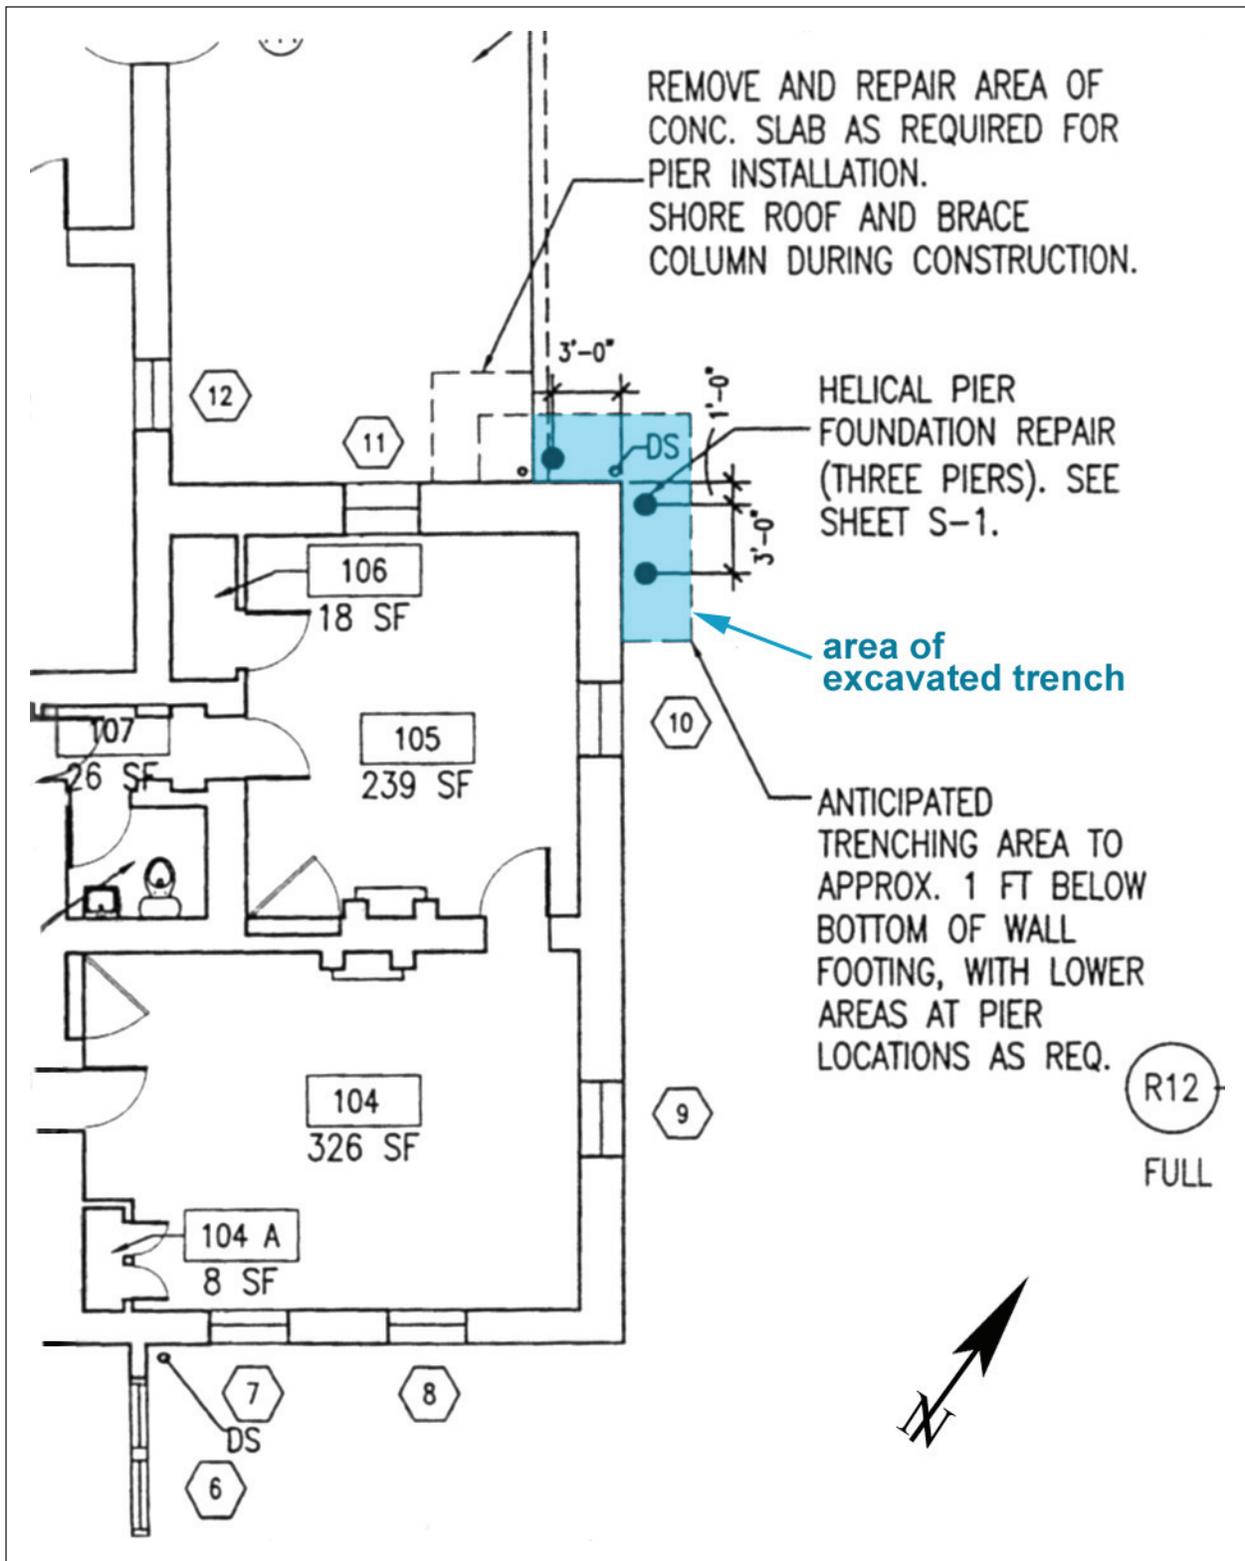
Figure 4. Schematic drawing of helical pier and excavated area.

Monitoring consisted of observing the hand-excavation of a 60 cm wide by 90 cm trench on the north corner of the building (Fig. 4). This trench was 0.8 m long along the northwest wall and 1.50 m long along the northeast wall. As the trench was excavated, the fill was examined for cultural deposits, and artifacts were collected. Notes were taken describing the fill and contents of the trench as it was being excavated. When excavations were complete, profiles and a plan view were drawn to document the trench. Photos were also taken of the trench before, during, and after excavation. Once it was determined that excavations were not going to continue any further, the trench was backfilled by the contractors.

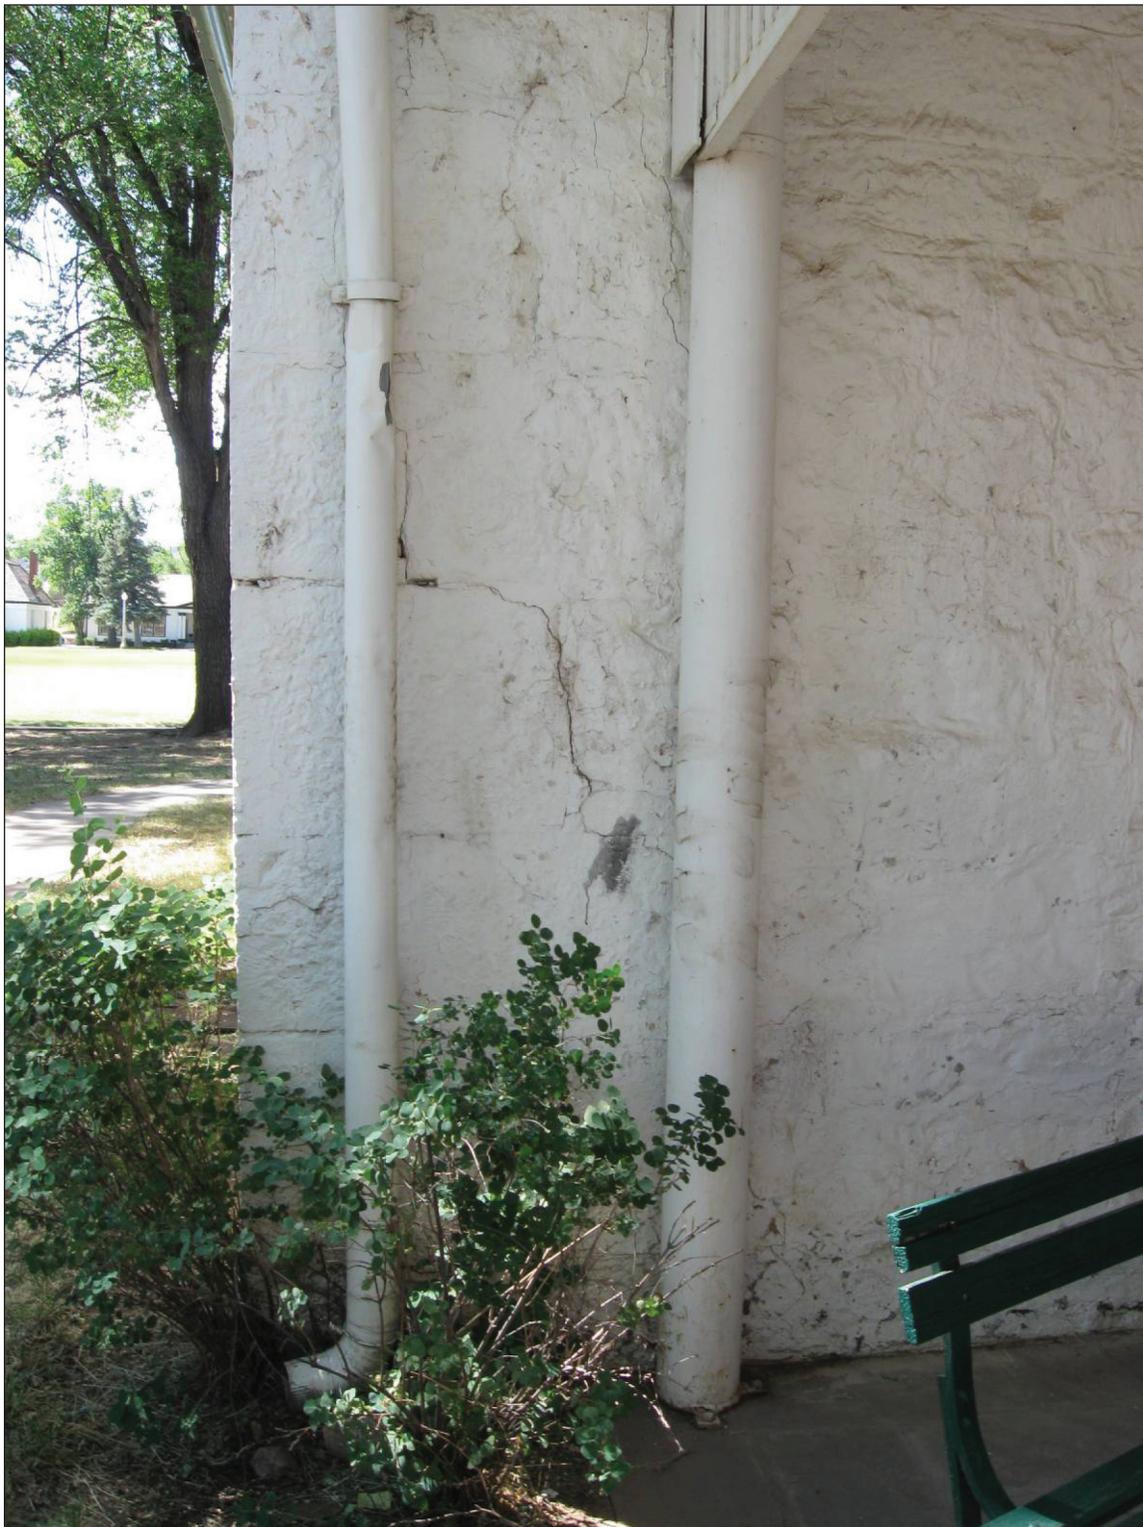
Figure 5. The northwest wall before excavation.

Initial observations of the wall showed that the northeast and northwest sides had a crack 1 cm wide running vertically from the base to near the top of the wall (Fig. 5). The crack in this wall had prompted the placement of helical piers at this location.

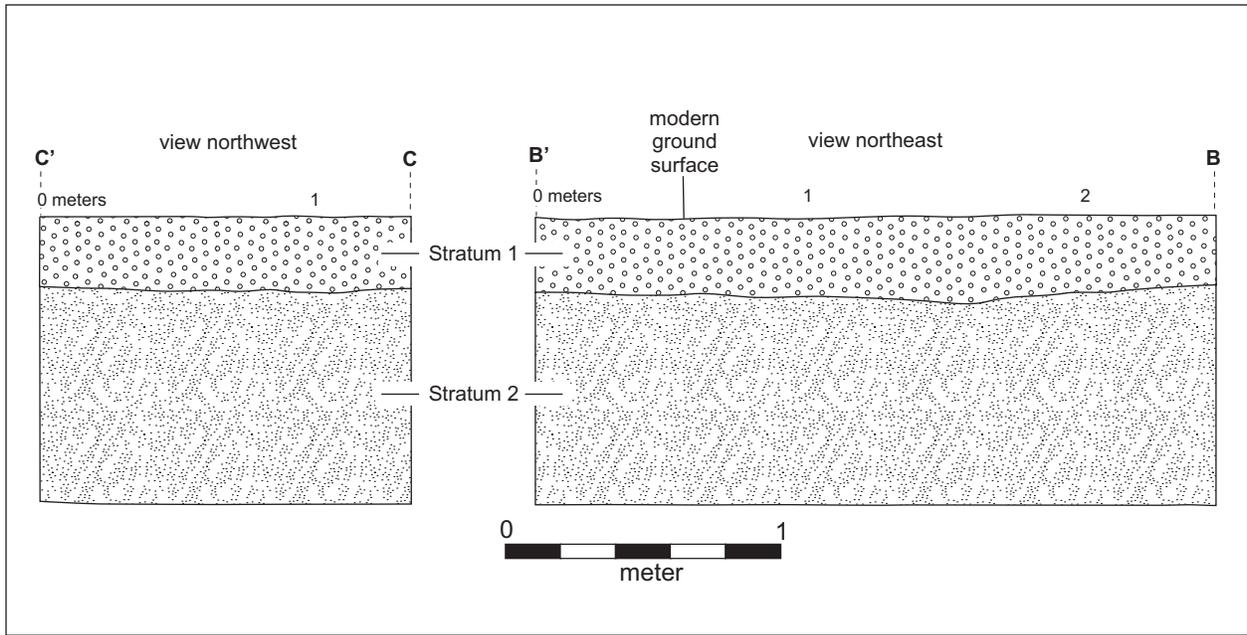
Figure 6. Profiles of northwest and northeast trench walls.

Excavations revealed two distinct strata. The upper stratum (Stratum 1) was 24–28 cm thick and consisted of a consolidated, dark brown (Munsell

10yr 3/3), silty clayish sand with inclusions of 1 percent pea gravel and roots. Artifacts and other cultural inclusions consisted of a mix of concrete and sandstone pieces, glass, metal, a peach pit, a modern key, plastic, foil, paint pieces, two Native ceramic sherds, one lithic artifact, animal bone, and very sparse charcoal flecks. Five cm beneath the surface, a loose concrete slab (56 cm wide by 80 cm long by 10 cm thick) was removed; it did not appear to be related to the construction of the building, and may have been a discarded piece from the slab in the nearby portal. The lower stratum (Stratum 2) was 68–72 cm thick and had the same consistency and content as Stratum 1, except that modern refuse was absent. Artifacts and other cultural inclusions consisted of a few pieces of glass, metal, animal bone, and very sparse charcoal flecks (Fig. 6).

Strata 1 and 2 appear to be redeposited or disturbed fill. Stratum 1 appears to be more recent, judging from the modern refuse, and may have been introduced to level the area. Stratum 2 could be as early as the building; it may be redeposited fill used to fill in the trench foundation for the building.

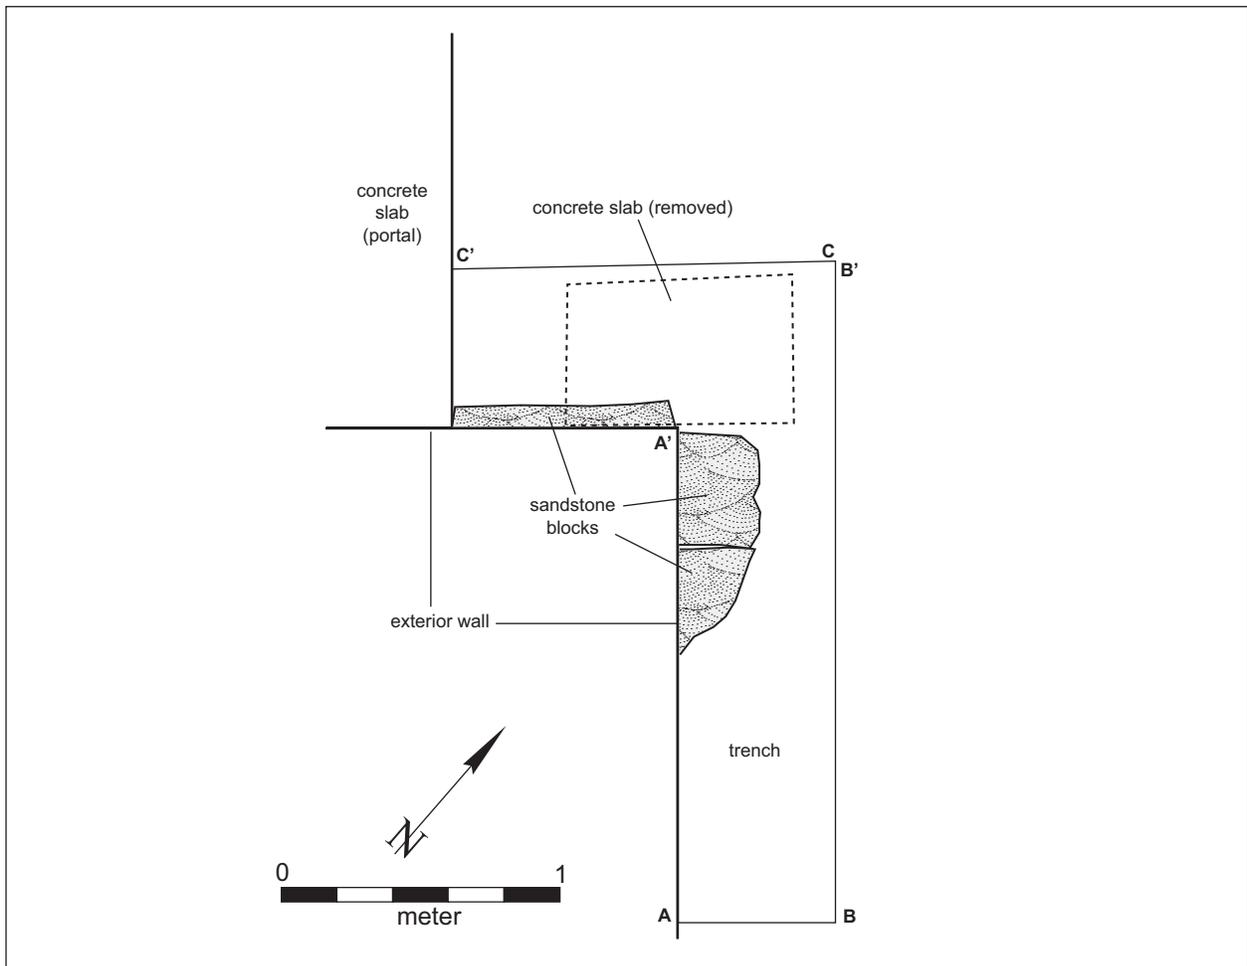
Figure 7. Plan of north corner.

About 24 cm below the ground surface, large pieces of cut-sandstone blocks (ranging in diameter from 16 to 40 cm) were encountered below the corner of the building, protruding into the trench (Figs. 7–10). These sandstone blocks continued to 60 cm below the base of the wall. It appears that these sandstone blocks were placed beneath the corner of the building during construction to support the corner. Excavation for the helical piers could not continue because of their location, and it was determined that an alternate plan would have to be made at a later date.

As anticipated, no cultural features were encountered during monitoring. Soils were disturbed and contained a mixed context. They were probably introduced during construction. Because the original plan of placing galvanized steel angle plates below the foundation was compromised by sandstone blocks, excavations were halted. A new strategy for supporting the northeast wall will have to be developed. Future archaeological monitoring will depend on what new strategy is devised. If the new strategy requires excavation in areas that were not excavated previously, additional archaeological monitoring is recommended. Future monitoring is also recommended because the depth and age of the soils are still unknown.
