# FROM ACEQUIAS TO INDUSTRY, THE ARCHAEOLOGY OF NEIGHBORHOOD AND INFRASTRUCTURE AT THE SANTA FE RAILYARD

## VOLUME I: EXCAVATION, ANALYSIS, SYNTHESIS

Office of Archaeological Studies

Archaeology Notes 422

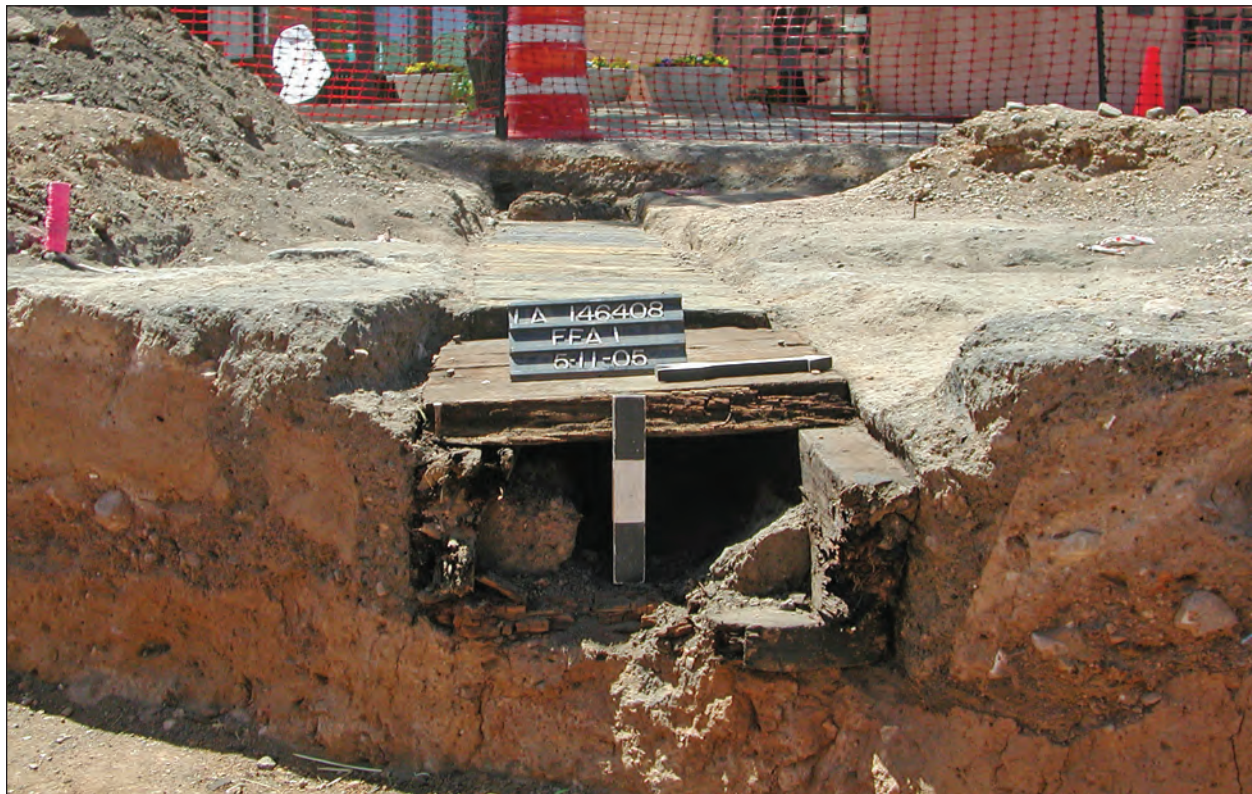
Figure 2.7. LA 146408, BHT 51, west wall, Features 1 and 28, cross sections after excavation of overburden, showing construction details.

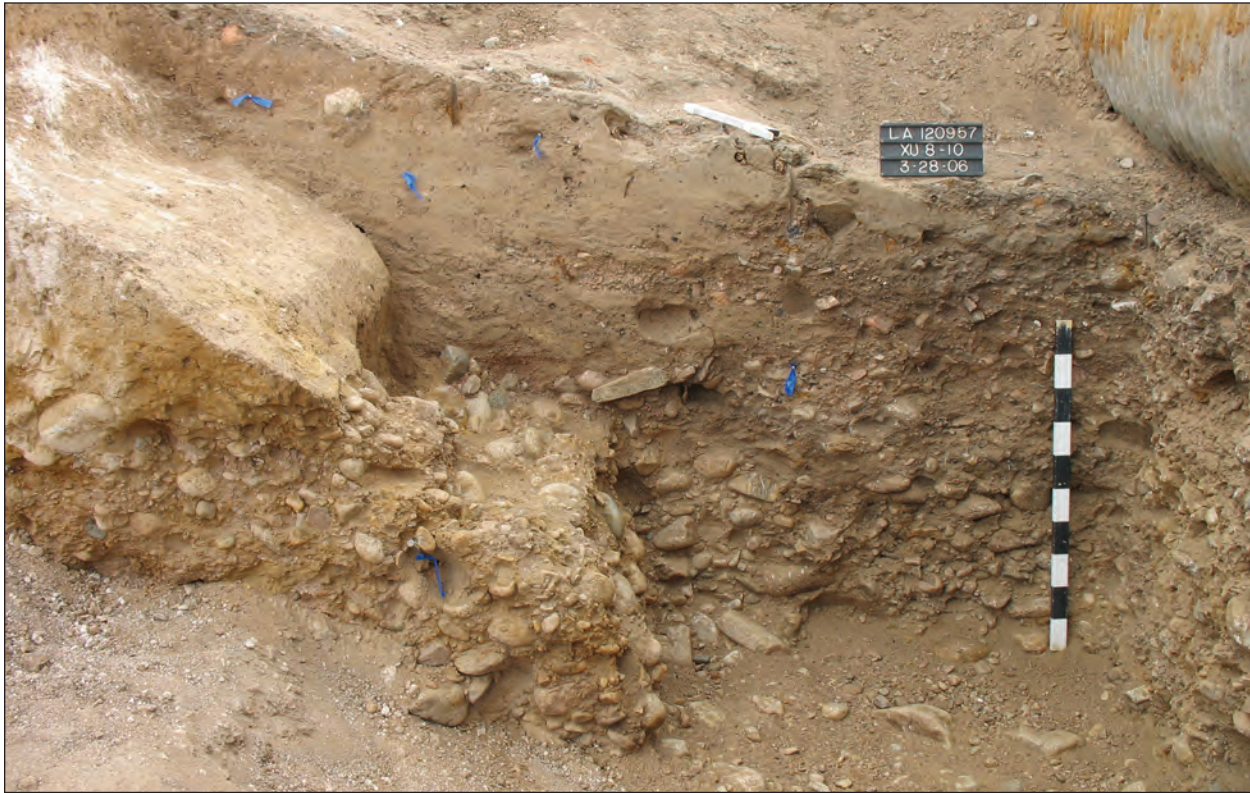
Figure 2.69. LA 120957, view of XUs 8–10, east wall, showing the deeply buried channel of Feature 1022 below the modern steel culvert.

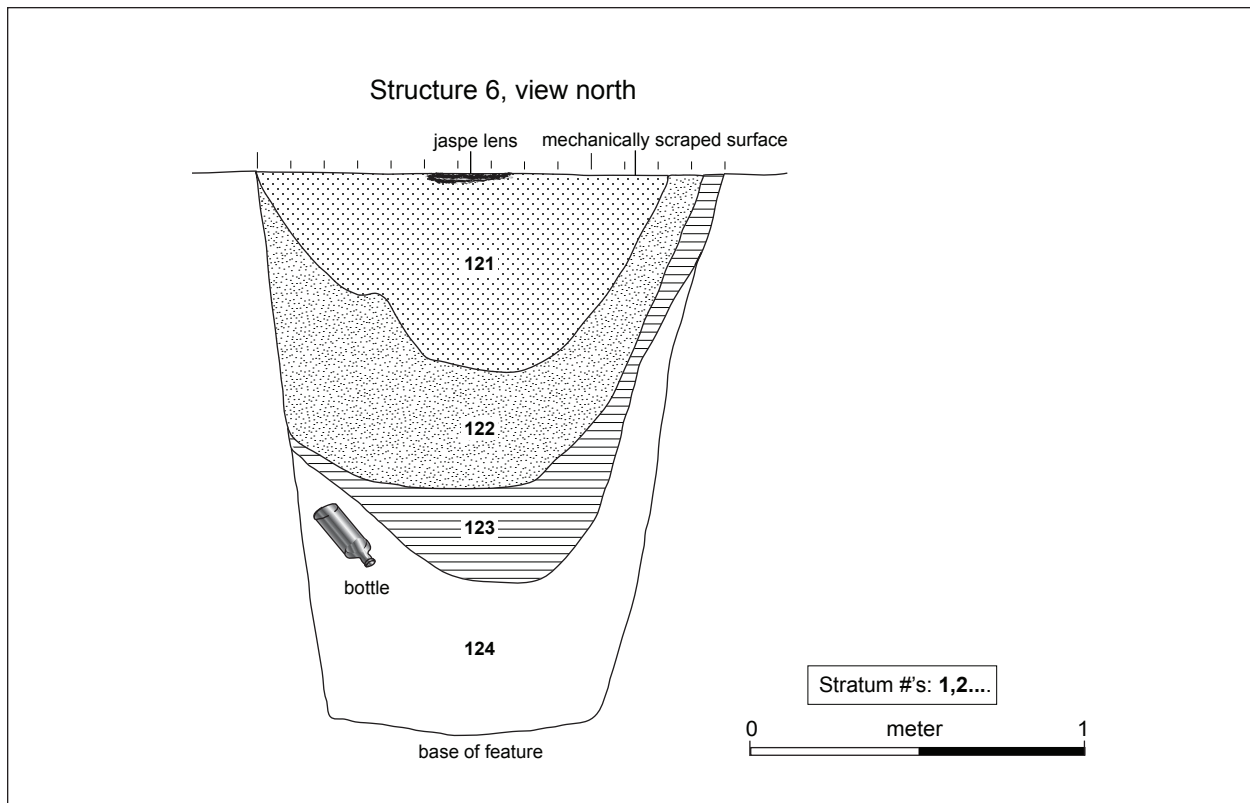
Figure 3.47. LA 146402, Structure 6, cross-section view.

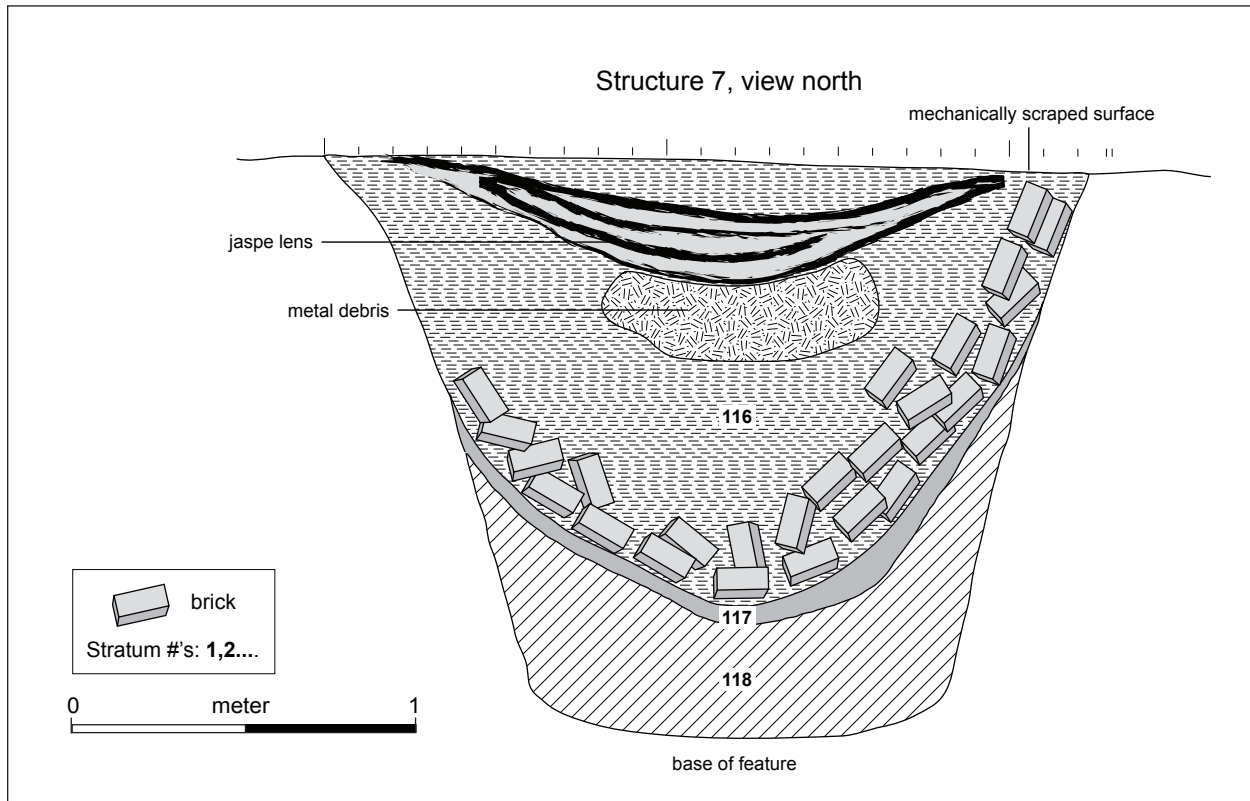
Figure 3.48. LA 146402, Structure 7, cross-section view.

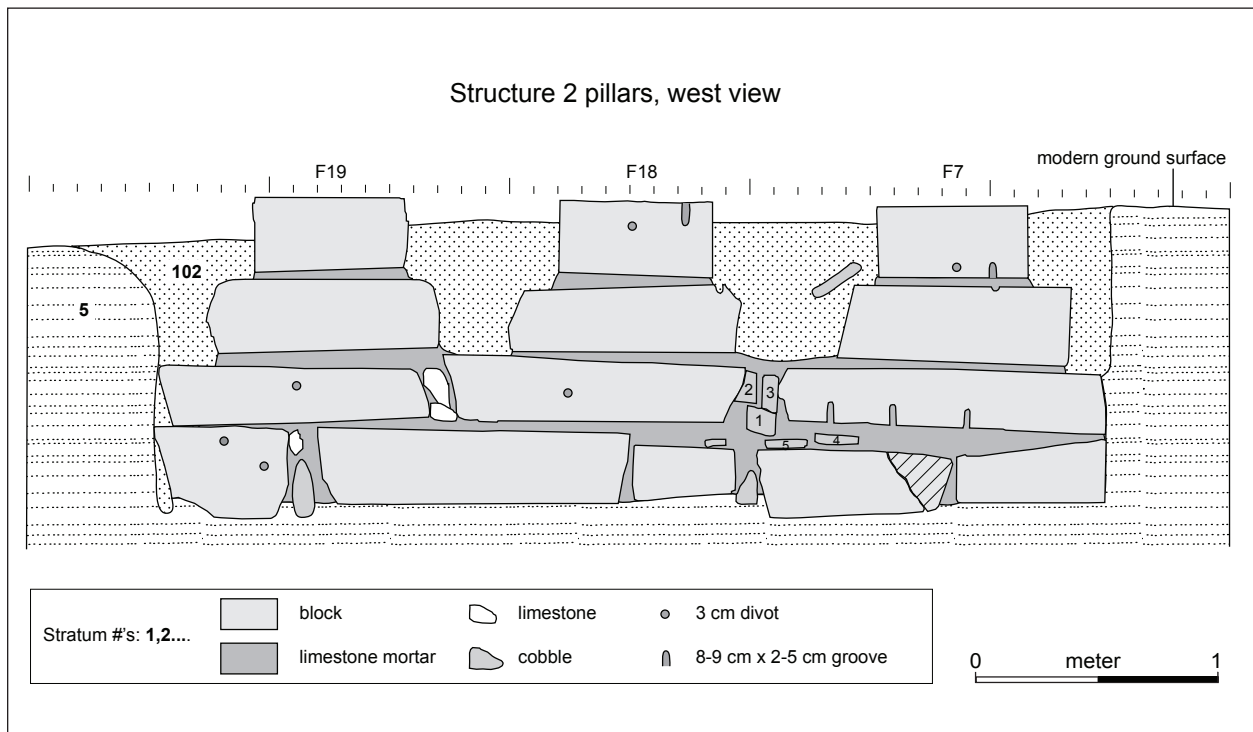
Figure 3.92. LA 146403, Structure 2, water tower profile.

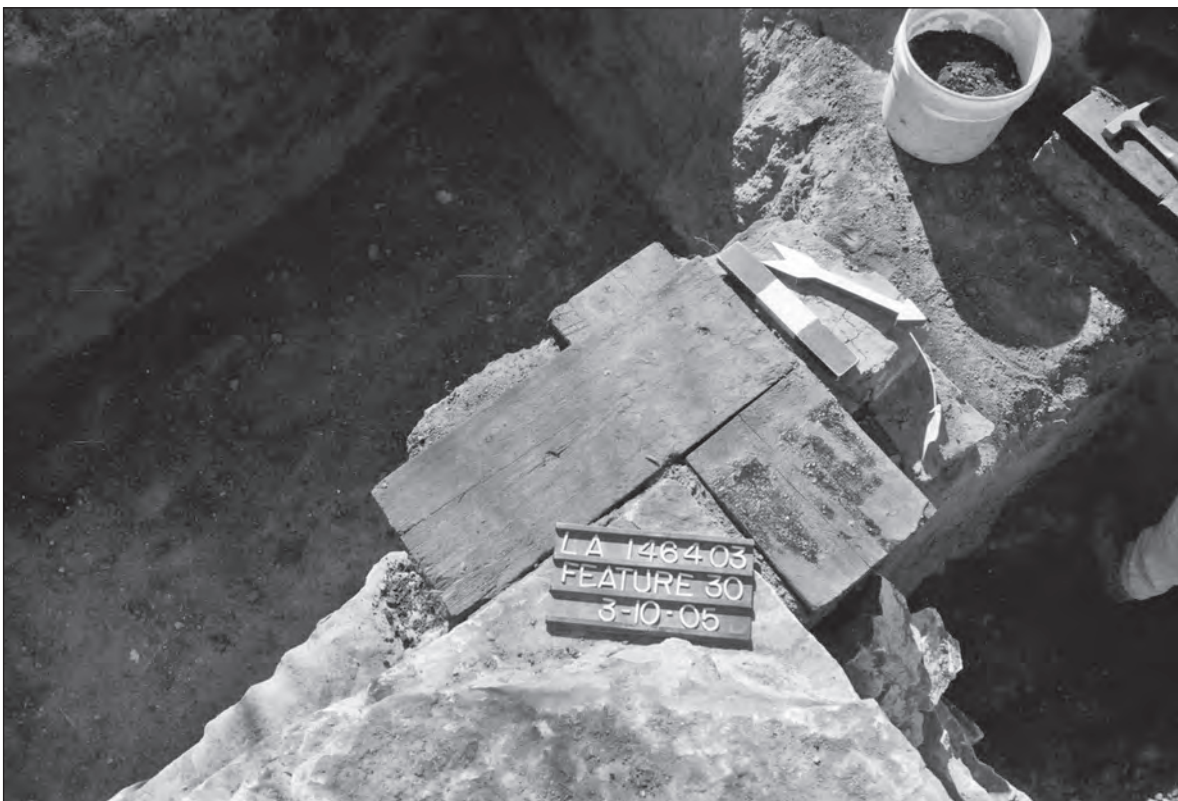
Figure 3.99. LA 146403, Structure 2, Feature 30, wooden brace detail.

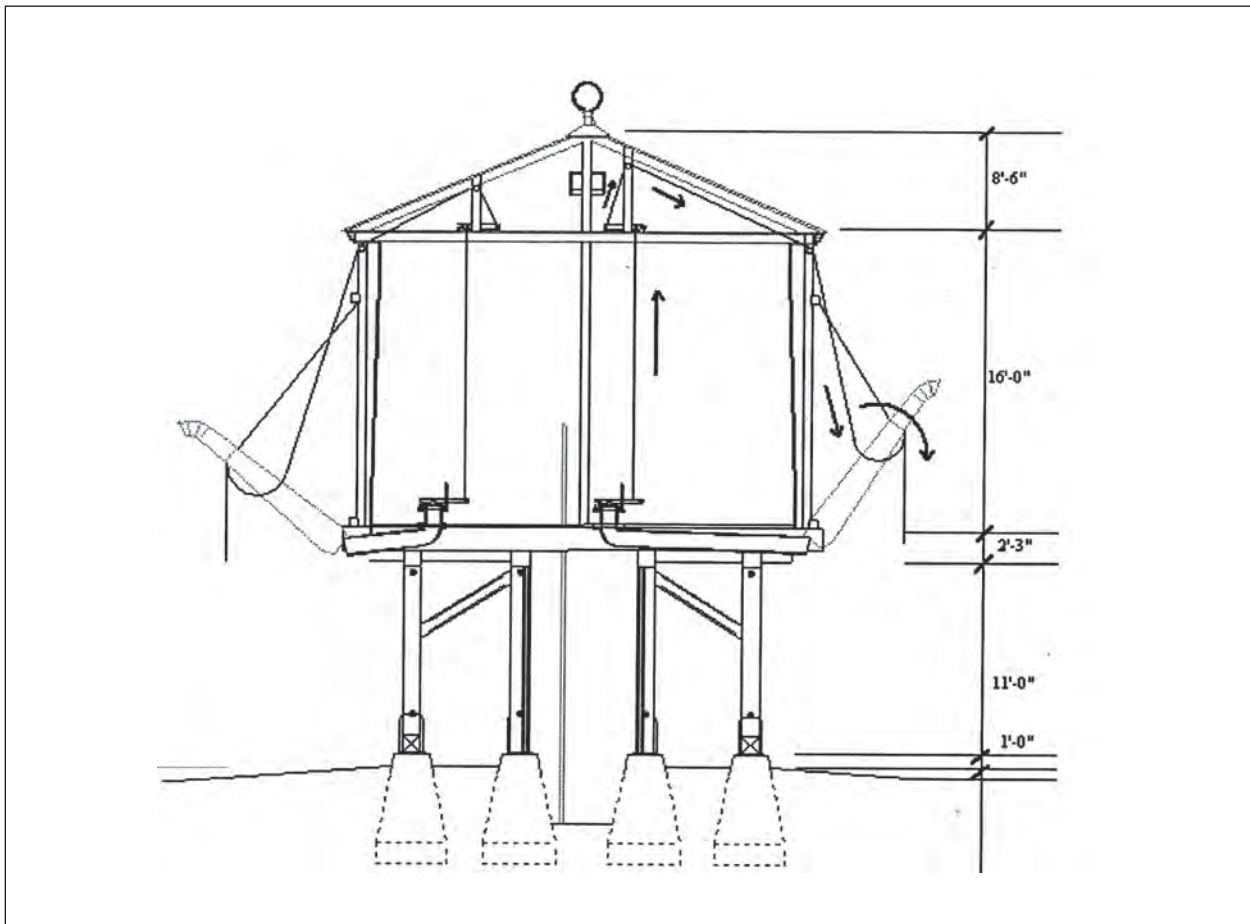
Figure 3.102. Plan view and elevation detail of 50,000 water towers at Chama, NM (courtesy Sandia Software © 2000).

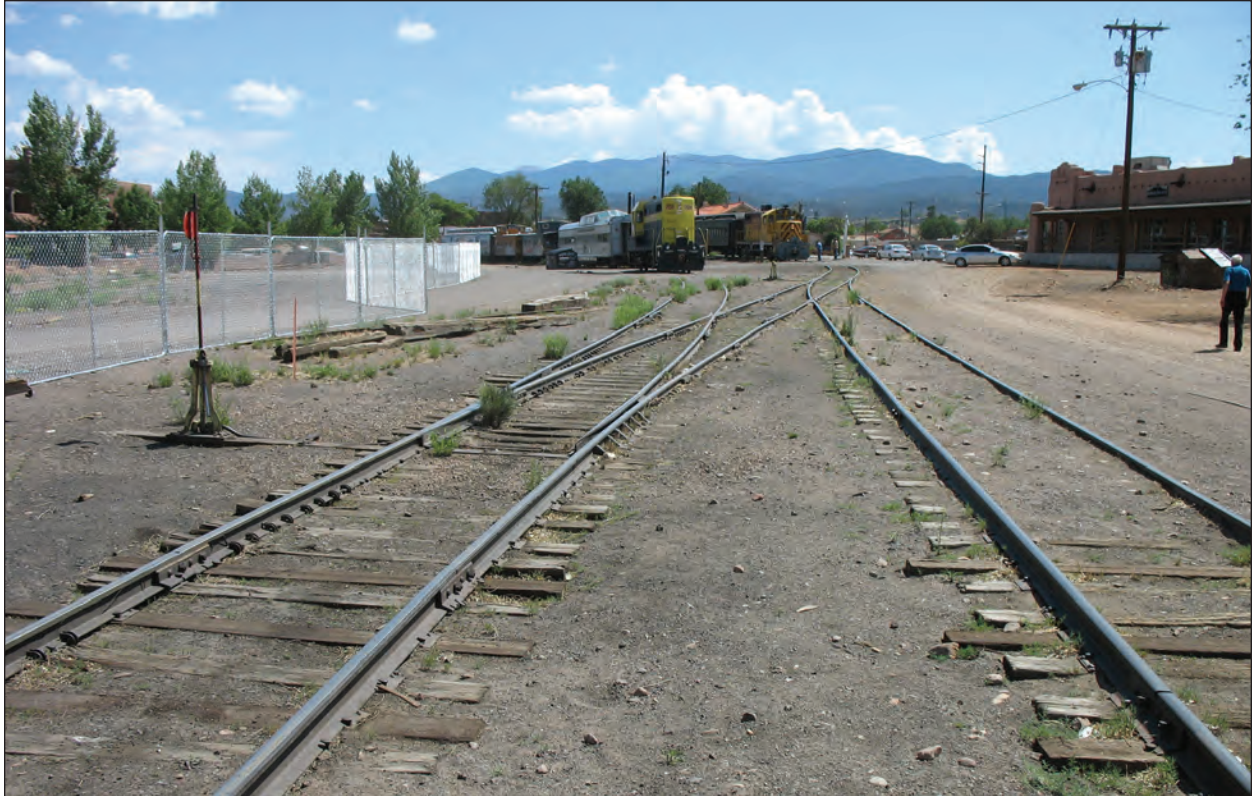
Figure 3.109. View of railroad tracks (LA 153441) in the Santa Fe Railyard, facing northeast toward the Manhattan Avenue crossing. The 1909 AT&SF depot is in the background, behind the locomotives; note the manual switch stand in the left mid-ground.

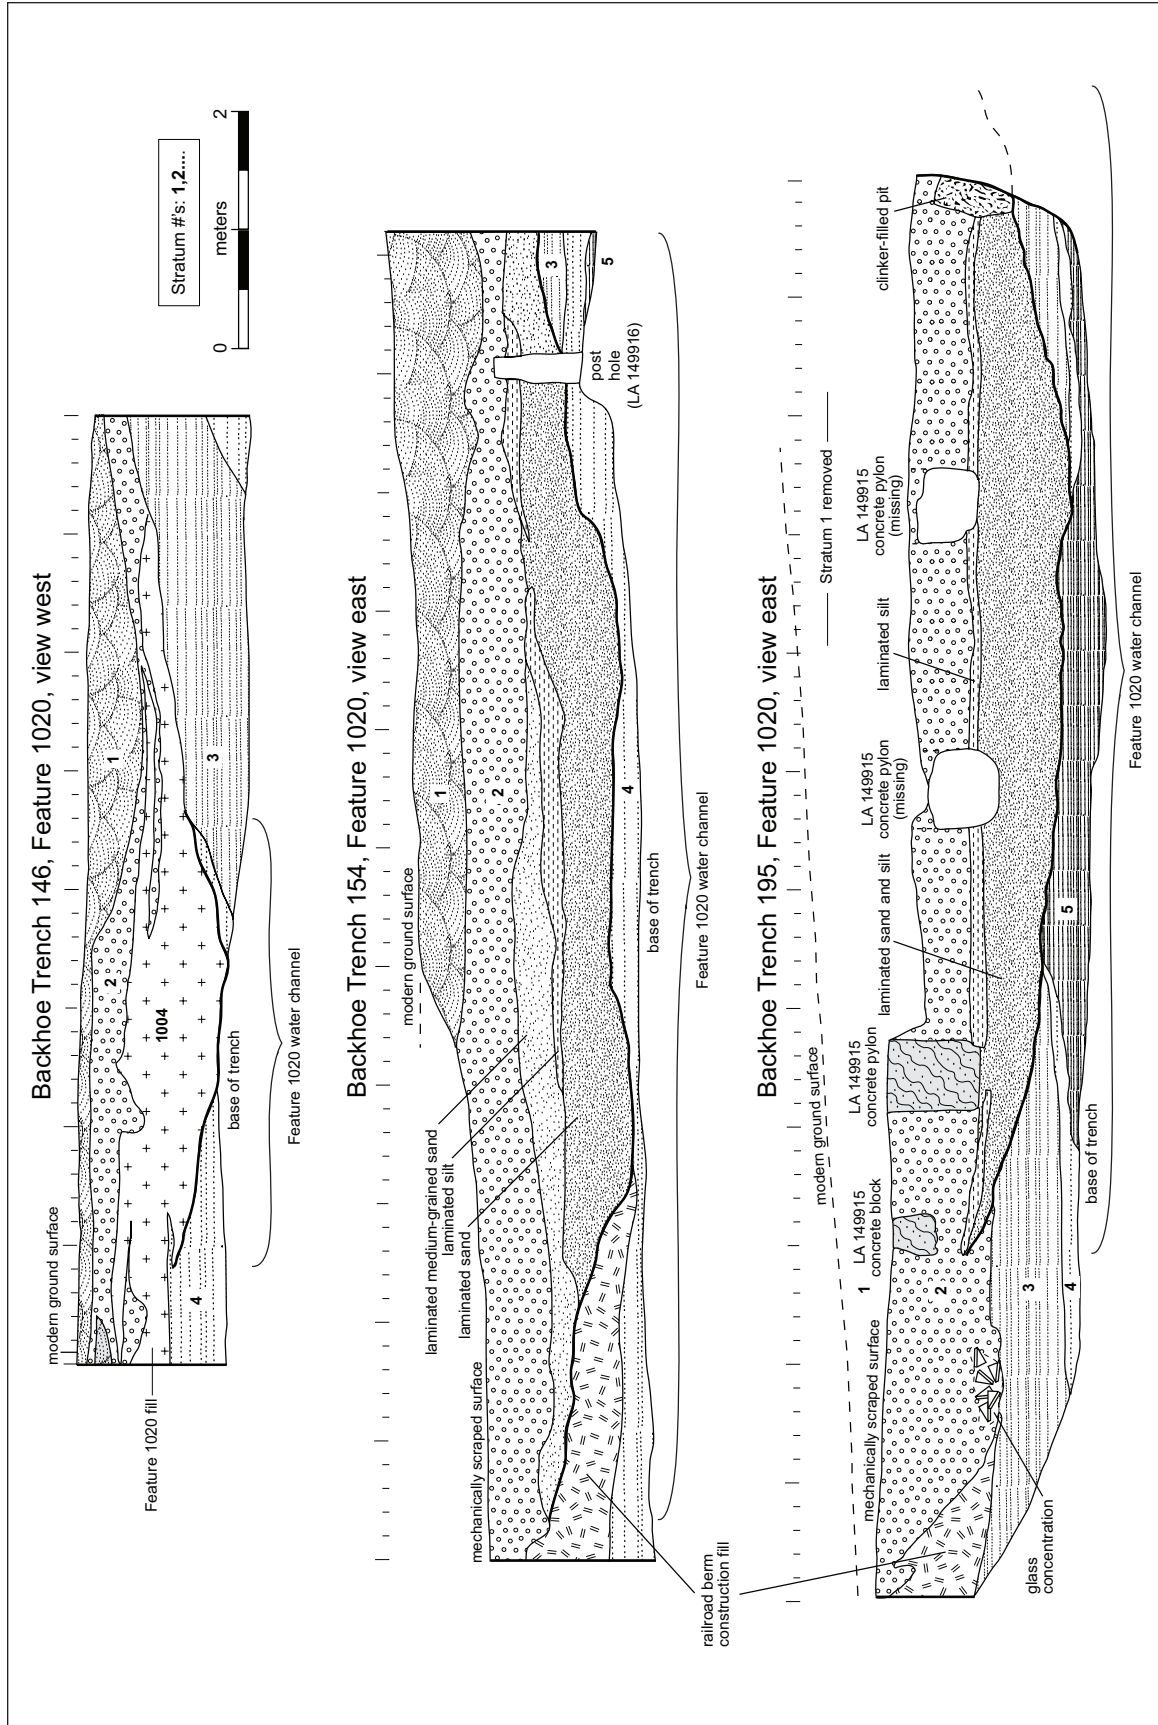
Figures 4.20, 4.21, 4.22. LA 149913, top (Fig. 4.20): BHT 146, west wall, cross-section view of Feature 1020; middle (Fig. 4.21): BHT 154, east wall, cross-section view of Feature 1020; bottom (Fig. 4.22): BHT 195, east wall, cross-section view of Feature 1020.

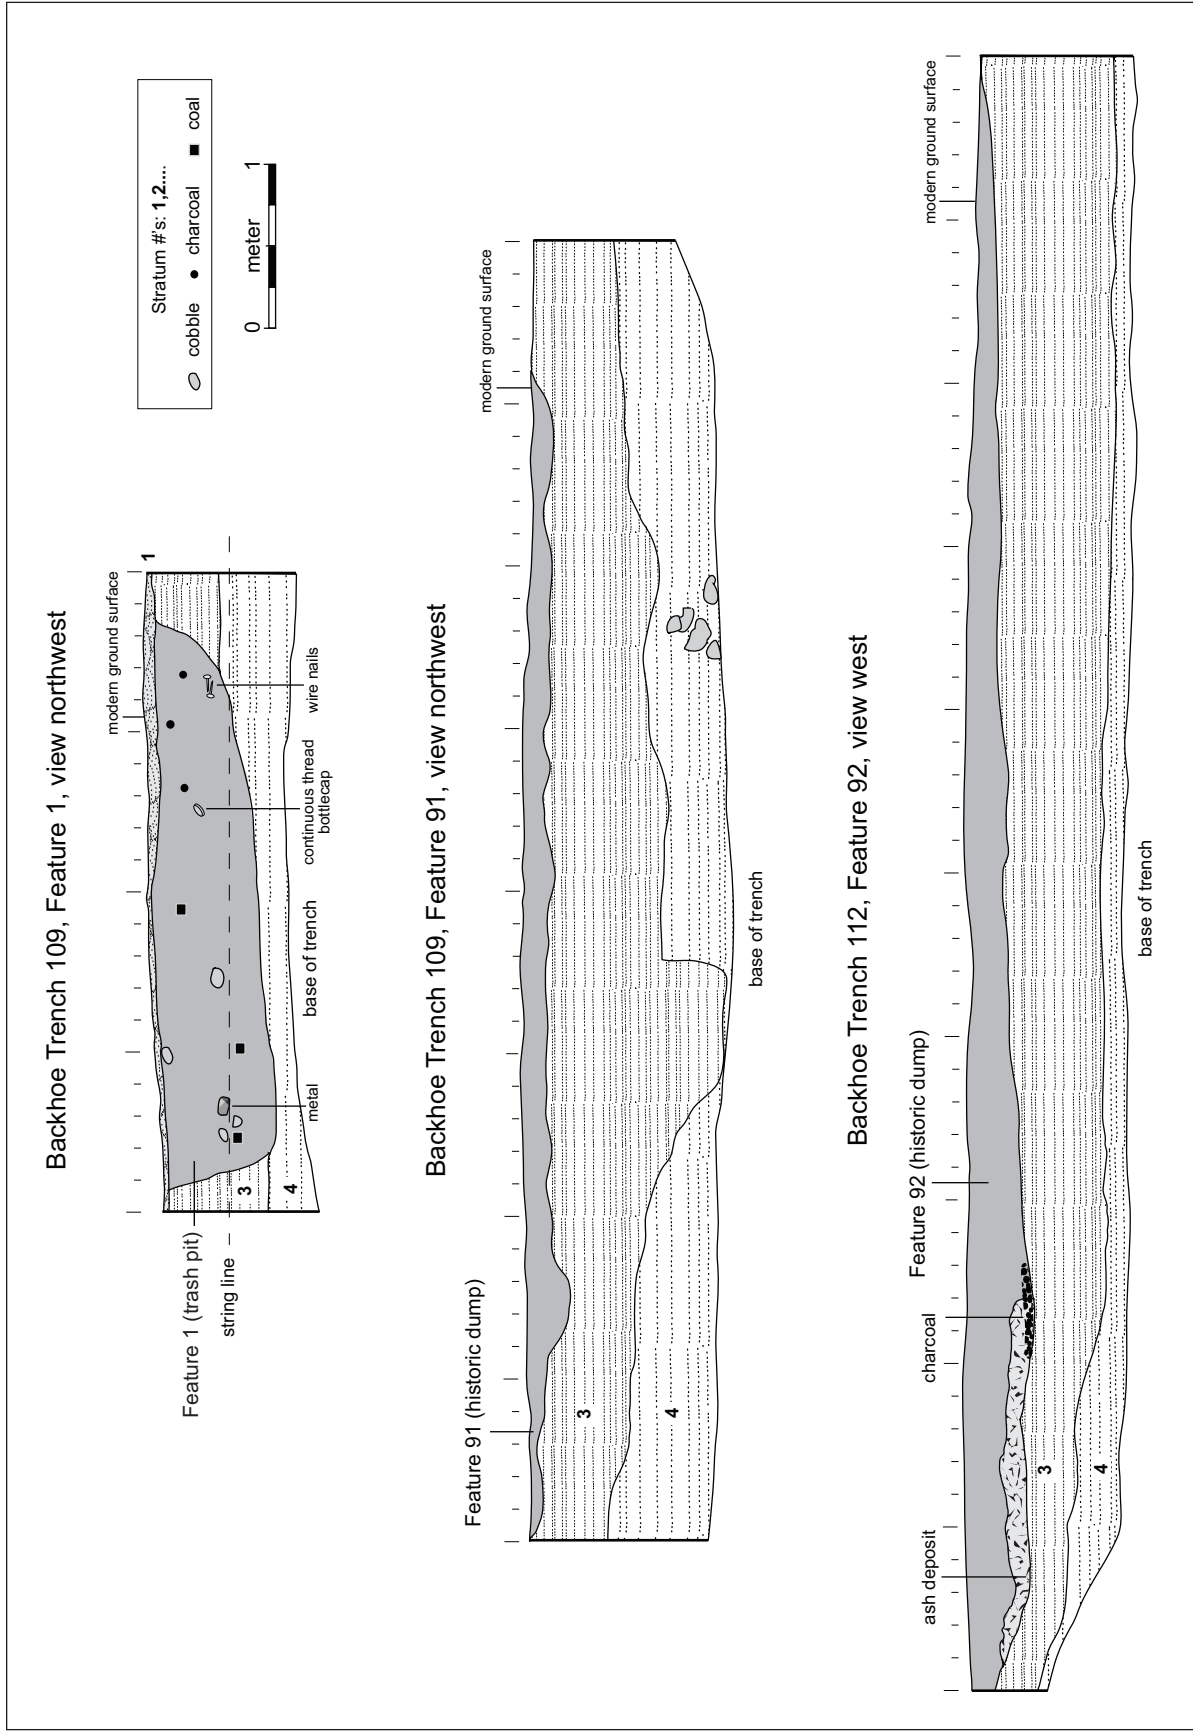
Figures 5.7, 5.8, and 5.9. LA 146413, top (Fig. 5.7): Feature 1, profile; middle (Fig. 5.8): Feature 91, profile; bottom (Fig. 5.9): Feature 92, profile.

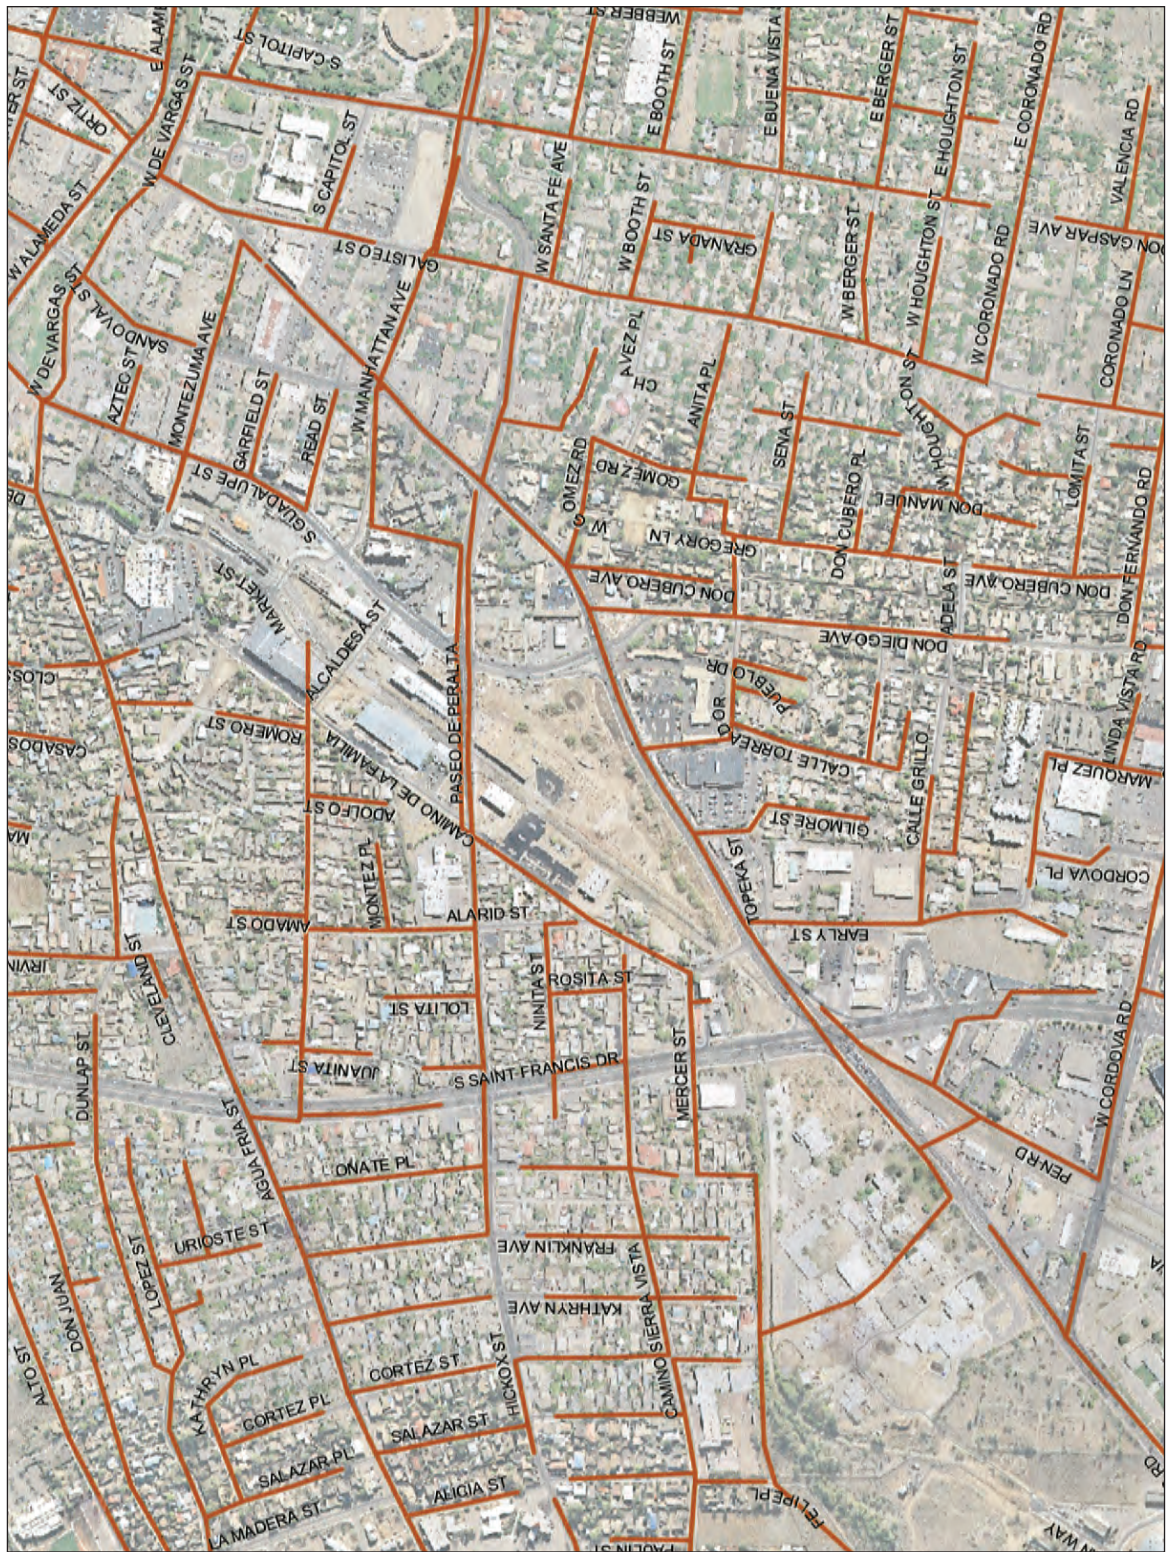
Figure 7.12. GIS map of Santa Fe's sewer systems, ca. 1990 (courtesy David Barsanti, Santa Fe, GIS Specialist, City of Santa Fe). Note that, although there are currently disjuncts across the railyards, several sewer lines appear to occupy former ditch laterals.
