FROM ACEQUIAS TO INDUSTRY, THE ARCHAEOLOGY OF NEIGHBORHOOD AND INFRASTRUCTURE AT THE SANTA FE RAILYARD

VOLUME II: APPENDIXES

Archaeological Geology of Acequias in the Santa Fe Railyard

Stephen A. Hall
Red Rock Geological Enterprises
Santa Fe, NM

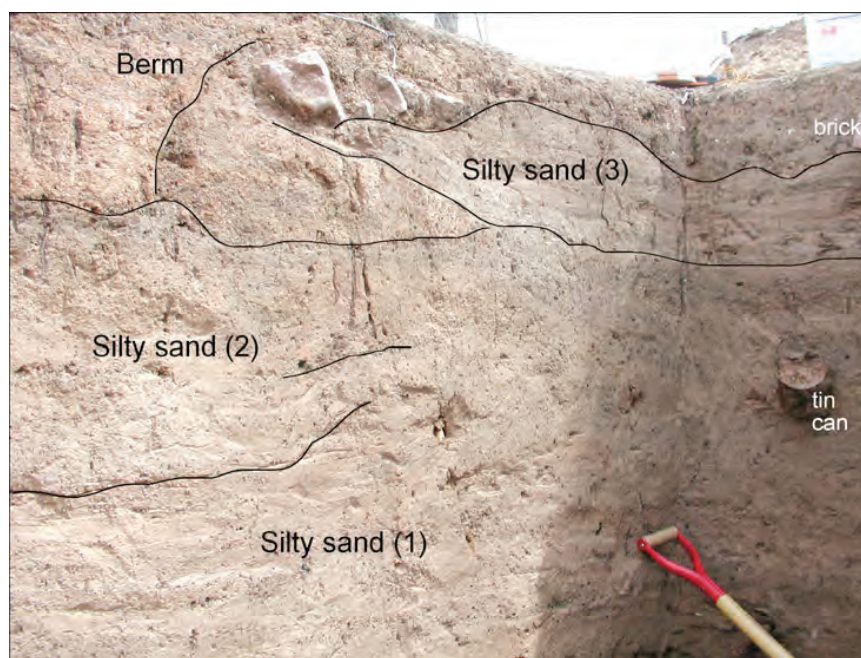
Figure App1a.9. Upper exposure of three separate acequia fills on the north side of Acequia Madre, BHT-158. A very weak A horizon soil occurs at the top of the “Silty sand (2)” sub unit. The Acequia Madre channel is on the other side of the wall where the shovel handle is shown. Photographed in 2006; compare with **Fig. App1a.8**.

Testing adjacent the present-day Acequia Madre channel has exposed evidence of additional acequia channels, presumably earlier channels of the Acequia Madre. The fresh exposures of the earlier channels in BHT-158 and BHT-201 show that they were dug into unit 4 deposits (**Figs. App1a.6–App1a.8**). The earlier channel fills are complex and show some variability from place to place. In BHT-158, three separate deposits of silty sand appear to be earlier channels (**Fig. App1a.9**). The latest early channel fill, “silty sand 3,” occurs at the top of the stratigraphic sequence and appears to be associated with a berm composed of rocks and sediment, the sediment possibly derived from unit 3 sandy silt (**Figs. App1a.8–App1a.9**).

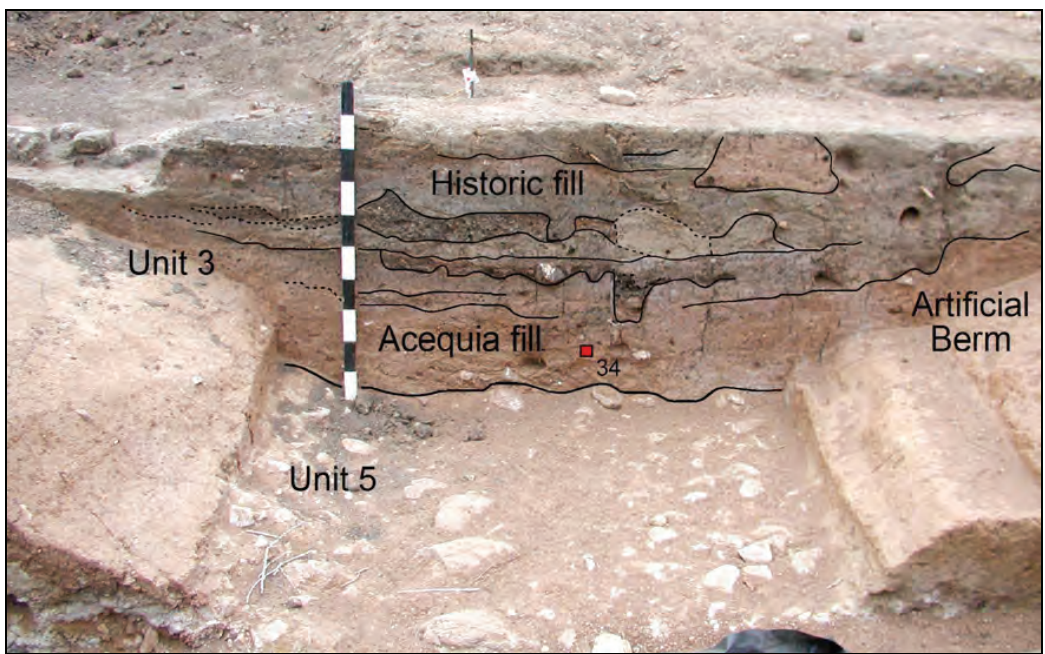
Figure App1a.18. Cross-section of Acequia de los Tenorios at location where acequia emerges from natural channel; artificial berm on the right (northwest) of acequia; BHT-164 (also illustrated in **Fig. 2.45** and in Wenker, 2006, fig. 28). The acequia fill sediment is poorly sorted sandy silt (44% silt) (**Tab. App1a.1**, sample #34). The geometry of the acequia channel is less clear at this locality than at other localities. Photograph taken in 2006; 1-meter scale.

At BHT-164, the acequia was dug through Unit 3 sandy silt down into Unit 5 gravel. The geometry of the acequia channel is wide and shallow. The greatest width is about 360 cm and estimated depth is 54 cm. The acequia fill is about 32 cm thickness; the sediment above the fill is historic fill composed of various sediments and trash. The acequia fill appears to have been disturbed as well, especially in the central axis of the channel. The acequia channel forms a sharp contact with the underlying Unit 5 gravel (**Fig. App1a.18**).

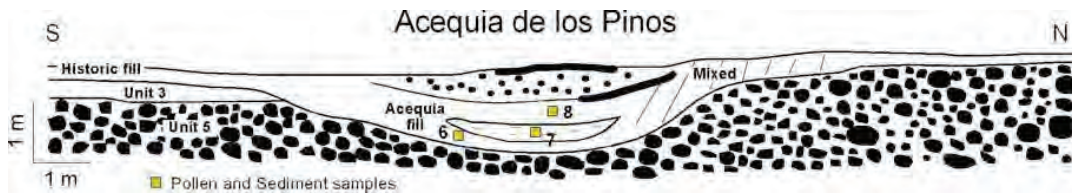
Figure App1a.19. Cross-section sketch of Acequia de los Pinos at LA 149909, BHT-192, at approx. 1:1 scale. Pollen samples # 6–8 (**Tab. App1a.2**) and sediment samples # 6–8 (**Tab. App1a.1**) (splits from the same material) were collected from this locality. Pollen sample #7 from the lens of laminated silty sand contains the only record of *Zea mays* pollen documented in this investigation. The above field sketch differs in detail from the more precisely drawn cross-section illustrated in Wenker (2006b).

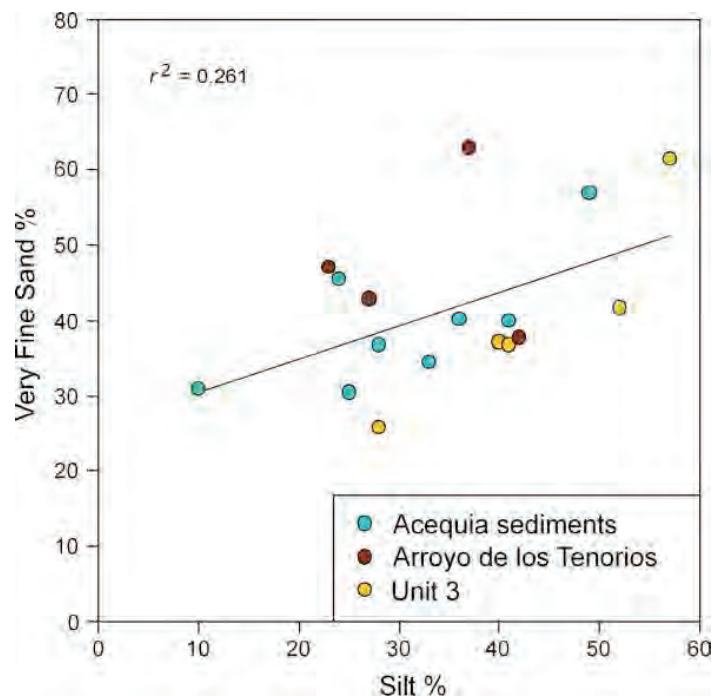
Figure App1a.20. Plot of very fine sand versus silt in samples from Unit 3, Arroyo de los Tenorios, and three acequias. All of these deposits exhibit fine texture. The arroyo and acequia deposits are ultimately derived from Unit 3 that is the uppermost deposit of the local surficial geology.

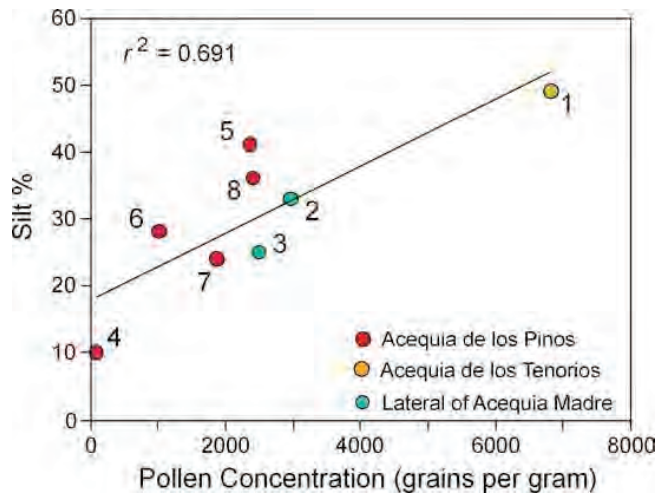
Figure App1a.21. Pollen concentration versus percentage of silt in 8 samples collected from acequia fill sediments, Santa Fe Railyard (numbered samples are listed in **Tabs. App1a.1, App1a.2**).

One sample, however, the basal sample from Acequia de los Pinos (BHT-191), is essentially barren of pollen. Part of the reason for the lack of pollen in this particular sample may be attributed to the coarser texture of the sediment (55% fine sand) compared with the other samples that are dominated largely by silt and very fine sand. In other words, the pollen grains may simply have not been deposited along with the sandy sediments at the base of the acequia fill. Overall, the acequia sediments are fine-textured. A plot of the pollen concentration and the amount of silt shows a fairly good relationship. Most of the acequia pollen samples cluster in a zone between 1000–3000 grains per gram along with 25–40% silt (Fig. App1a.21).

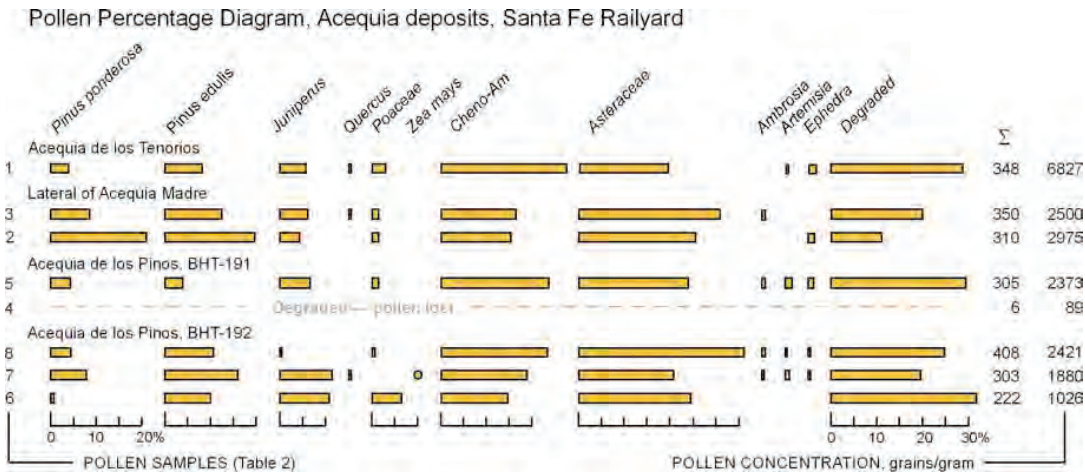
Figure App1a.22. Pollen percentage diagram of sediments from three acequias, Santa Fe Railyard. The pollen from each acequia is arranged in stratigraphic order, bottom to top of sampled sequence. Pollen data are presented in **Table App1a.2**. Analyses by Susan J. Smith.

Railyard acequias. The pollen record from the historic-age acequias in the Railyard reflects the present-day vegetation. The pollen assemblages are dominated by Asteraceae, Chen-Am, pine, juniper, and grasses, in that order (**Fig. App1a.22**). Minor percentages of oak, *Ambrosia*, *Artemisia*, and *Ephedra* are present. Although the high percentages of Asteraceae and Chen-Am pollen could be indicative of local disturbance of the plant community, their abundance in high-desert grassland pollen records is common. The comparatively high percentages of degraded pollen grains, averaging 23%, indicate either a moderately poor preservation of pollen in the acequia environment of deposition or poor pollen preservation in local surface materials, a major local source of sediment and pollen grains washed into the acequias.

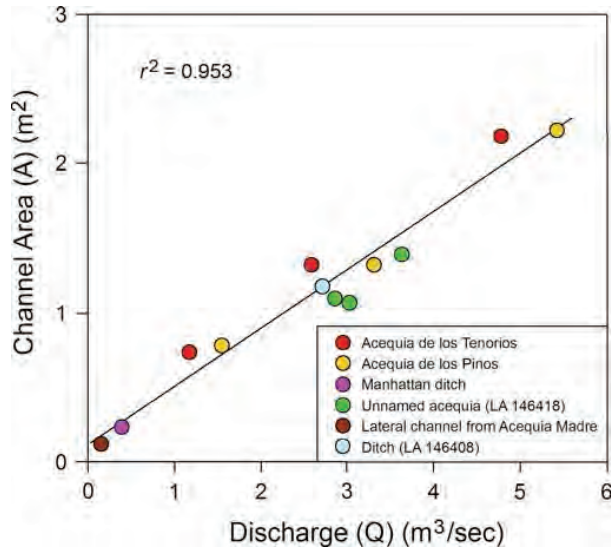
Figure App1b.2. Area (measured from field sketches) versus Discharge (calculated with the Manning equation) of six acequia channels in the Santa Fe Railyard. In the above linear regression, Area (A) = 0.105 x (0.389 x Q). The values are in meters.

One of the clearest relationships in this analysis is that channels with greater area (A) also have greater potential discharge (Q) (**Fig. App1b.2**). After a fashion, however, this is built into the Manning equation; channels with greater area will also have greater potential discharge. As noted in this report, the discharge values are only potential discharge and probably do not represent the true discharge of the acequia channels during actual flow conditions.
