**Monitoring of Cultural Resources within Segments
of U.S. 180, U.S. 60, NM 12, NM 32, NM 36, and NM 435
for Tree Thinning in Catron County, New Mexico**

ARCHAEOLOGY NOTES 337

NMDOT Project No: TPS-180-1(1)19, CN 3954.

MNM Project No: 41.742 (Catron County Tree Thinning).

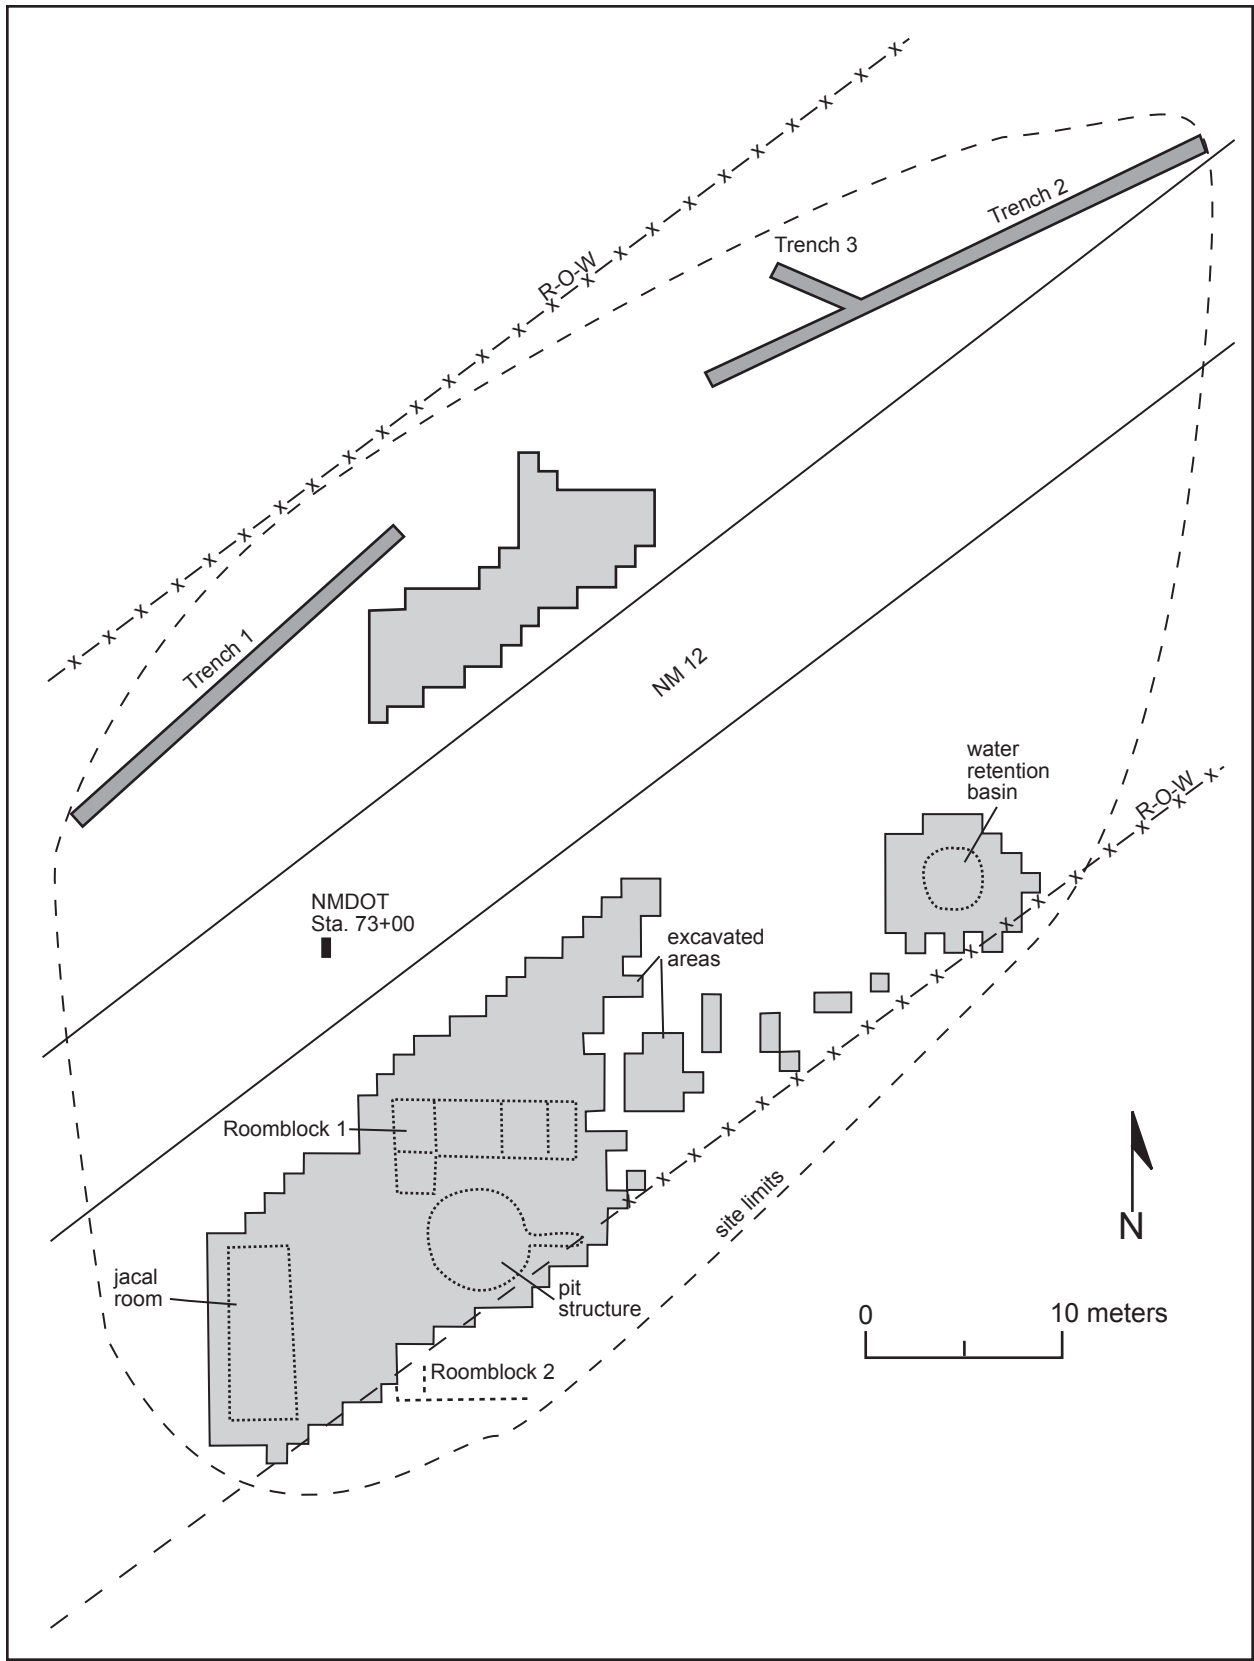
Figure 2. Site map of LA 39968.

Background: LA 39968 was first recorded by Pool and Logan in 1980 (ARMS files). It consists of two small roomblocks (one within the right-of-way), a large pithouse, a jacal structure, and a water-retention basin (Figs. 2 and 3). OAS excavated the entire site within the right-of-way in the mid-1990s (Oakes and Zamora 1999). It was dated to A.D. 1200 through archaeomagnetic sampling, placing it within the Tularosa phase of the Mogollon cultural sequence. The 1.9 m deep pithouse was backfilled carefully because the USDA Forest Service requested that it be left intact for future interpretation.

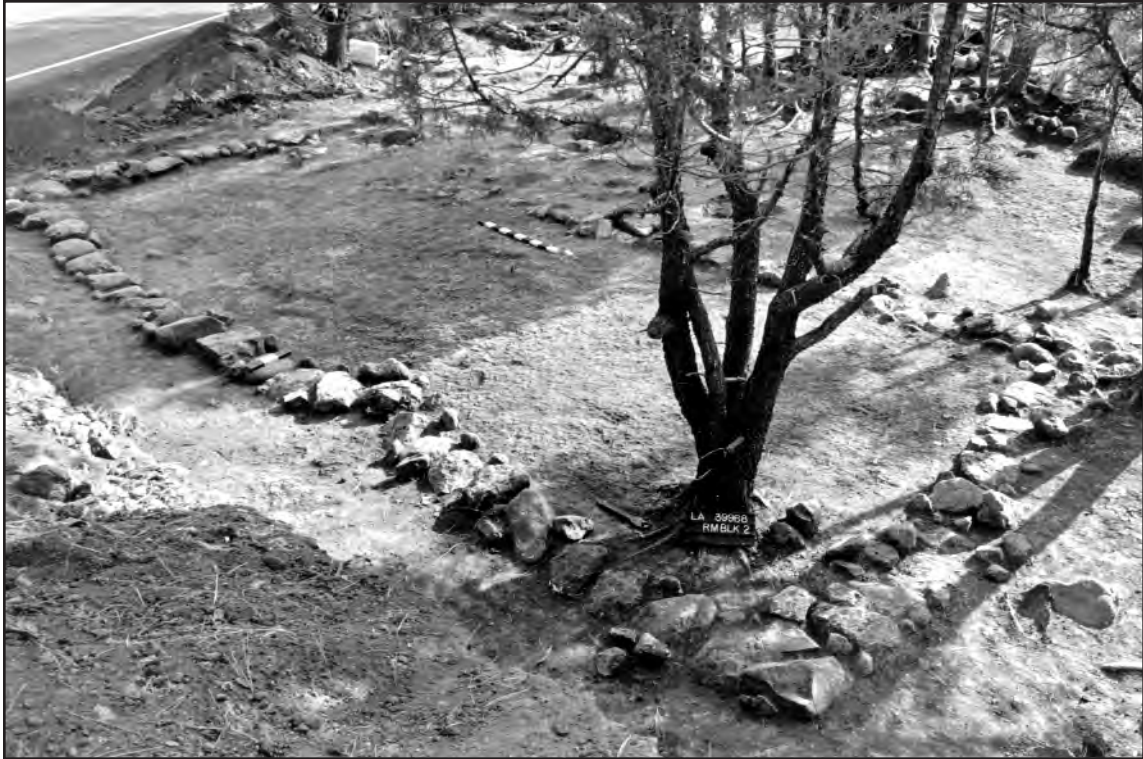
Figure 3. Trees at LA 39968 after it was excavated in 1994, facing east (Oakes and Zamora 1999[2]:115). NM 12 can be seen at the upper left.

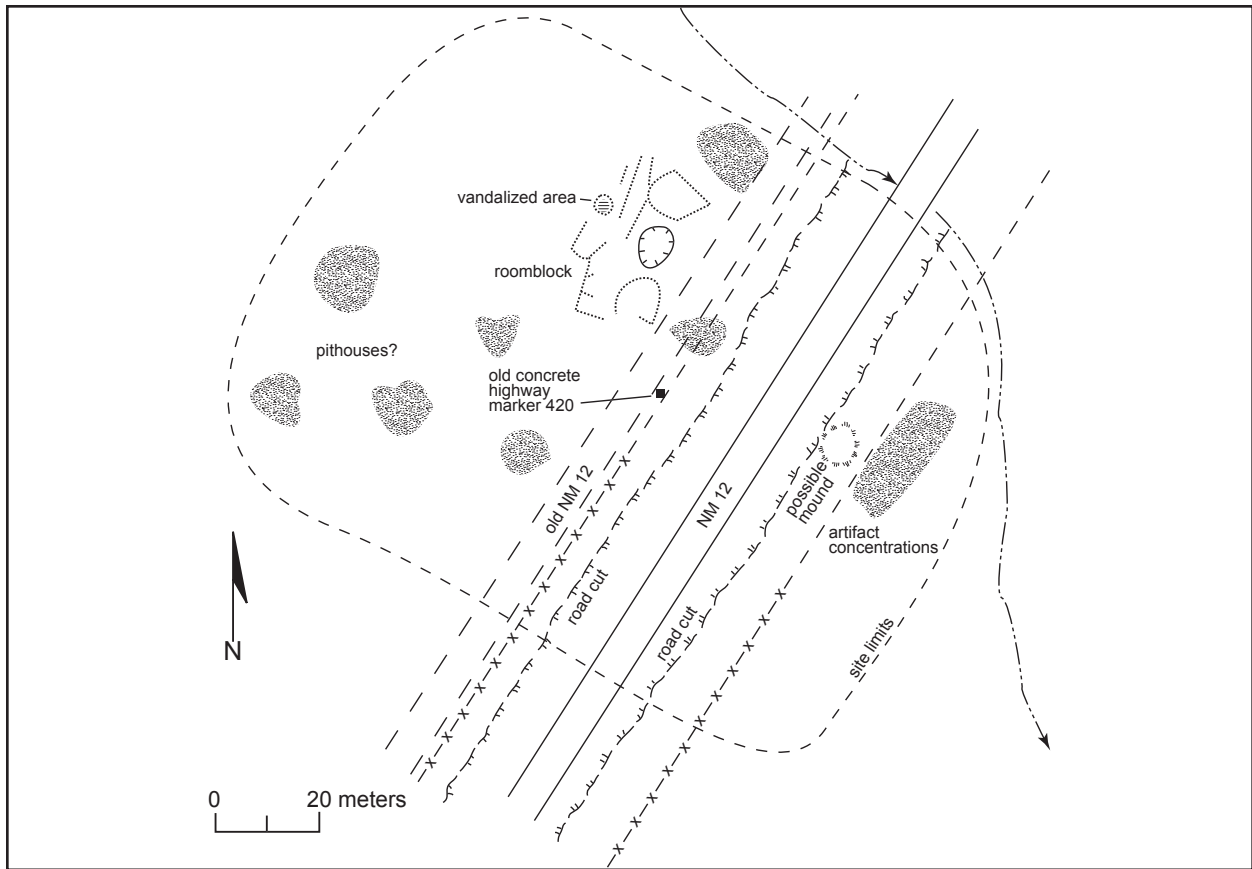
Figure 5. Site map of LA 43885.

Results of Monitoring: Elkhorn Construction notified OAS that tree thinning was approaching LA 43885. OAS archaeologists mapped the site (Fig. 5) and took photographs of it (Fig. 6) before the thinning crew arrived. Only the east side of the highway required monitoring; no trees were present on the slope on the west side. The tree-thinning process was monitored by OAS. No equipment was driven on the site, and trees were lifted off of the site before chipping and mulching. Cut wood was stacked on the slope immediately adjacent to the bar ditch so that no traffic would occur on the site. The process went smoothly, and no damage was done to the site.

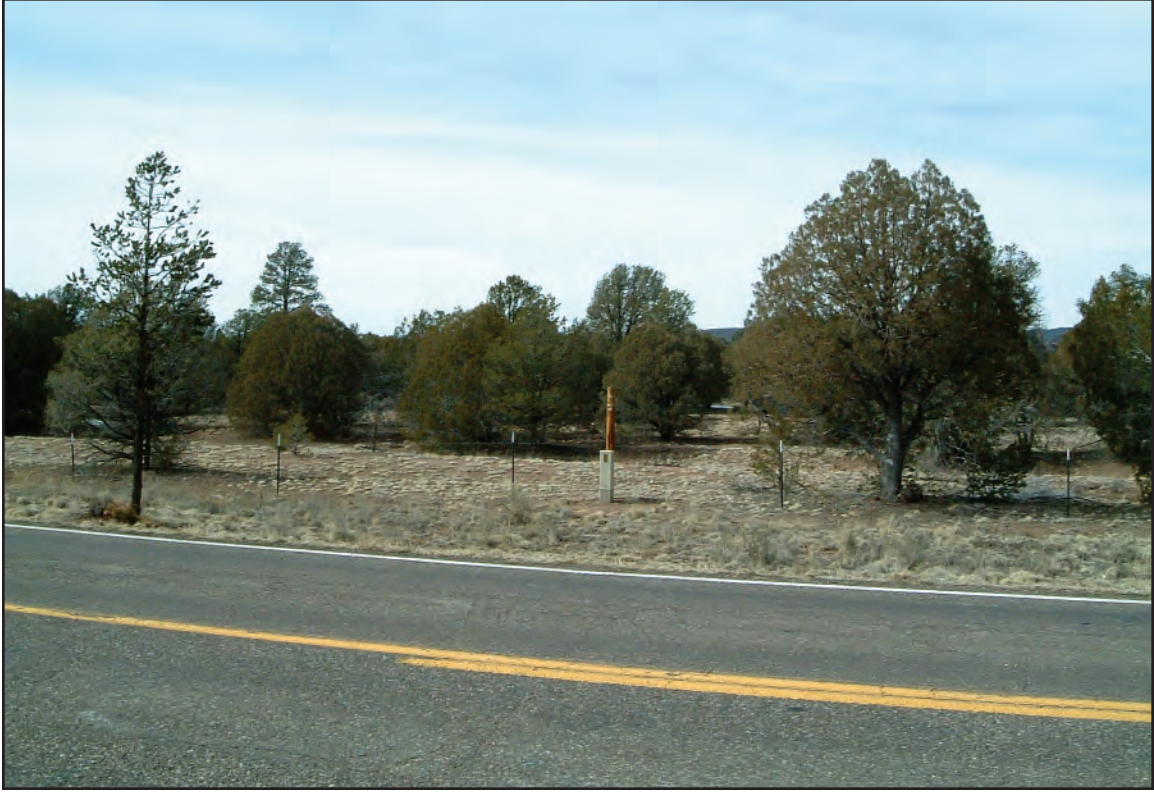
Results of Monitoring: Elkhorn Construction notified OAS before tree thinning occurred at this site. The site was mapped (Fig. 7) and photographed (Fig. 8) before thinning began. Only one small tree was within the cutting zone. No damage occurred at the site at this time. The thinning crew temporarily stopped work along NM 12 after tree clearing at the site was completed and before proceeding further. They returned to thinning along U.S. 180, where they had been waiting for specialized equipment. They were reminded to give two days' notice before returning to work along NM 12. However, Elkhorn Construction did not give notice until two days after resuming work. In the interim, trees immediately north of the flagged area of LA 143613 were cut by the crew. This was not a site area; however, with no archaeologist present, the mulcher went back and forth over LA 143613 when mulching the nonsite

Figure 8. LA 143613 before thinning.

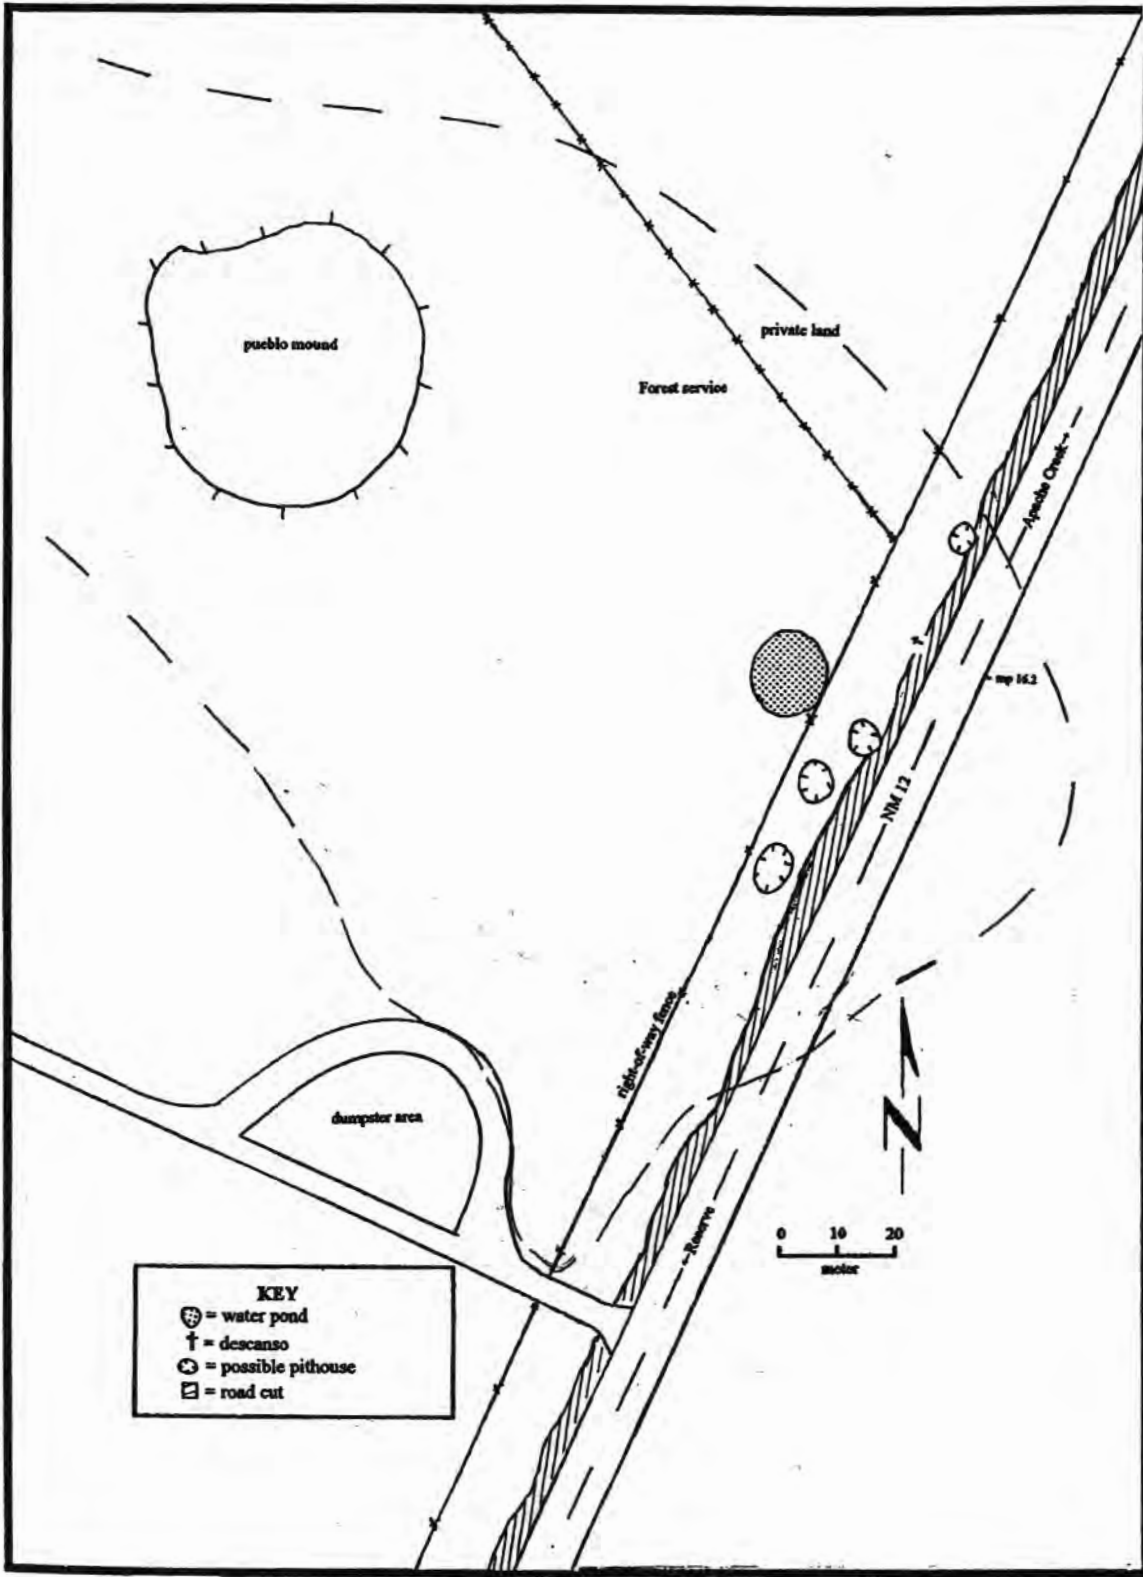
Figure 11. Site map of LA 43884.

Effects of Tree-thinning Project: The archaeologist was not notified prior to tree thinning at LA 43884; however, no damage was done to the site during thinning. ATV trails run through the centers of both sides of the right-of-way. On the west side, this ATV trail runs over hundreds of artifacts and several probable pithouses. OAS noted recent tracks on these trails and very recent tracks running vertically up the road shoulders onto the site, directly over possible pithouses (Fig. 10). The thinning crew did not create these tracks. The installation of a fiber optics line left a cleared trail across LA 43884 and many other sites to the north along NM 12. This trail is now used extensively by ATVs and four-wheel-drive trucks. The site is in extreme danger of losing structural and artifactual integrity to erosion and vehicular traffic. A new site map was drawn with adjusted boundaries (Fig. 11).

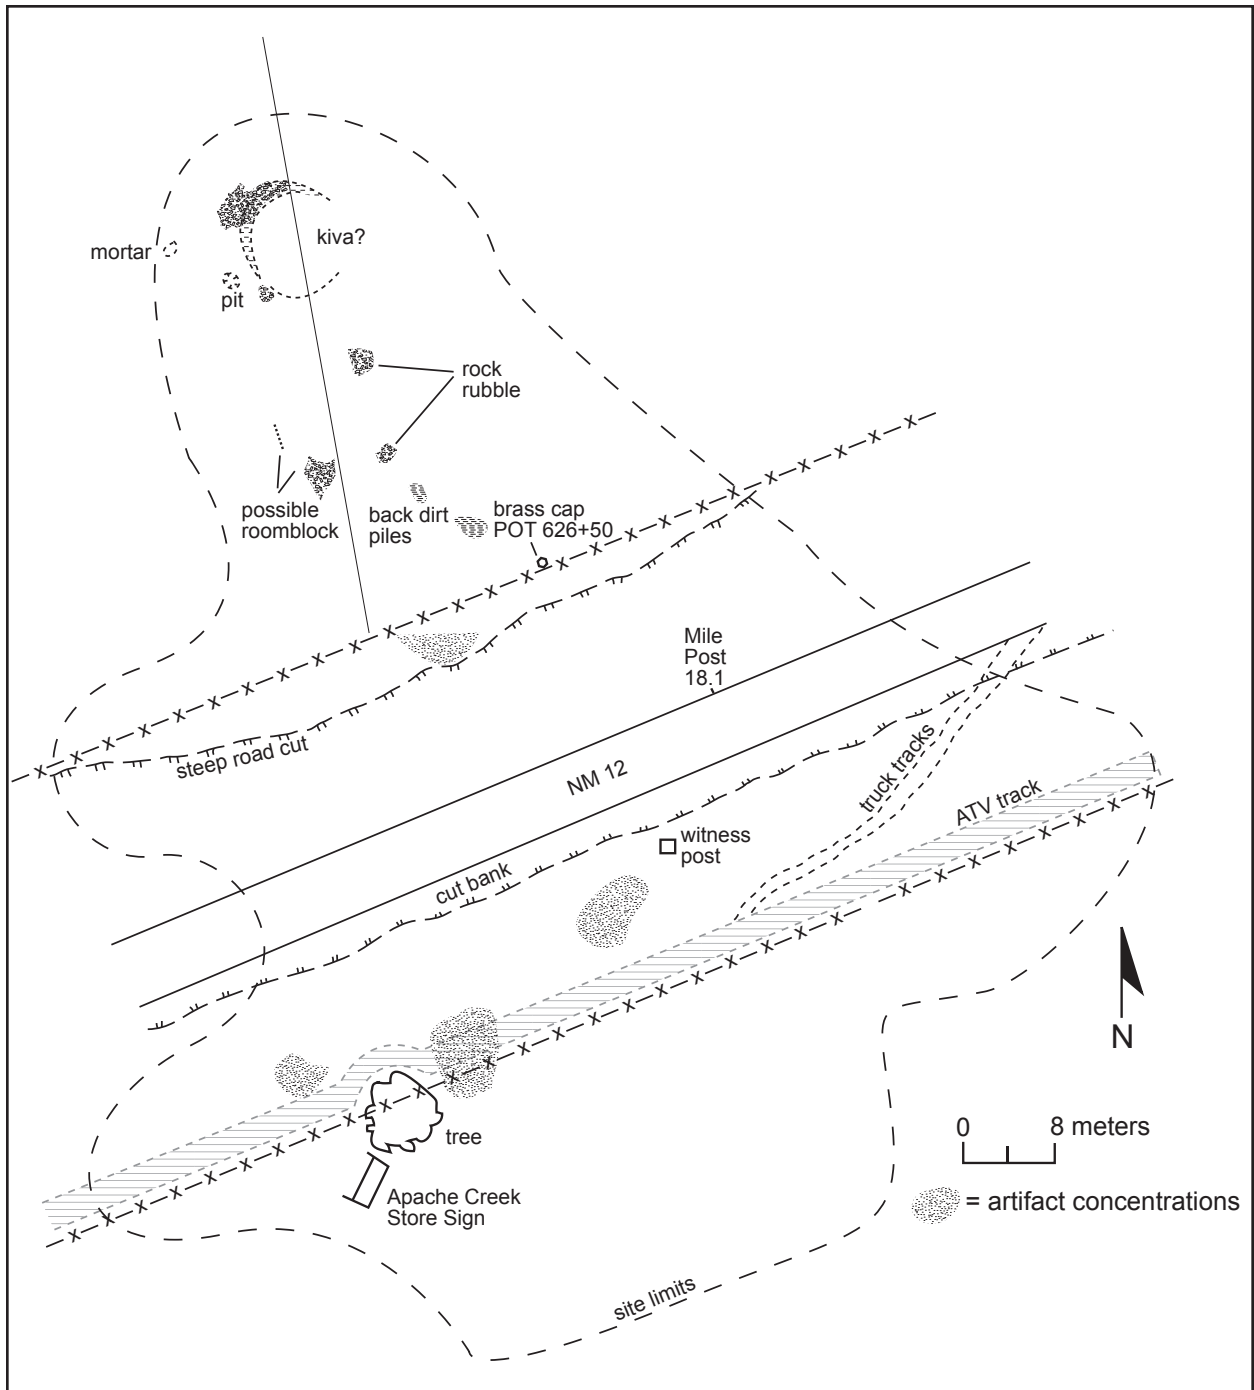
Figure 12. Site map of LA 43896.

Effects of Tree-thinning Project: The OAS remapped the site (Fig. 12) and determined that only the south side of the right-of-way required monitoring. However, the thinning crew did not give notification prior to cutting trees on the site, so it was not monitored by the archaeologist.

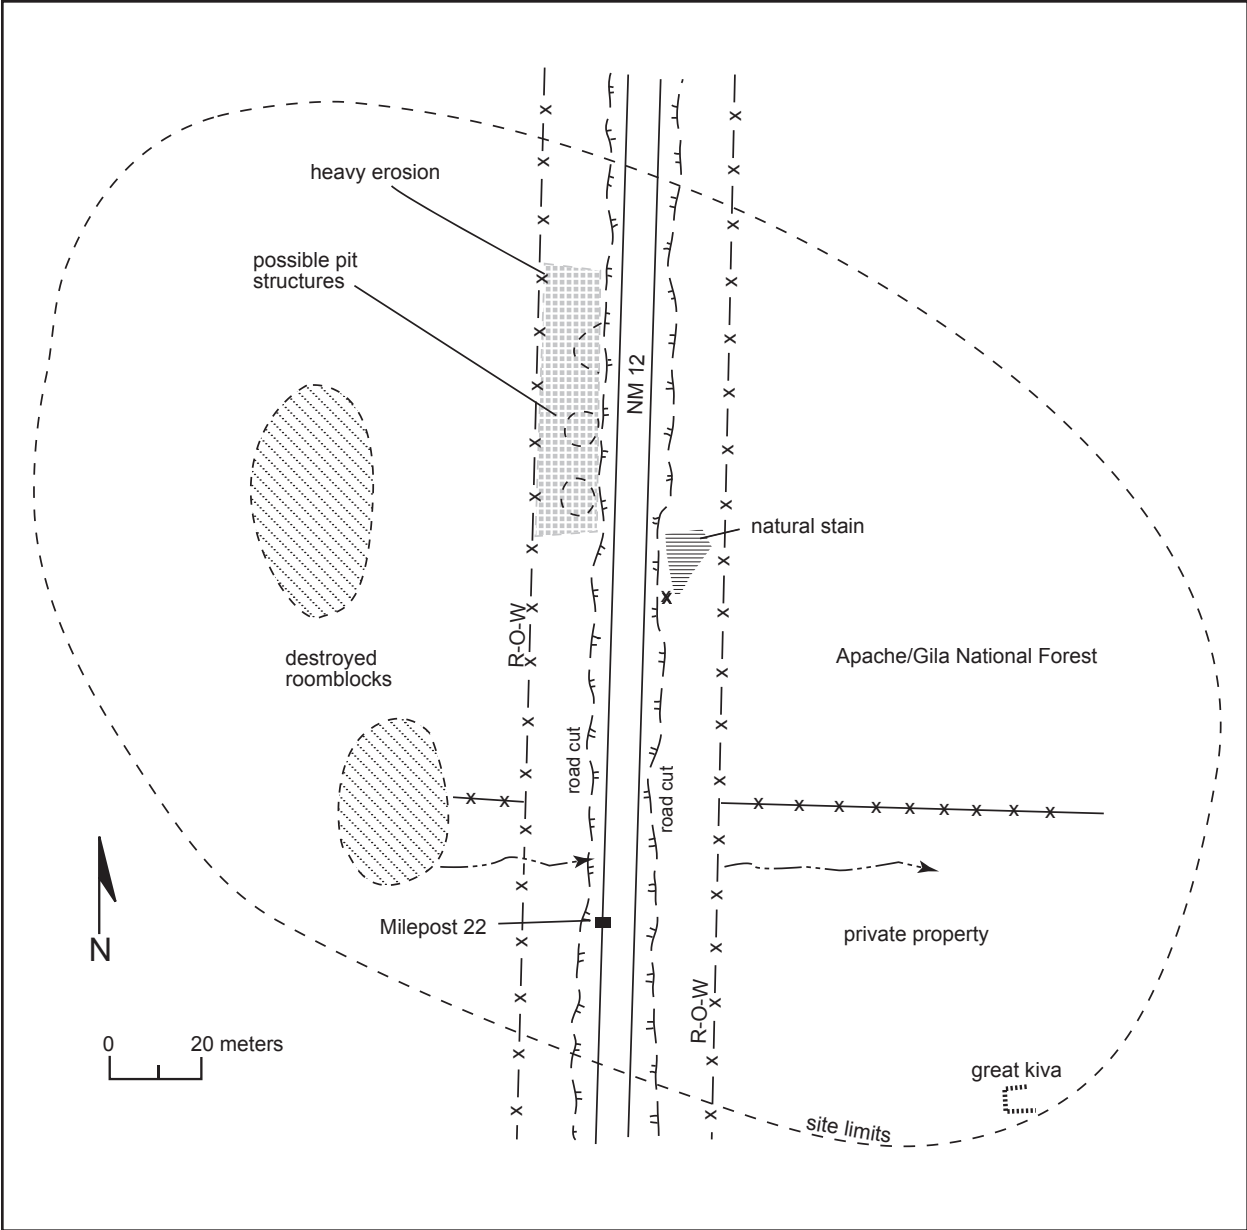
Figure 21. Site map of LA 3259.

Effects of Tree Thinning Project: The thinning crew did not notify the archaeologist before cutting trees on the slopes of the site (Fig. 20). An inspection of the site showed that no damage had occurred to the eroding features. OAS utilized the map produced in 1999 for this report because no changes to the site were noted (Fig. 21).

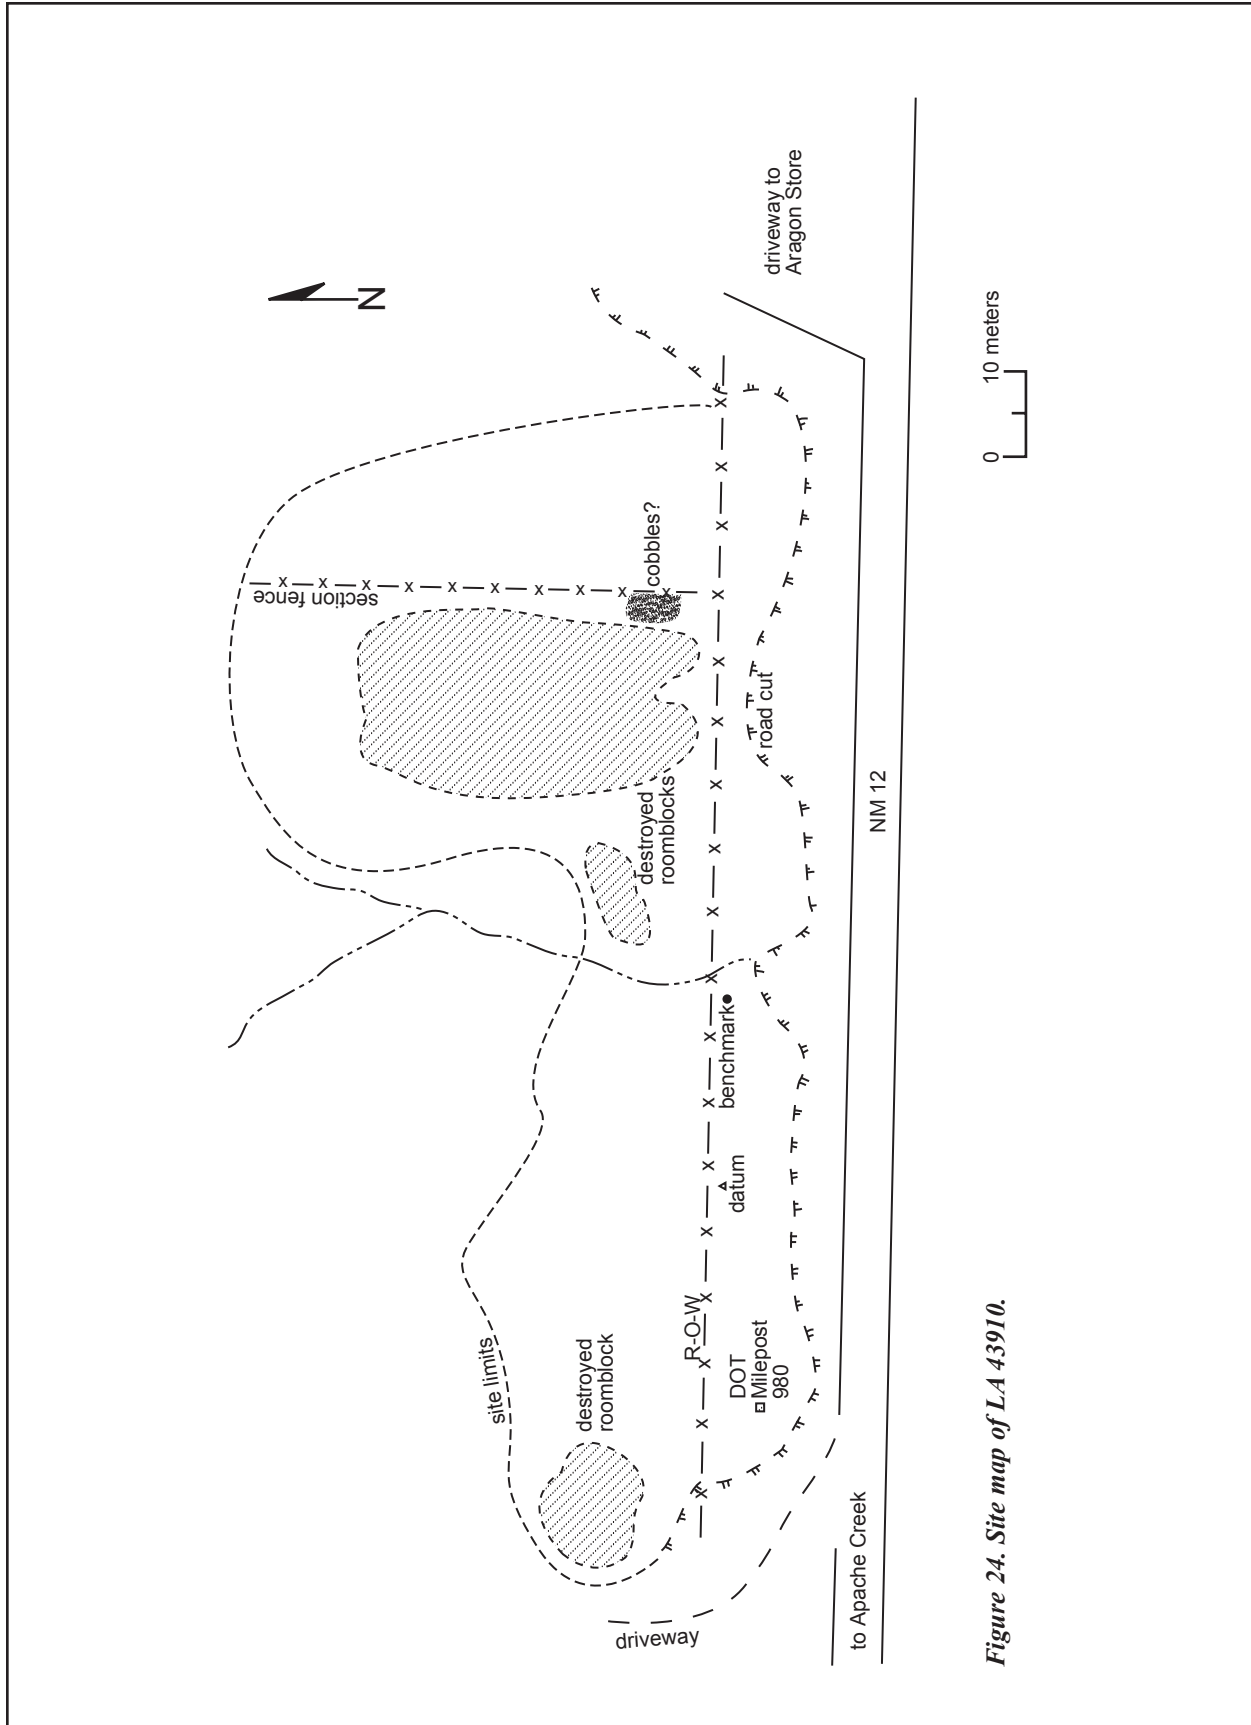
Figure 24. Site map of LA 43910.

Effects of Tree-thinning Project: The archaeologist was not notified by the thinning crew of the cutting schedule for LA 43910; therefore, the site was not monitored. Upon later inspection of the site by OAS, it was observed that tree cutting took place only on the slopes in a few areas (Fig. 23), and there was no damage to the site. The site was mapped (Fig. 24).

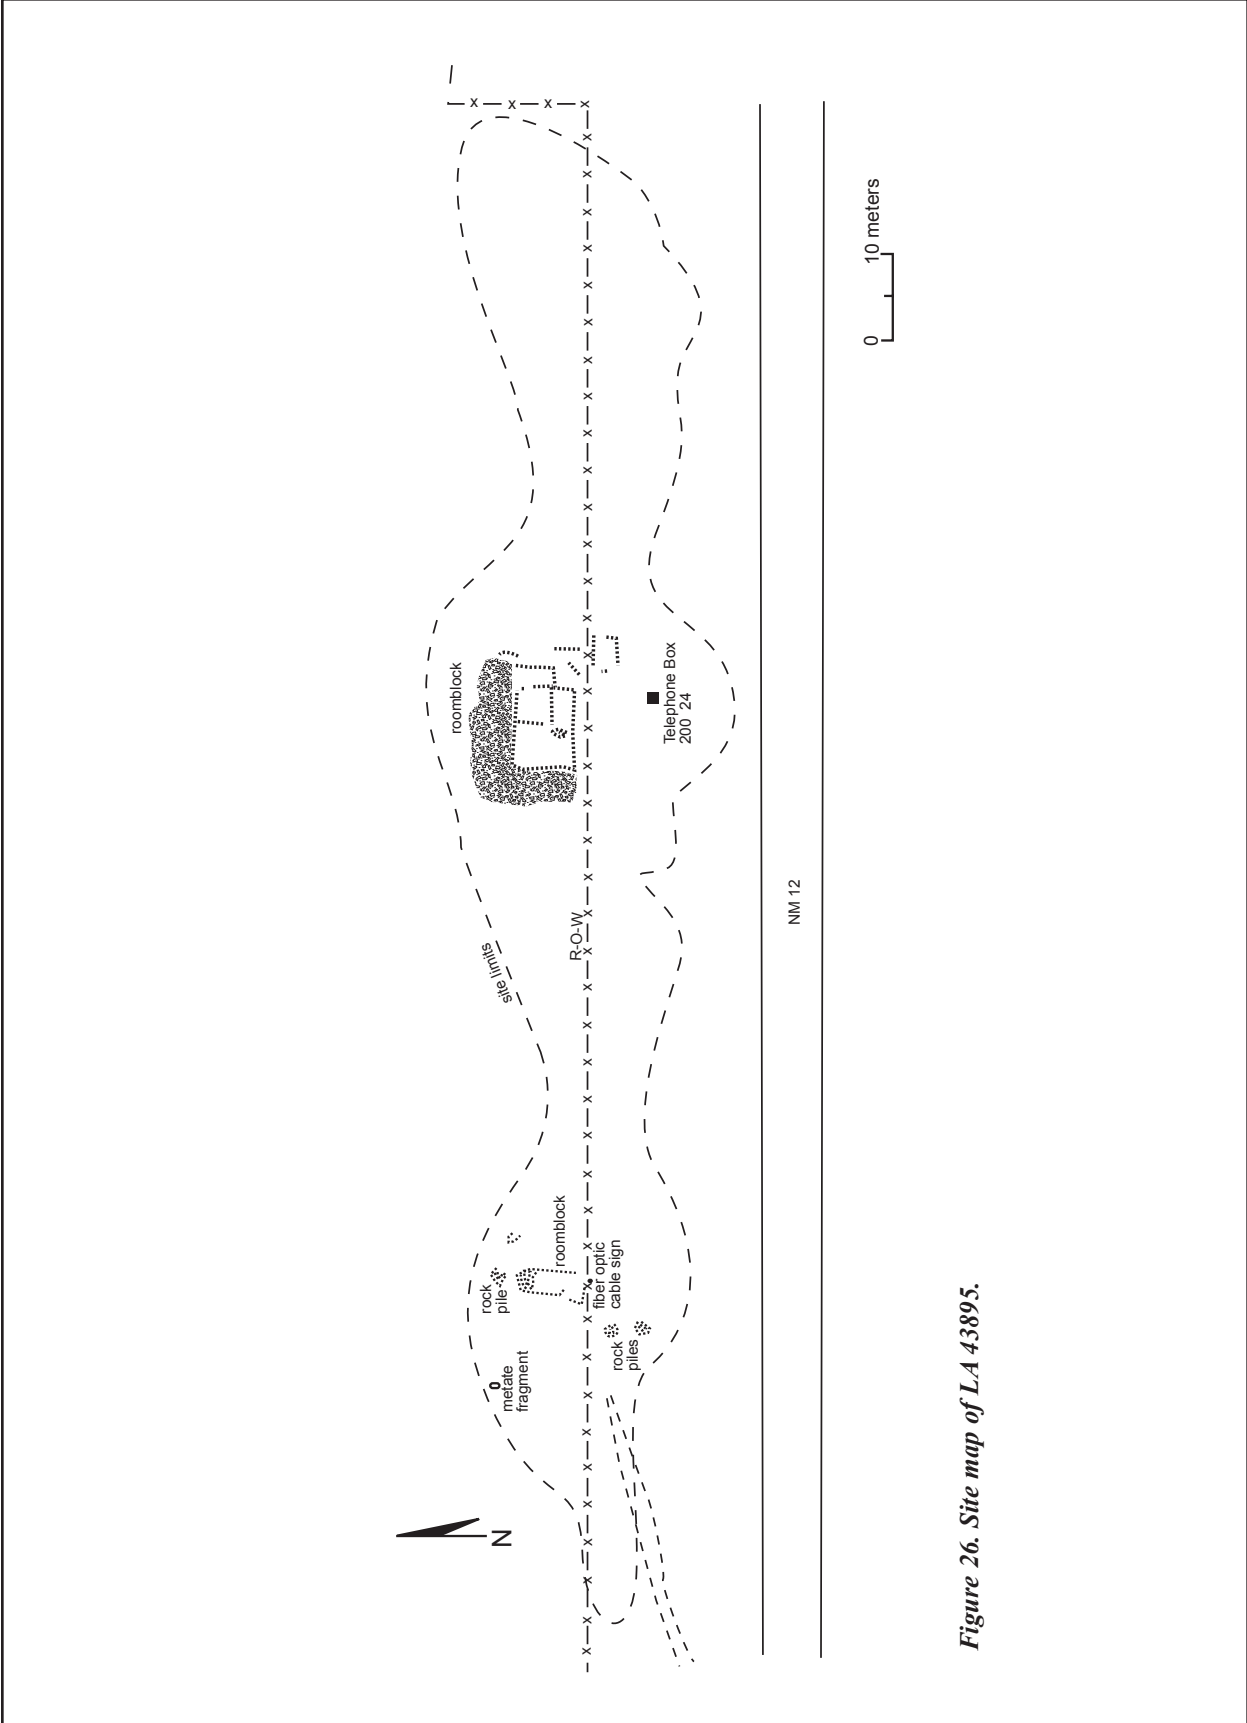
Figure 26. Site map of LA 43895.

Effects of Tree-thinning Project: The archaeologist received no advance notification of the thinning schedule for the site, and therefore it was not monitored. Tree cutting involved only a single tree, and thinning activities did not disturb the site. The OAS photographed and mapped the site (Fig. 26).
