Office of Archaeological Studies

Monitoring of the
Replacement of Water Mains and
Residential Water Meters on
Gomez Road, Rael Road,
and Anita Place,
Santa Fe, New Mexico

ARCHAEOLOGY NOTES 493
2018

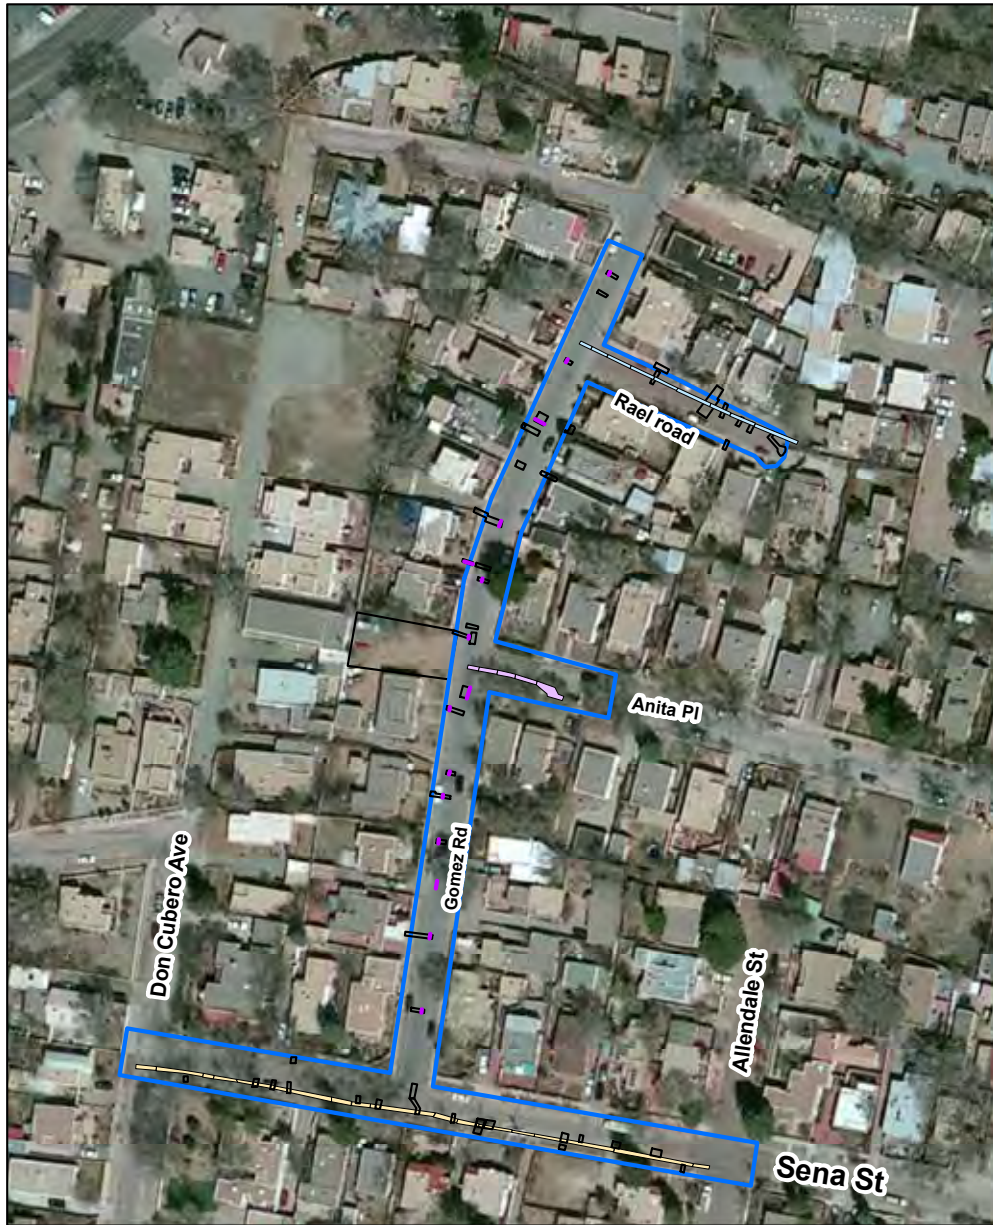
Figure 7.1. Overview of all main lines and residential connections.

Main water lines were installed on Gomez Road, Sena Street, and Anita Place (Figs. 7.1–7.8). Trenches ranged greatly in length from 3.48–22.50 m, though most were between 6–9 m. The shortest main line trenches were on Anita Place and Rael Road, and

The Sena Street main line excavations consist of 14 contiguous segments of main line trench, two tie-in trenches at the intersections with Allendale and Gomez, and two fire hydrant excavations at the east and west ends of the main line (see Fig. 7.1). Together, these excavations permitted a comprehensive overview of stratigraphic deposition on Sena Street. This street, to a greater extent than others in the project, was dominated by deep, intact alluvial deposits derived from ancestral routes of the Santa Fe River (Stratum 1). These were underlain by alluvial slope sediments deposited by smaller streams originating from the southwestern flank of the Sangre de Cristo Mountains (Stratum 3) (Johnson and Koning 2012:7). Sena Street excavations were overwhelmingly devoid of cultural remains, which were encountered in only two locations: one at the far west end and one at the intersection with Gomez Road.

Two contiguous trenches located at the intersection of Gomez and Sena Streets were dug to connect the new water main to the existing line on Gomez Road (see Fig. 7.1). The combined trenches doglegged between the main lines on Sena and Gomez Road (Fig. 9.9). Numerous utilities bisected these trenches, two of which were the 1944 water mains running parallel to Sena and Gomez. A massive 20 inch storm drain and its associated trench bisected the north end. A substantial portion of the 2 inch water

Twelve residential connections were performed on Sena Street between Don Cubero on the west and Allendale on the east (see Fig. 7.1). Only two of these involved replacing old meter cans (330 and 311.1). In all other instances, the only requirement was to switch the 1 inch residential copper line from the old water main to the new. Six of these are described below (two excavation units at 330 are described as a unit). Six trenches—303, 303.1, 311, 316a, 324, and 333.1 Sena—have been omitted from the descriptions as they were devoid of intact stratigraphy at the time of excavation. All fill was reworked from a combination of the 2017 and 1944 water main installations—the latter often bedded with crushed angular basalt gravels. This gravel bedding was observed in trenches at 303 and 316a Sena. However, all these residential trenches contained intact stratigraphy at the far south end where they had been exposed during excavation of the main line. These intact sediments were documented in Segments 13 and 14 of the main line.

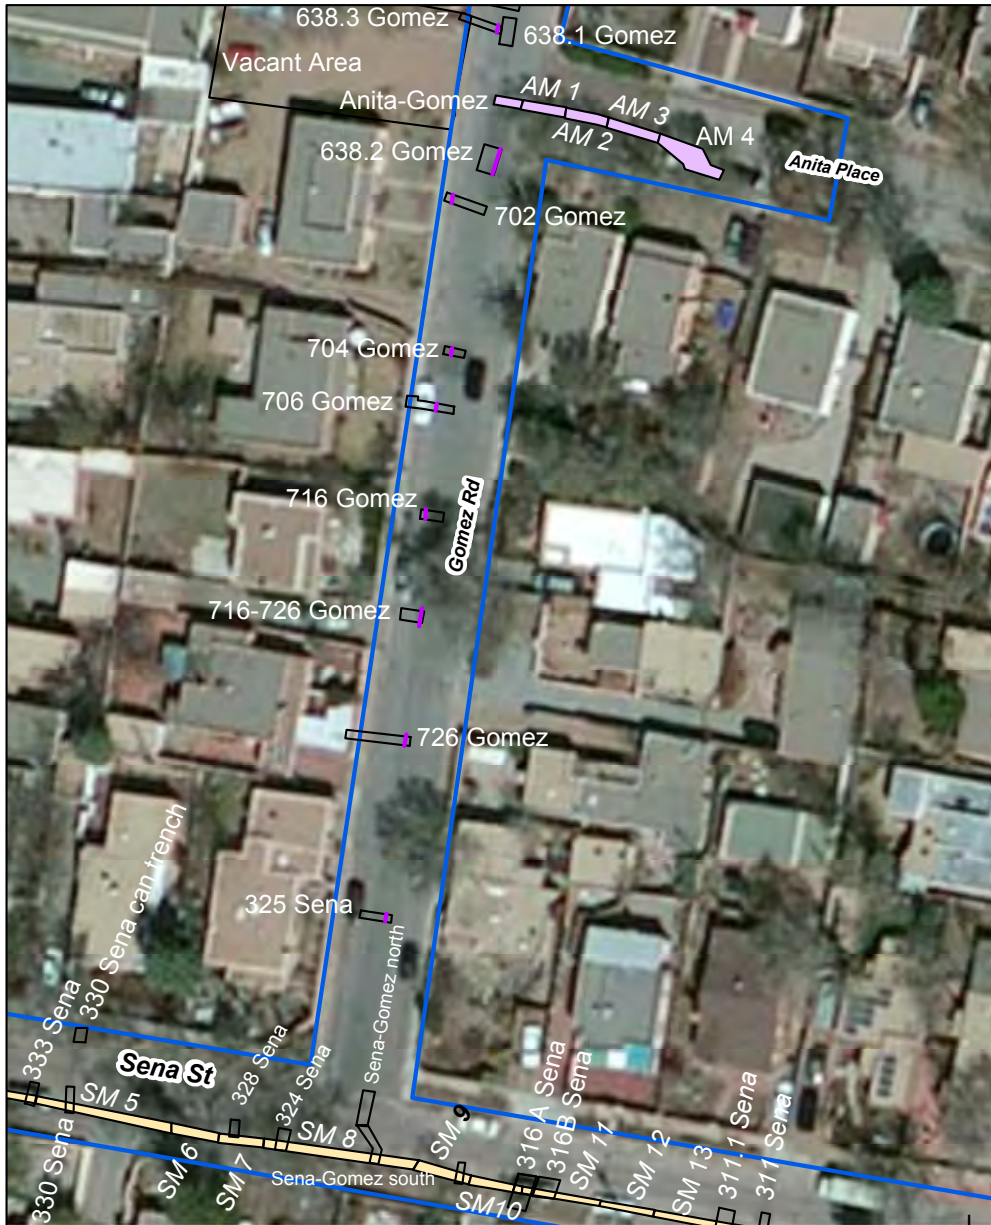
Figure 7.6. Gomez Road main line and residential connections, south area

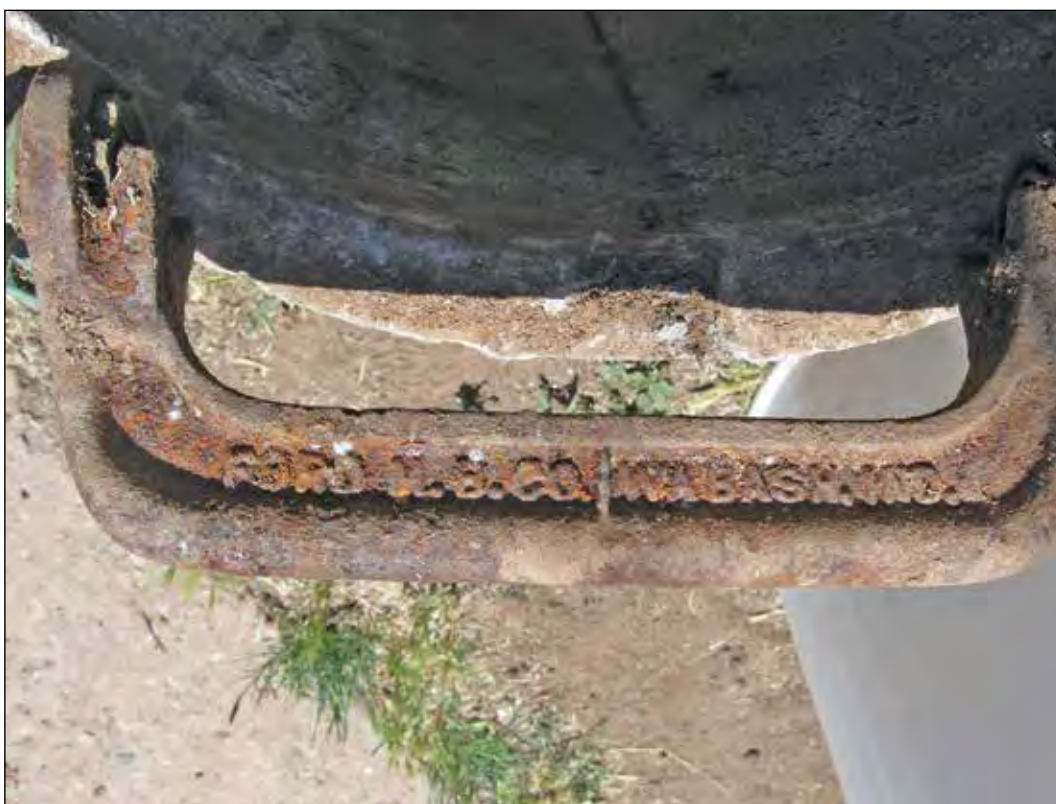
Figure 9.12. Iron yoke bar from 311.1 Sena Street meter.

The most reliable date for this meter may be based on the presence of an iron yoke bar at the top of the meter. The bar was embossed with "FORD M. B. CO. WABASH IND," which refers to the Ford Meter Box Company founded in 1898 and still in operation today (Fig. 9.12). The bar may date to 1930, when water metering first began in Santa Fe (Plewa 2009:250). Iron yoke bars made today by Ford are strikingly similar.

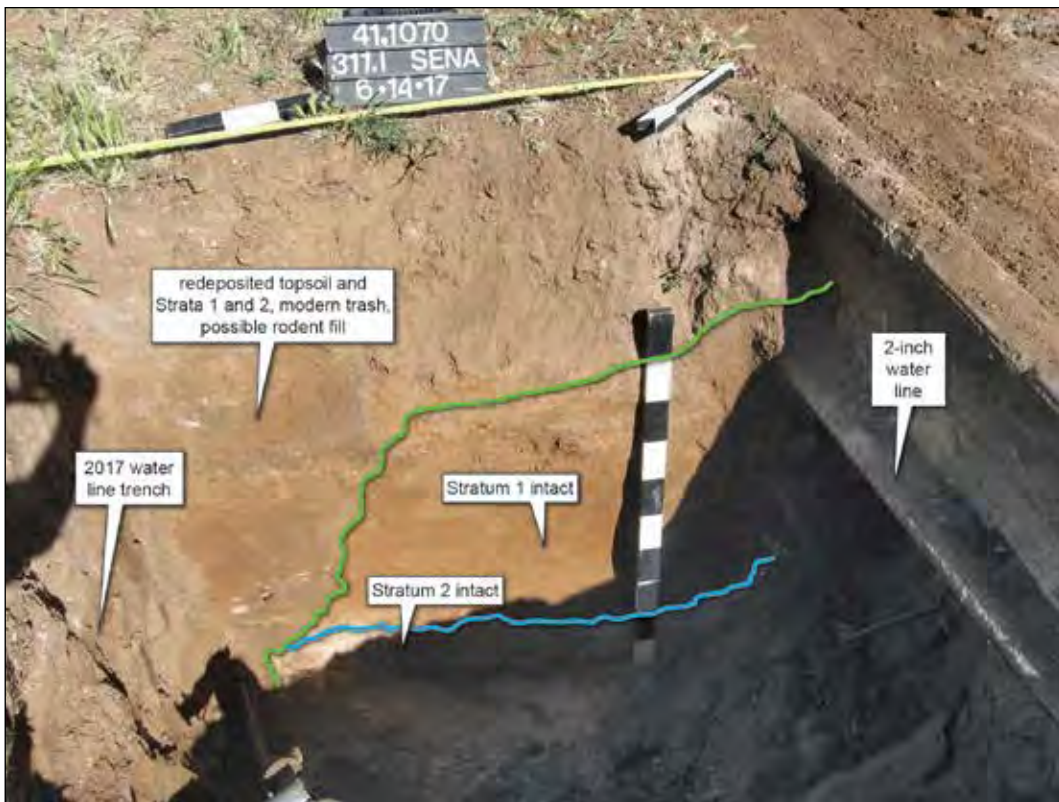
Figure 9.13. 311.1 Sena Street can replacement trench, view west.

Most of the sediments within the trench were redeposited, but a segment of intact Strata 1 and 2 existed at the northwest corner (Fig. 9.13). Stratum 2 was encountered at about 1.10 m bgs and extended to the base of the trench. About one-third of the street portion of the trench was occupied by the 2017 water main trench, which was documented in Segment 13 of the main line. North of this, stratigraphy was identical to that of Segment 13, which consisted of a layer of redeposited Stratum 1 underlain consecutively by intact Strata 1 and 2. Stratum 3 was not contacted in the 311.1 trench. The 1944 water main was not exposed, but the gravel bedding used as infill accounted for most of the northern third of the street trench. An interesting side note to this address was the piece of manganese glass found lodged in the sidewalk adjacent to the trench.

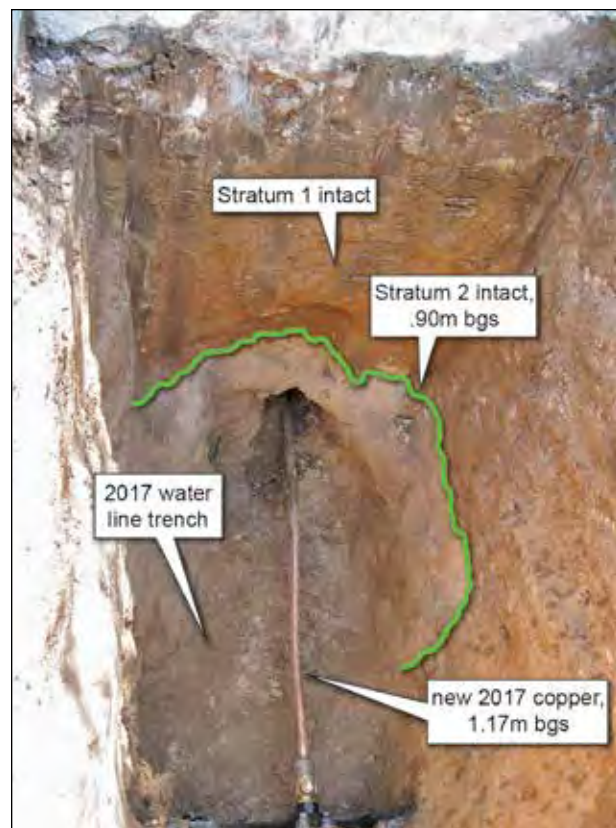
Figure 9.15. 318 Sena Street, south face.

Roughly two-thirds of the trench was redeposited from the 1944 and 2017 water main installations and the residential copper line that bisected the trench from north to south at 1.17 m bgs. Two areas of intact sediments were preserved: an 80 cm strip between the two water mains and the extreme southern 32 cm. In these areas, Strata 1 and 2 were very well defined, the latter consisting of nearly pure white caliche. Minor mottling of Strata 1 and 2 existed at the contact zone, but otherwise the two layers were quite uniform in color and texture. The new copper connection was driven through Stratum 2, leaving the surrounding sediment intact (Fig. 9.15).

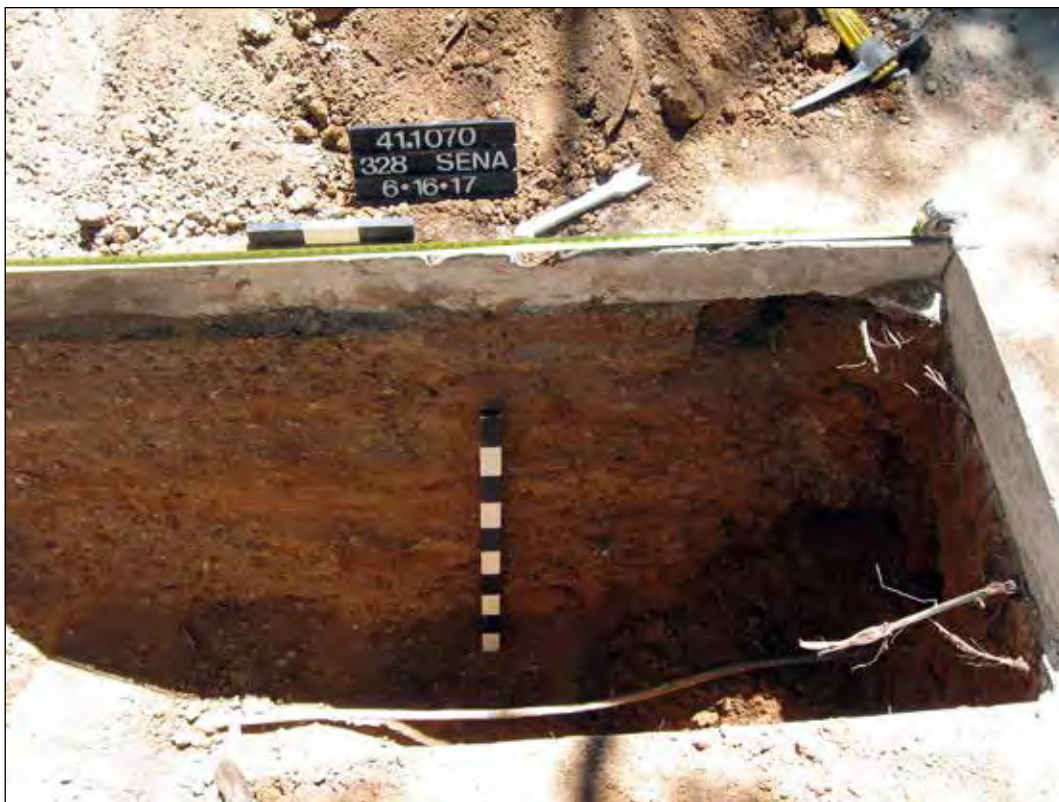
Figure 9.16. 328 Sena Street, east face.

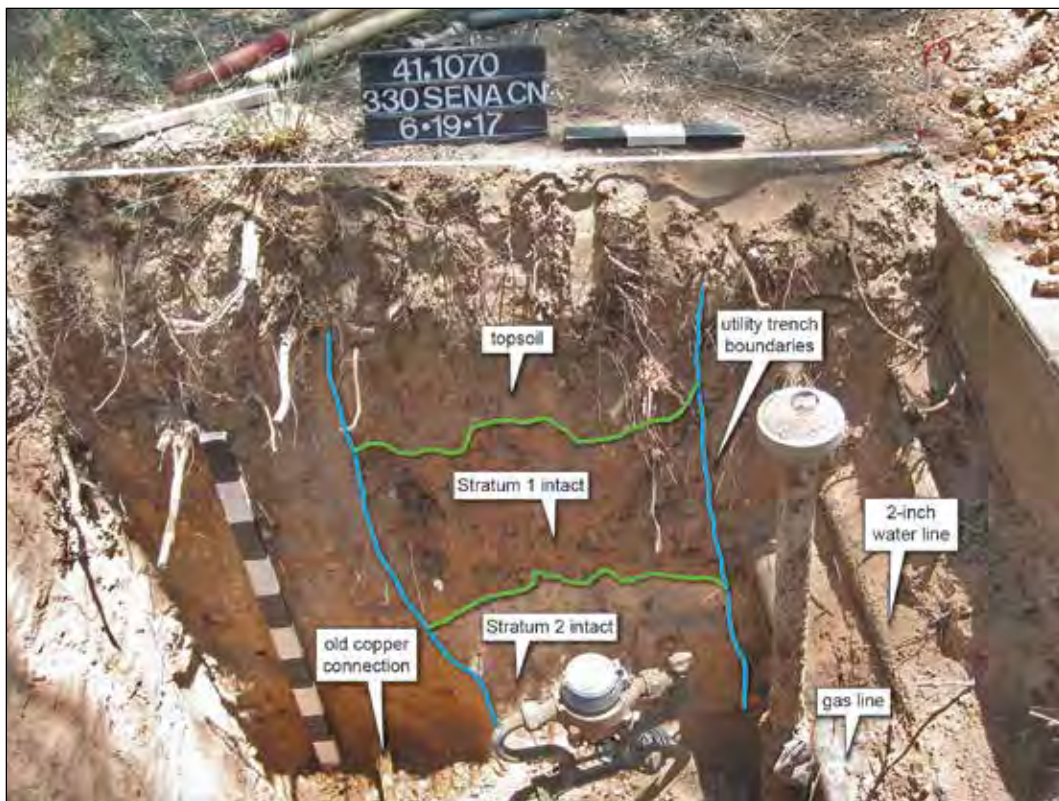
Figure 9.17. 330 Sena Street can replacement trench, view southeast.

Intact stratigraphy consisted of clearly delineated layers of topsoil, Strata 1 and 2 (Figs. 9.17 and 9.18). This intact strip was visible on the east, west, and north walls of the trench. Stratum 3 was not exposed. Well-defined layers of Strata 1 and 2 were typical of excavations along Sena Street, particularly at the west end and in excavations adjacent to the road. Topsoil extended from 0–32 cm bgs. Stratum 1 extended from 32–82 cm bgs, and Stratum 2 extended from 82–126 cm bgs, the latter being the excavation limit.

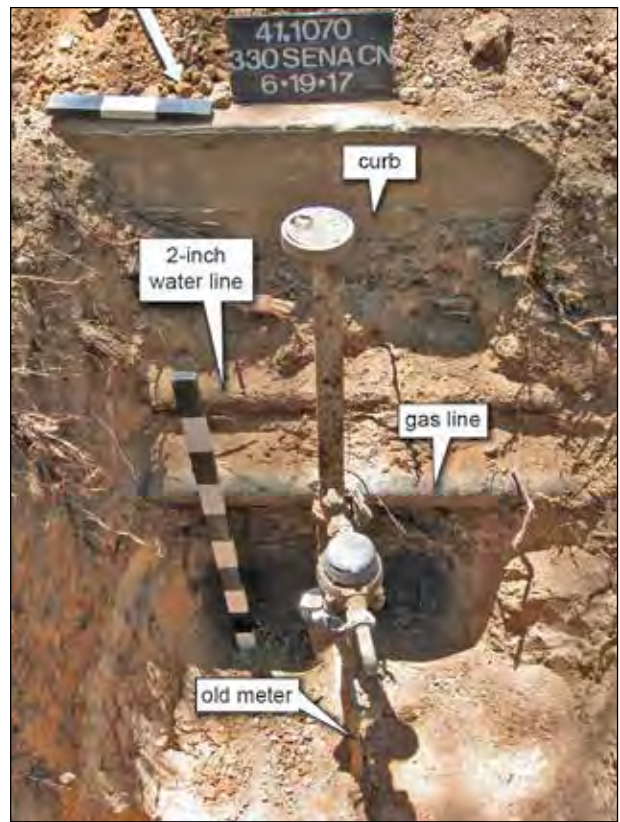
Figure 9.18. 330 Sena Street replacement trench, view southeast.

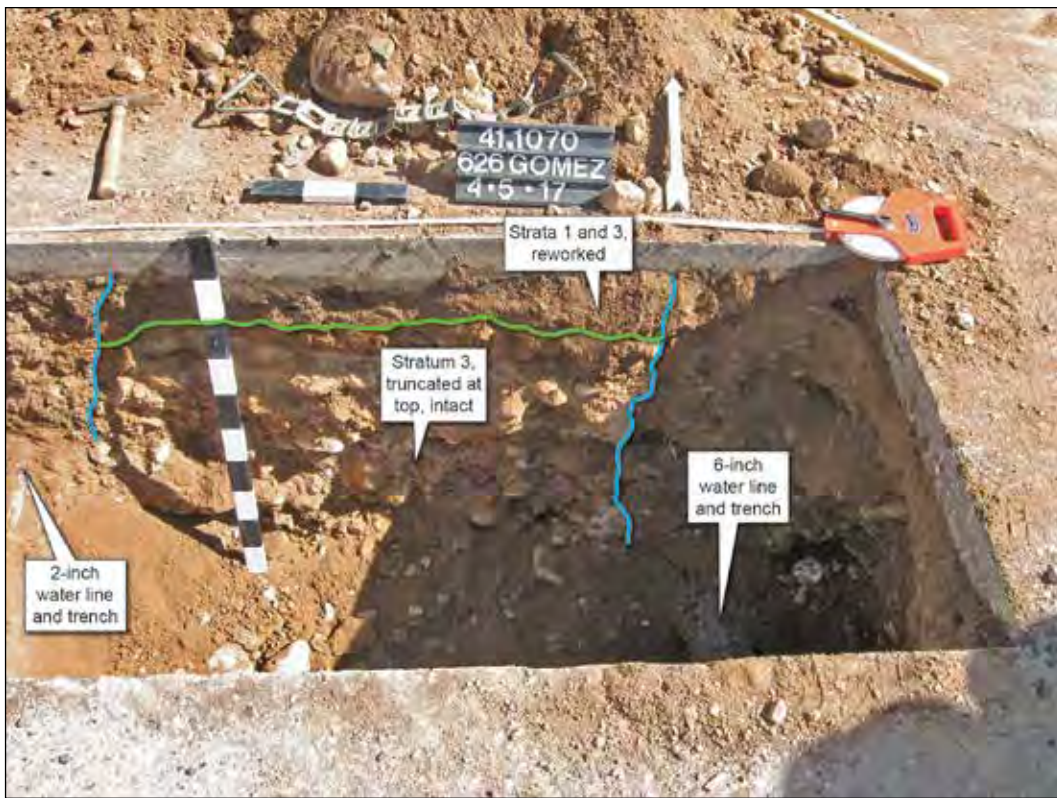
Figure 9.20. 626 Gomez Road, view north.

most notable variation from this churned mix of Strata 1 and 2 was the presence of a thick layer of Stratum 3 rock at the intersection with Rael Road (Fig. 9.20). In this trench, the upper portion of Stratum 3 consisted of coarse, red, granitic sand and uncalcified rock in the upper 0.44 m. The lower portion to 1.10 m bgs was calcified cobbles and sand. This pattern was repeated moving up Rael Road to the east.

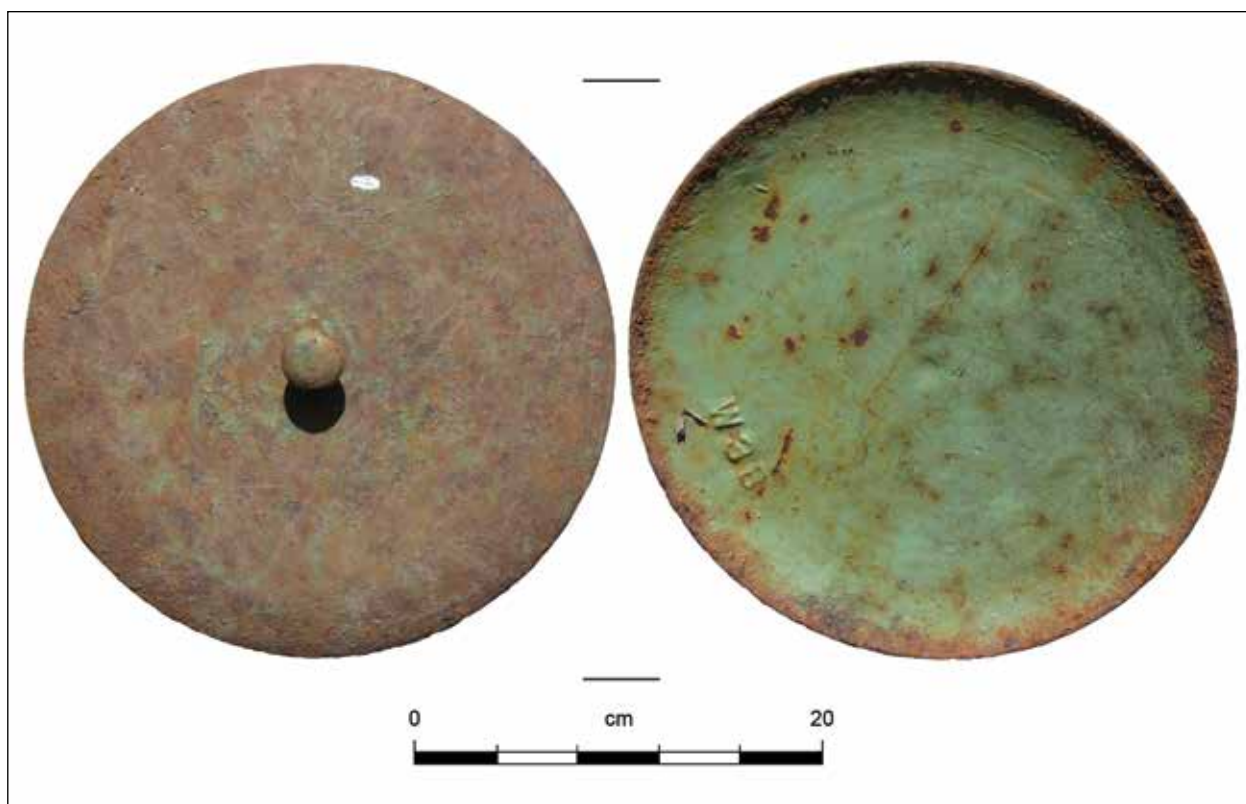
Figure 9.26. Cross cap from 627 Gomez Road meter.

The can was a concrete cylinder topped with double layers of brick fragments mortared in place on the north side and un-mortared elsewhere. The metal top was set directly on the bricks. The platform supporting the can was set entirely in a heavily calcified layer of Stratum 3. On the surface next to the can was a “cross cap” (Fig. 9.26). Cross caps are normally found inside cans and atop the meter for insulation.

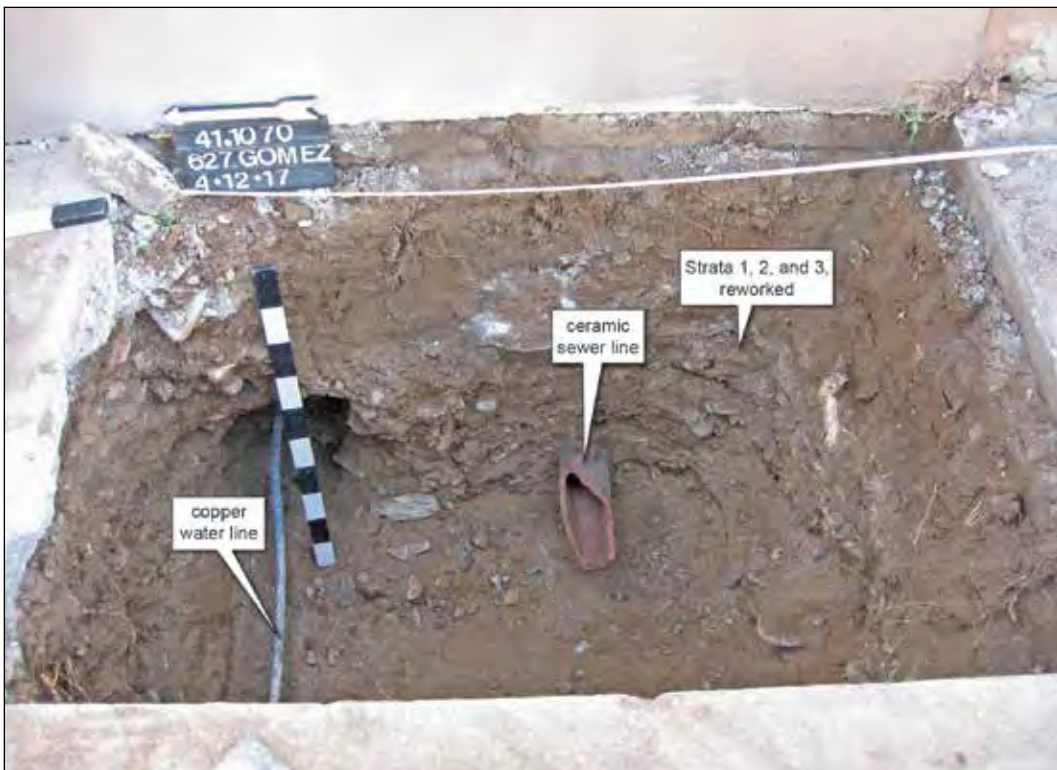
Figure 9.27. 627 Gomez Road sidewalk trench, view east.

Fill inside the sidewalk trench consisted of reworked Strata 1 and 3. Large, uncalcified cobbles up to 60 cm long were dispersed throughout the fill up to 1.0 m bgs. Below this, Stratum 3 was calcified as in the can trench (Fig. 9.27).

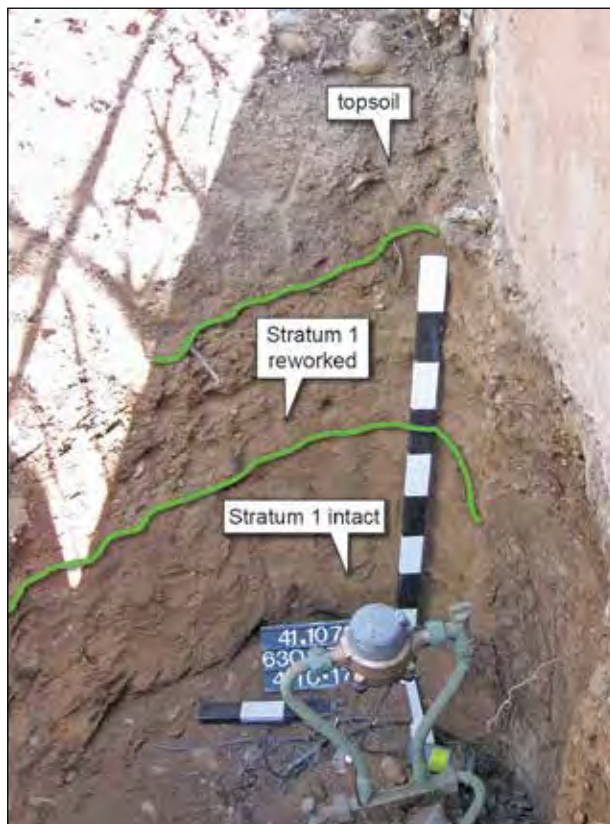
Figure 9.28. 630 Gomez Road can removal trench, view north.

630 Gomez Road: The can removal trench for 630 Gomez was inside a walled garden near the northeast corner of the property. The adjacent sidewalk outside the wall was removed and excavated to house the new meter. A street trench enabled connection to the main line. Aside from the meter installation, disturbances in the can trench area included home construction and garden landscaping work. A cobble walkway covered the surface, beneath which was a layer of garden topsoil mixed with brick fragments, concrete fragments, and isolated small cobbles. A large fir tree grows directly north of the can. Beneath the topsoil from 52–78 cm bgs was a reworked layer of Stratum 1 mixed with caliche bits and pea gravel (Fig. 9.28).

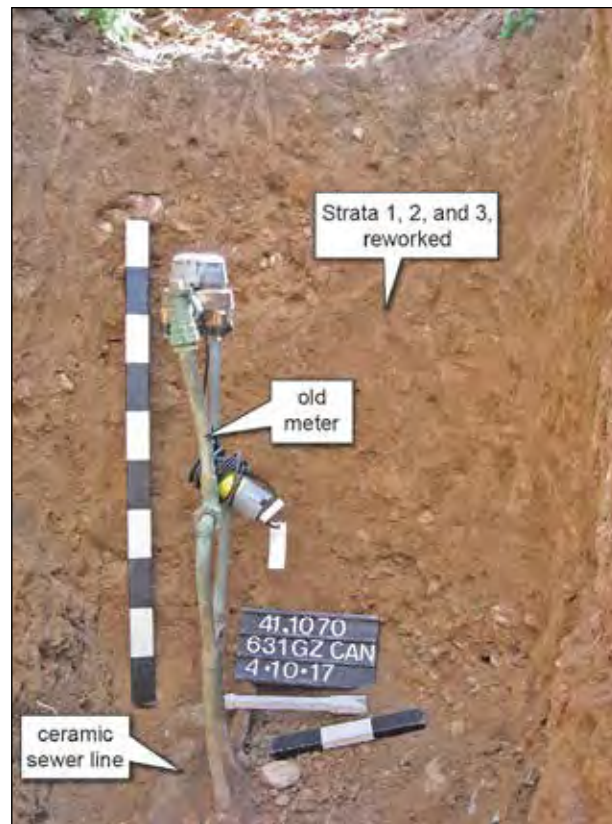
Figure 9.29. 631 Gomez Road can trench, view east.

garden bordered by a chain-link and wood lattice fence at the northwest corner of the property. In the old can trench, the surface layer consisted of topsoil mixed with Stratum 1 from 0.0–35 cm bgs. Beneath this was an extremely uniform layer of Stratum 1 down to 150 cm bgs (Fig. 9.29). The old meter can was a concrete cylinder set on a 2 ft tall cylindrical concrete platform (Fig. 9.30). Whole and fragmentary clay and pumice bricks around the perimeter supported the metal can top. The bricks were laid on edge, and portions of the bricks were mortared on the top. The shut-off valve was directly against the can, unlike others where it was slightly offset.

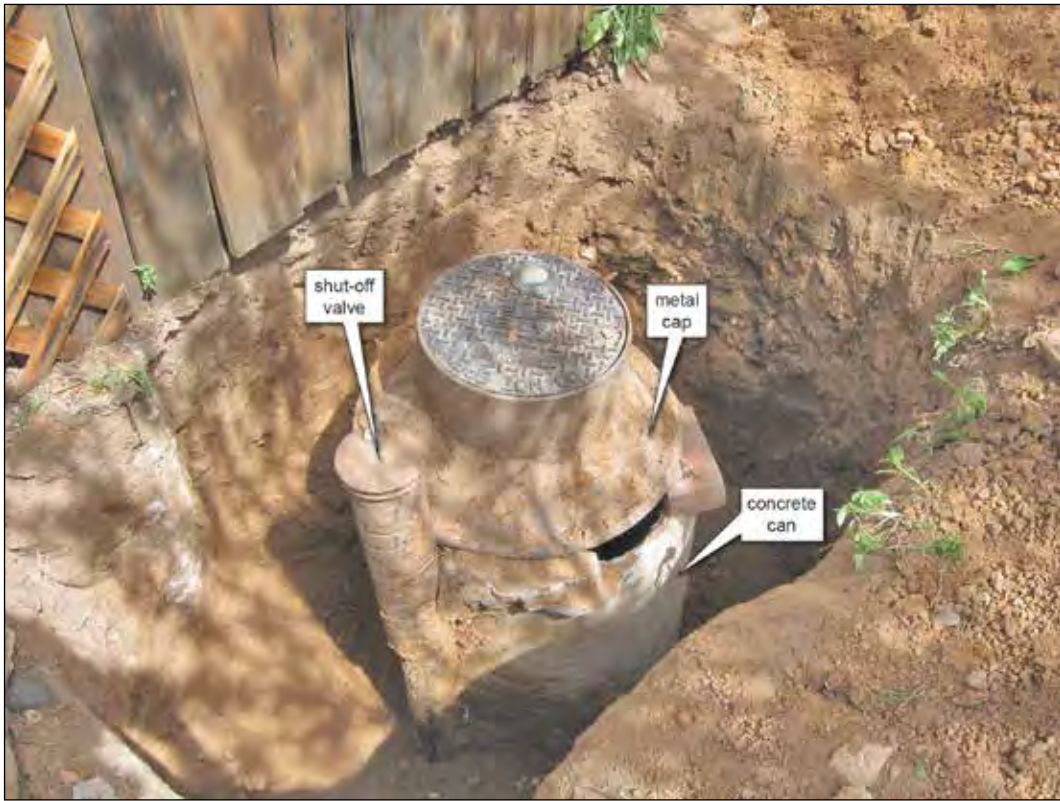
Figure 9.30. Old meter can at 631 Gomez Road, view northeast.

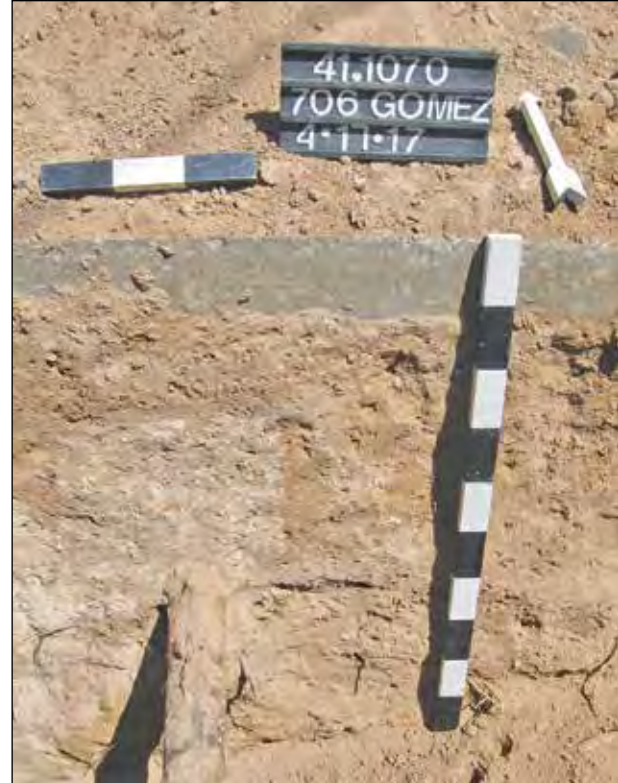
Figure 9.35. Detail of 4 inch water line at 706 Gomez Road, view north.

scattered in the fill around the old meter can (Figs. 9.34 and 9.35). Asphalt chunks were scattered in the fill beneath the gas line. No artifacts were found in this excavation.

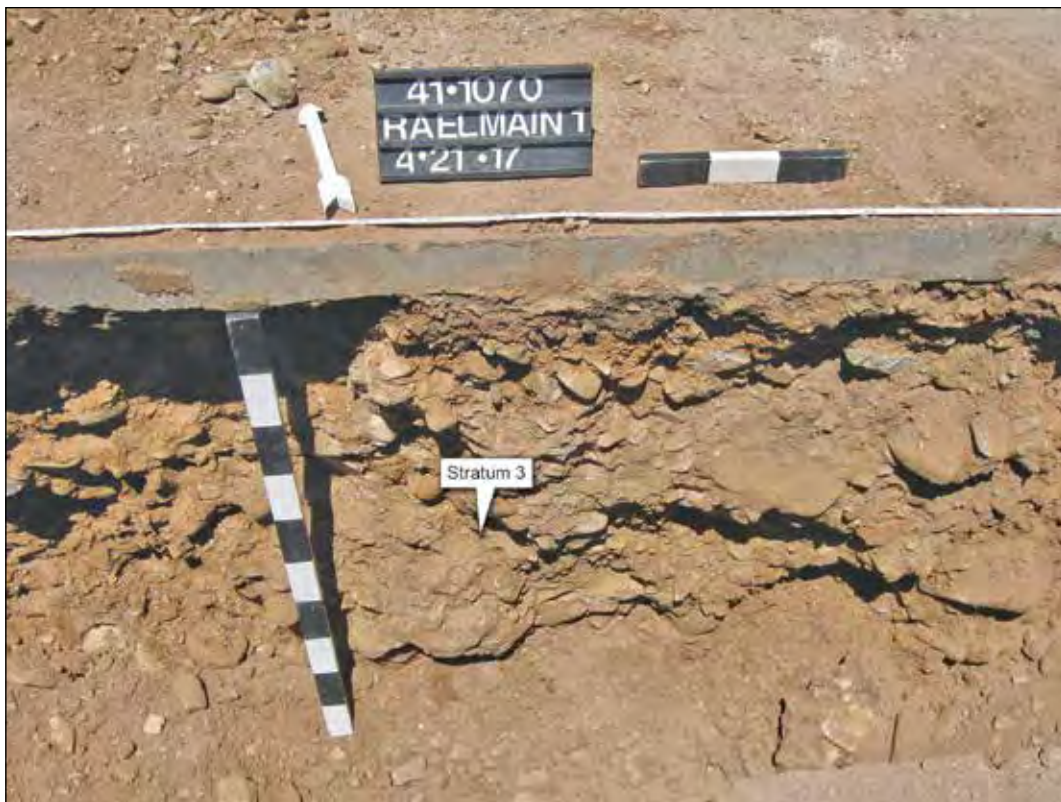
Figure 9.36. Rael Main 1, view north.

The main line on Rael Road displayed an extensive swath of intact stratigraphy beneath the asphalt. This applied to the westernmost 36 m of trench where Stratum 3 constituted the bulk of the profile in every segment. In Segments 1 and 2, the entire profile under the road surface was intact Stratum 3. In this area, cobble sizes ranged from small gravel to boulders up to 90 cm long, though most rocks fell within the 30-60 cm range (Fig. 9.36). The larger rocks were densest in Segments 3, 4, and 5 (19-36 m from the west end). Granite and micaceous schist accounted for virtually all of the represented rock

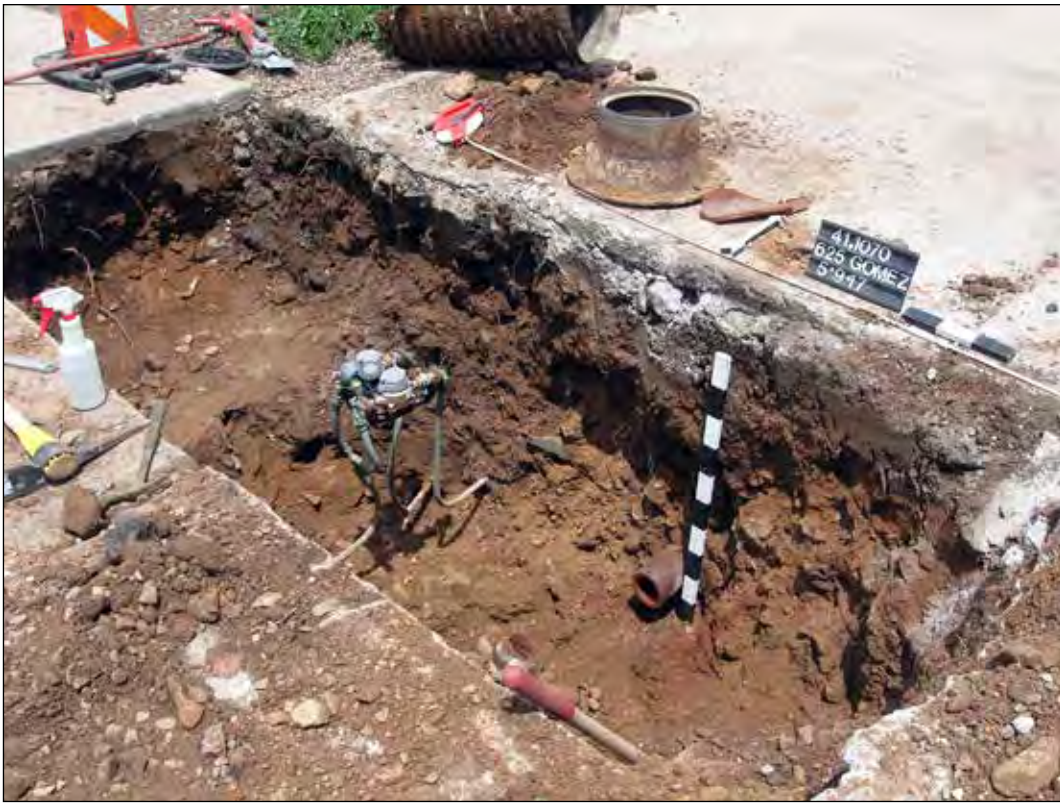
Figure 9.40. 625 Gomez Road, view northwest.

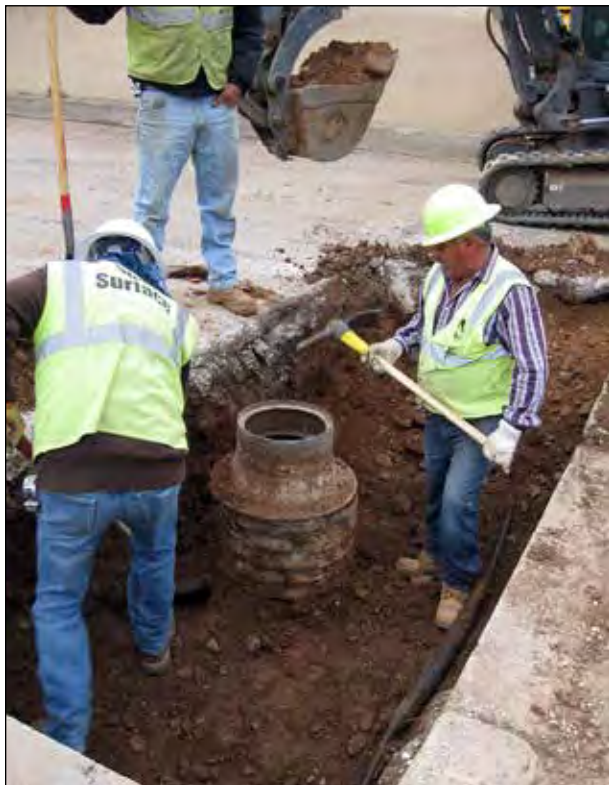
Most of the west face of the can trench was completely reworked during the installation of the copper and sewer lines. The old meter was housed in a concrete cylinder and the metal cap had been set directly on top. No platform was present.

Figure 9.41. Old meter can at 625 Gomez road, view southwest.

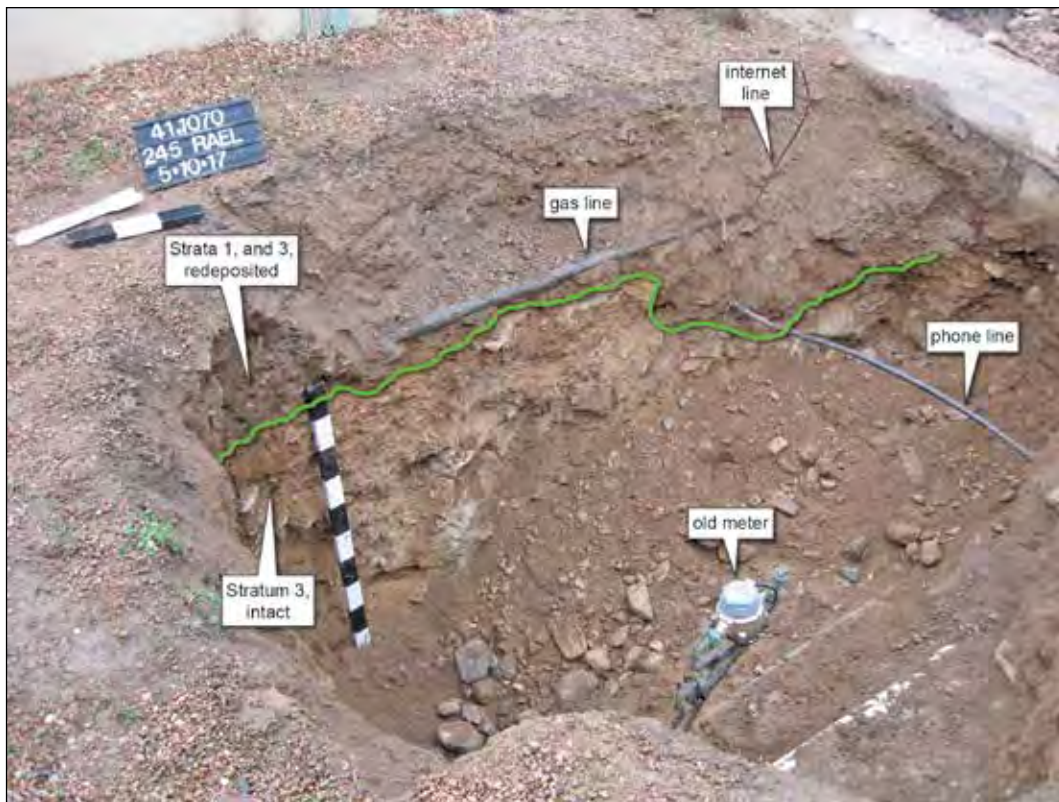
Figure 9.42. 245 Gomez Road can trench, view east.

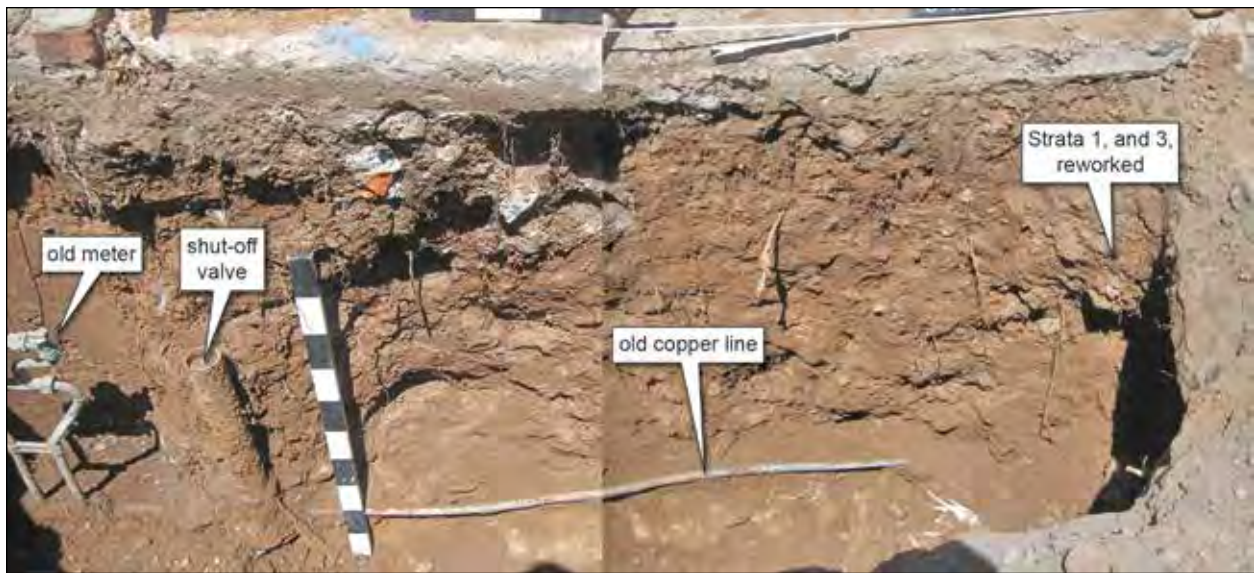
Figure 9.43. 247 Rael Road, view west. Image color shift is due to the combination of two images.

adjacent to a stepped concrete sidewalk that extended along the east side of the home at 248 Rael. The concrete walk varied in thickness from 10–16 cm. It was underlain by a reworked layer of Stratum 1 and large concrete chunks that varied in size from 14–28 cm thick. A Territorial Penitentiary brick fragment was mixed in with the concrete chunks, and a more recent dark red brick was set into the edge of the sidewalk. Penitentiary brick fragments were also mixed in the reworked fill around the shut-off valve. Below the concrete chunk layer to 1.35 m bgs was a redeposited mix of Strata 1 and 3 (Fig. 9.43). From 1.35–1.48 m bgs, Stratum 3 was intact, but consisted only of coarse red granitic sand.

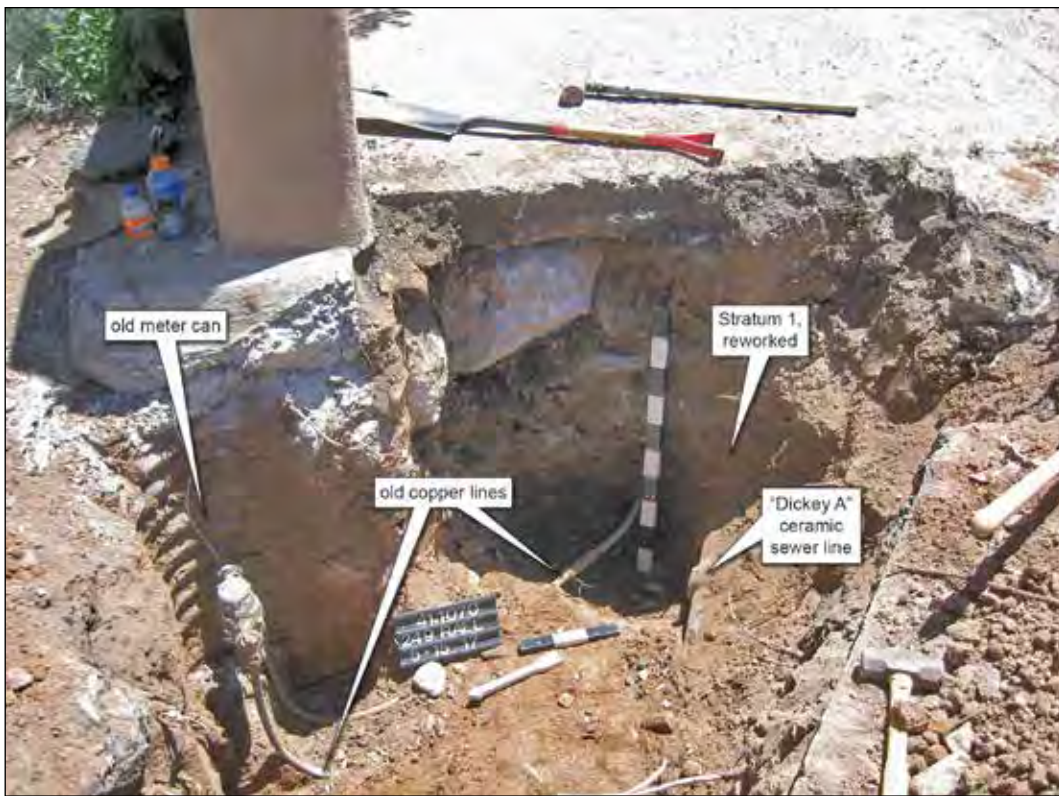
Figure 9.44. 249 Rael Road, view southeast.

249 Rael Road can and trench: A broad, irregularly shaped area was opened up to remove the old meter can at this location and connect it to the new water main. This area was located at the dead end of Rael Road adjacent to a faux adobe wall separating the 246 and 249 lots (Fig. 9.44). Disturbances in this trench were extensive, the meter can and connecting copper lines being the most significant. The can consisted of a length of corrugated culvert pipe set directly into the ground without a platform. Two copper lines (124 cm bgs) extended southwest and southeast from the can, these being the primary reason for the broad excavation in this area. Also, a 6 inch diameter ceramic sewer line stamped with “DICKY A UNION MADE PITTSBURGH” cut roughly east-west across the south end and was also exposed in the adjacent street trench to the west at 1.10 m bgs. The maker’s mark is linked with a broad date span ranging from 1889–1961 (Chapter 10).

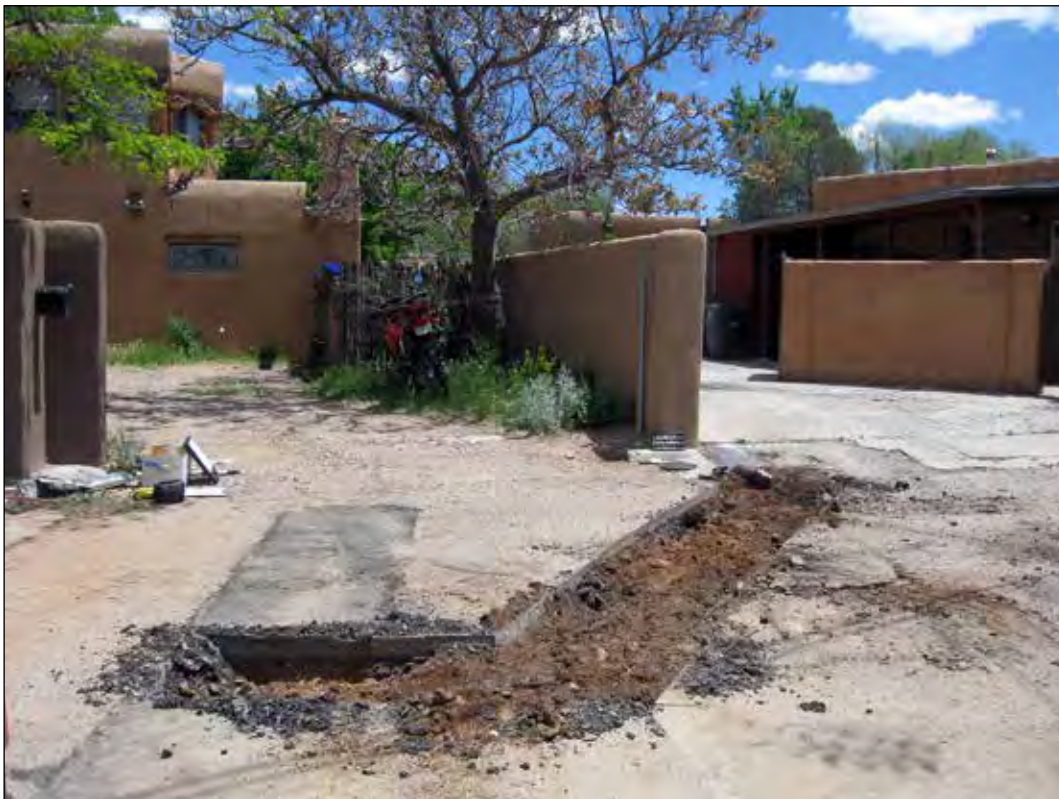
Figure 9.45. 249 Rael Road street trench, pre-excavation, view east.

Remarkably, in the adjacent street trench, sediments were intact, offering the only opportunity to view intact stratigraphy at the far eastern end of the road (Fig. 9.45). The profile here indicated that Stratum 3 trends down to the east, a pattern that could not be confirmed in the Rael main line due to disruption from previous utilities in the easternmost segments.

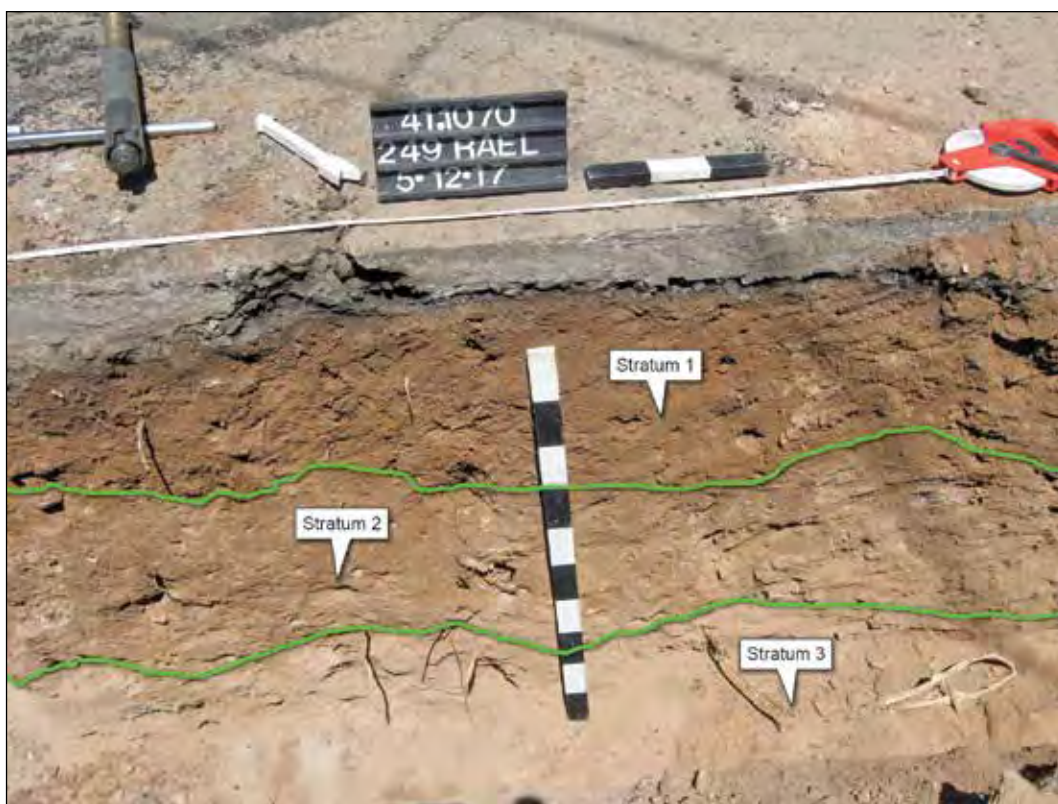
Figure 9.46. 249 Rael Road, view north.

The top layer consisted of Stratum 1—from the asphalt to a maximum depth of 48 cm bgs (Fig. 9.46). Stratum 2 extended 48–100 cm bgs. Below Stratum 2, Stratum 3 extended from 100–128 cm bgs. The upper boundary of Stratum 3 varied between 100–120 cm bgs. Stratum 3 was heavily calcified and contained not only less rock than locations to the west, but smaller rocks. The house at 249 Rael does not appear on any Sanborn map and no twentieth century references were located.

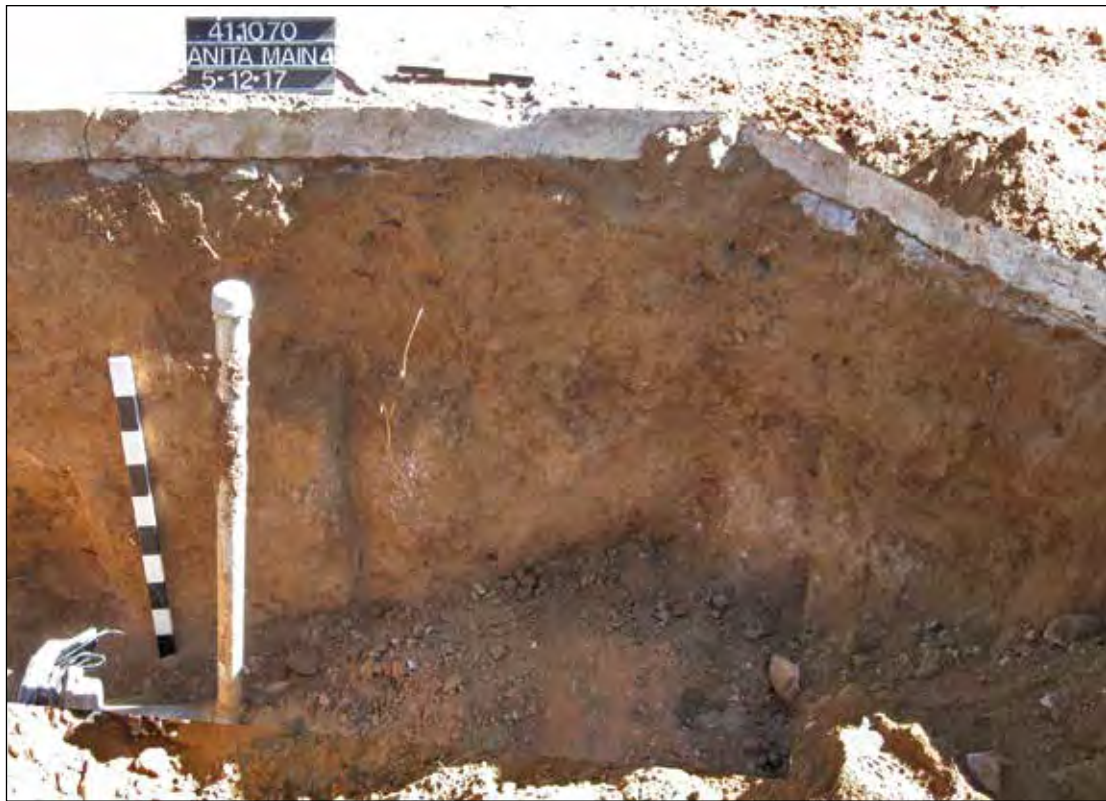
Figure 9.49. Anita Place Main 4, view north.

and 2 were thoroughly remixed down to 1.56 m bgs. The extreme upper boundary of Stratum 3 was contacted below (Fig. 9.49). Inside the trench dug for the vertical access pipe for the 1944 main a broken, proximal cow ulna was found near the base of the pipe at 1.56 m bgs.
