Office of Archaeological Studies

Monitoring of the
Replacement of Water Mains and
Residential Water Meters on
Gomez Road, Rael Road,
and Anita Place,
Santa Fe, New Mexico

ARCHAEOLOGY NOTES 493
2018

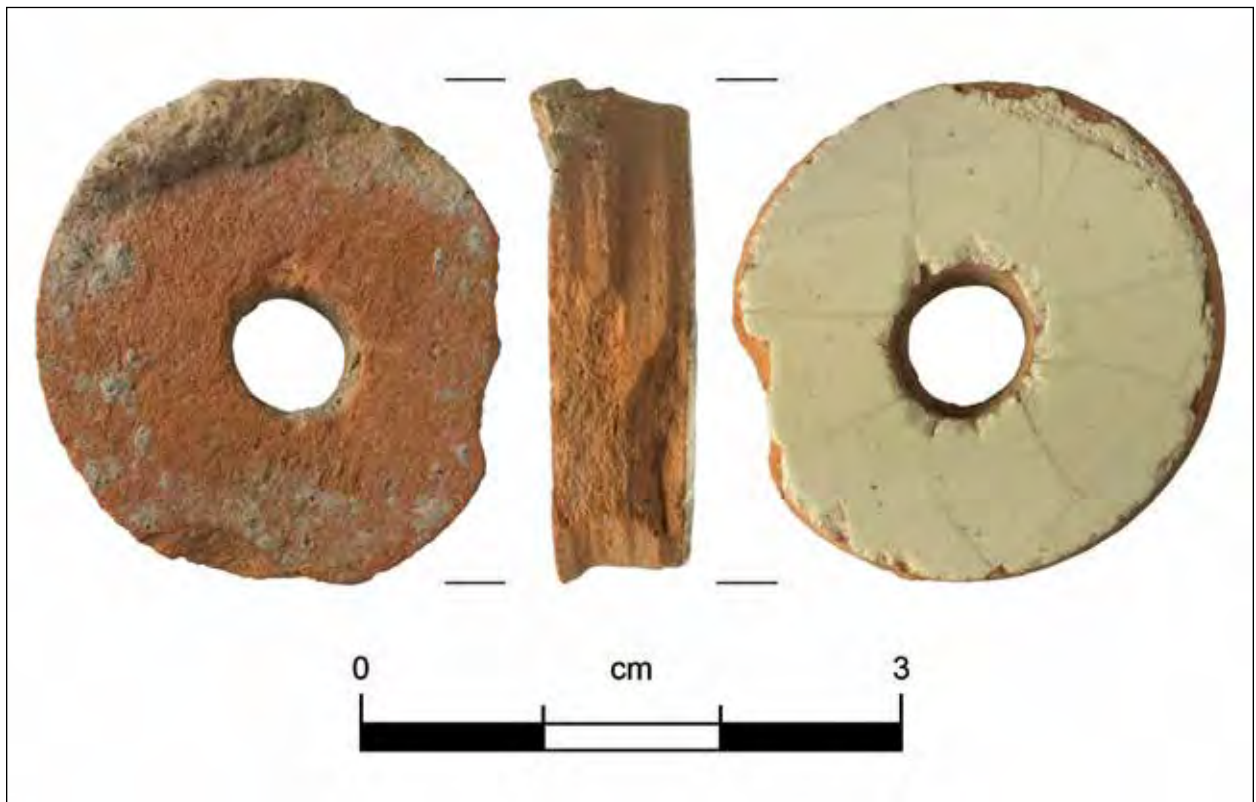
Figure 10.2. Cut architectural tile disk from 627 Gomez Road can trench.

The oval disk has been cut from a piece of white-glazed terracotta architectural tile for the purpose of mounting a pipe fixture to a bathroom or kitchen wall (Fig. 10.2). The edges exhibit concentric rings probably produced by a plug cutter or similar tool, and the center hole has been perforated with a drill bit (1 inch diameter, $\frac{1}{4}$ inch thick). The white glaze is crazed and the underside is lightly coated with cement mortar. Though the disk is not perfectly circular, there is no evidence of hand-shaping on any surface.

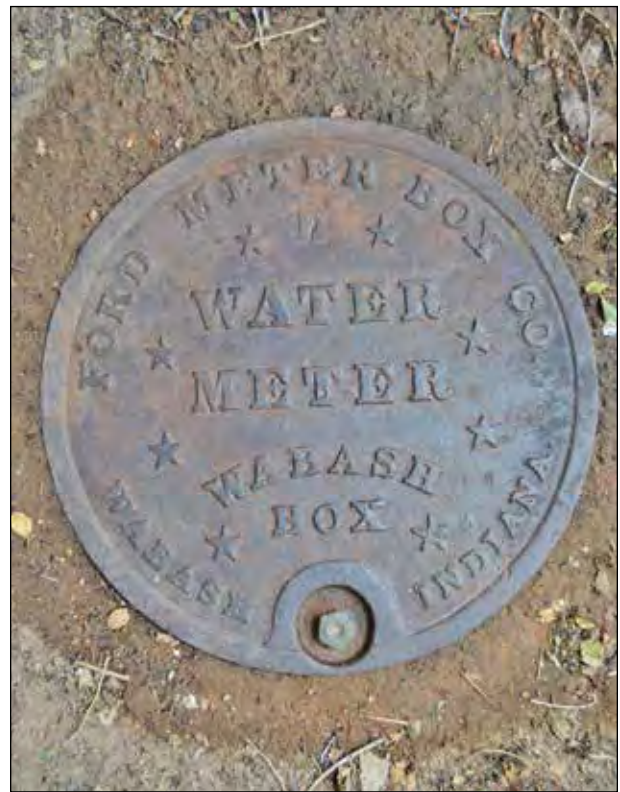
Figure 10.5. Ford Meter Box Company meter cover from Camino Don Miguel.

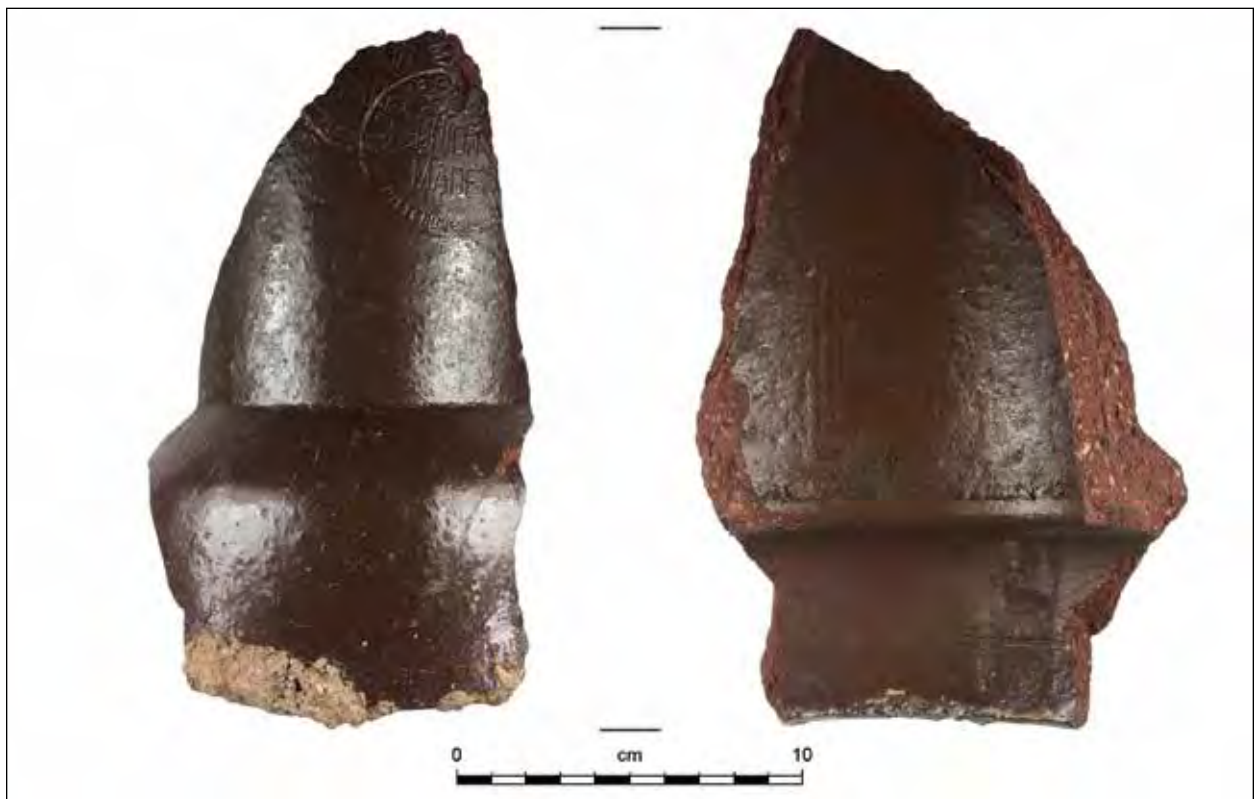
Figure 10.7. Stamped sewer pipe fragment from 249 Rael Road.
